NOTICE OF REGULAR BI-MONTHLY MEETING BOARD OF DIRECTORS

The Smith Saddle Tanks have been in service for 60 years and their interior and exterior coatings have reached the end of their useful lives - extensive corrosion has formed throughout the roof structures of the tanks. Previous inspection reports and video inspections have documented the interior conditions of the tanks, summarizing interior coating failures and severe corrosion on the roof structures of the tanks, the rafters and entry points, and specifically above the waterline.

The Consultant conducted a comprehensive evaluation of the tanks including structural, seismic, interior and exterior coating, safety, security and site area improvements. One of the tanks was completely drained and a detailed interior inspection of the floor, shell and roof steel framing and plates along with protective coatings was conducted. The structural and seismic evaluation identified significant areas of the existing tanks construction that are not in conformance with national standards which result in deficiencies in structural performance. Examples of structural deficiencies include lack of tank anchorage and strengthening to decrease o

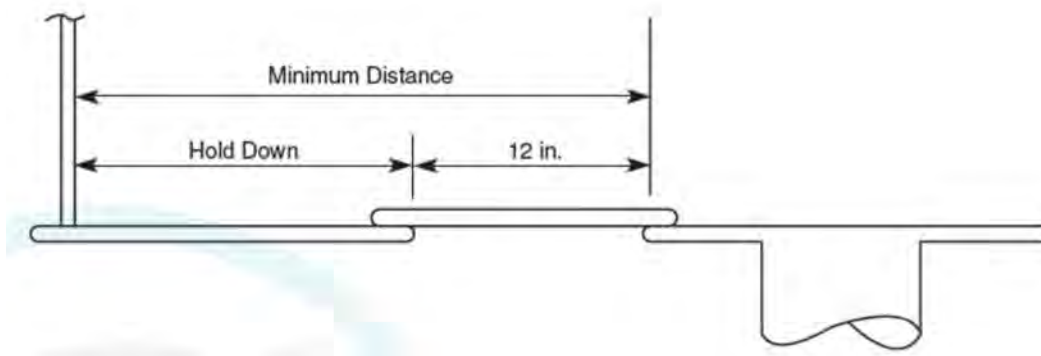
Figure 2: Bottom Piping Connection of Self-Anchored Tank

Bottom connections for self-anchored tanks should be located inside the shell a sufficient distance to minimize damage by uplift. The existing tanks have two bottom connections on each tank. An 8-inch-diameter drain connection, which is located approximately 10 inches from the inside of the shell on the tank to the centerline of the connection and a 24-inch-diameter intertie connection between the two tanks, which is located approximately 3 feet-0-inch from the inside of the shell on the tank to the centerline of the connection. In accordance with Section 13.6.2 of AWWA D100-11, the minimum distanced measure to the edge of the connection reinforcement should be the required width of the bottom annulus, 1-foot-7 inches, plus 12 inches, or 2 feet-7 inches overall, see Figure 1. The existing bottom connections provide 1- $\frac{3}{4}$ -inch for the 8-inch drain connection and 11- $\frac{1}{4}$ -inch for the 24-inch intertie connection. In order to prevent damage to the tank and avoid release of the tank contents due to failure of the piping system, the District should consider removing, plating over, and replacing the bottom piping connections to the two tanks.

Above ground piping connections were provided for the inlet and outlet on each tank with flexible connectors to provide sufficient flexibility. Based on AWWA D100-11 Table 30, the inlet and outlet piping connections to the tank should provide upward vertical displacement of at least 4 inches, downward vertical displacement of at least 1-inch, and horizontal displacement (radial or tangential) of at least 2 inches. Based on the type of flexible connectors provided, there should not be any reason why the minimum design displacements for above ground piping attachments would not be sufficient.

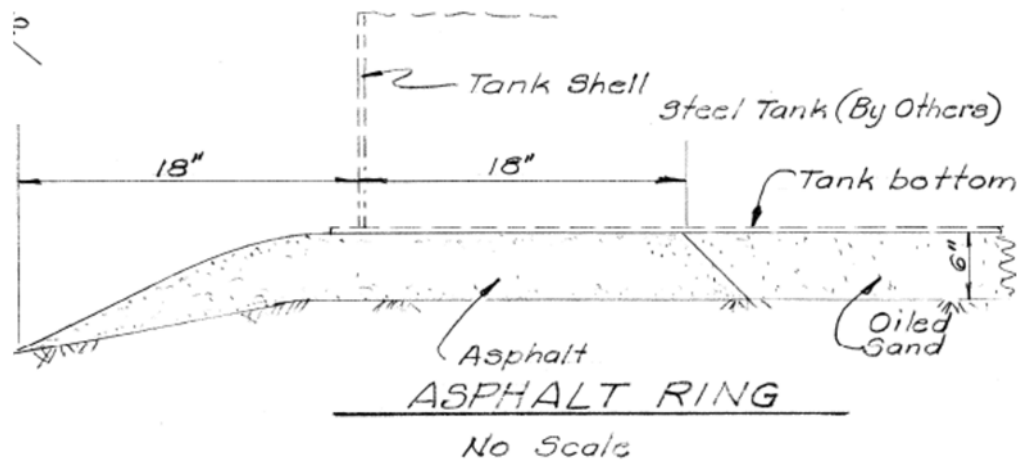
Figure 3: Existing Asphalt Ring Detail

Based on the District's Drawing No. 2873/C9-10-4, Sheet 1 of 4, asphalt ring detail the existing tanks were originally constructed with an asphalt ring of approximately 3 feet-0-inch width and 6-inch thickness with one-half of the ring width, 18 inches, intended to be placed beneath the floor plate of the tank, see Figure 2. The asphalt ring was intended to contain the 6-inch thick oiled sand layer beneath the floor plates of the tank. The 18-inch thickness beneath the tank floor is consistent with the total width of bottom annulus intended for bearing in accordance with AWWA D100-11 Section 13.5.4.1.1 based on the ¼-inch floor plate thickness of the bottom annulus. Many of the deficiencies with the bottom of the tank and lack of conformance with AWWA D100-11 were already presented in Sections 2.3 and 3. The existing asphalt ring foundation is similar to a Type 4 foundation, as noted in AWWA D100-11. However, asphalt was utilized instead of a granular material and the asphalt was not provided with adequate protection to ensure against foundation washout and adequate provisions for drainage. New tanks should be supported on reinforced concrete ringwall foundations.

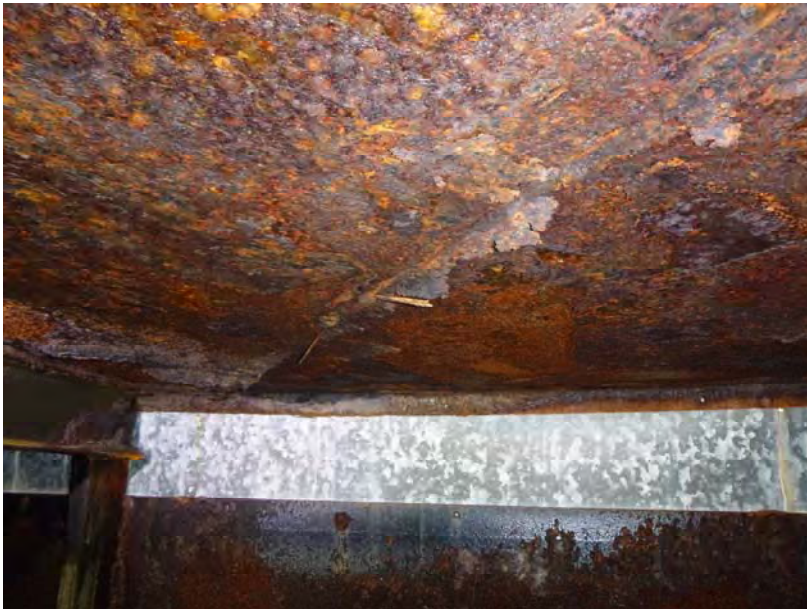
Photo #10:

Tank 1, Interior, Roof: Roof plates near shell with complete loss of coatings and extensive corrosion of metal.

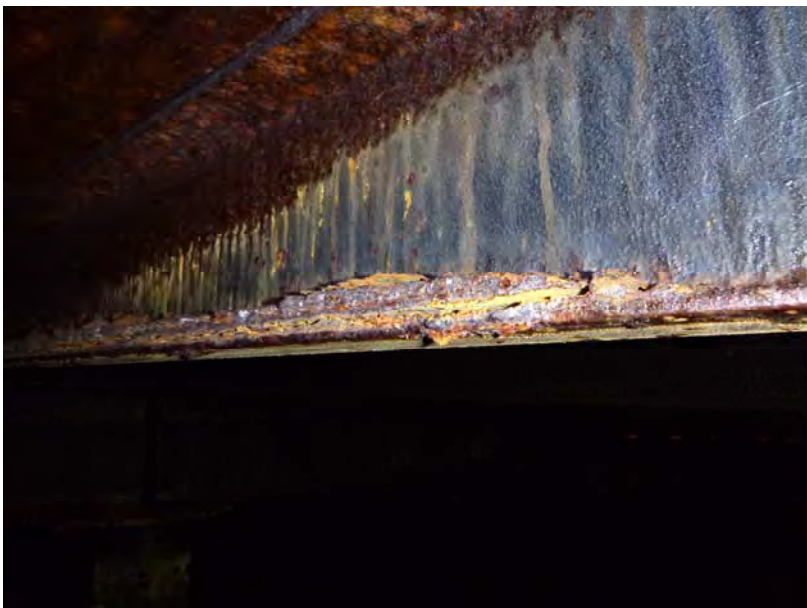
Photo #11:

Tank 1, Interior, Roof: Roof plates near shell with complete loss of coatings and extensive corrosion of metal.

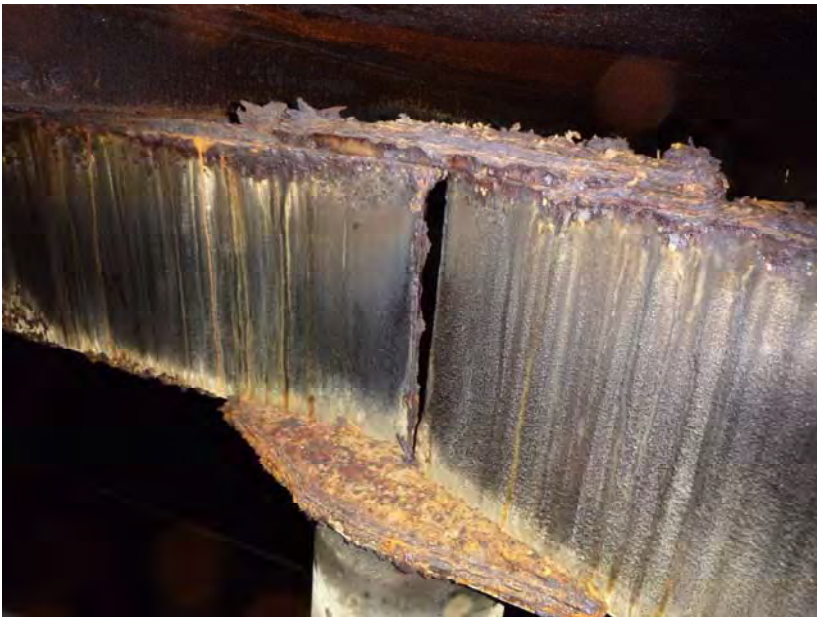
Photo #12:

Tank 1, Interior, Roof: Radial channel beams with corrosion of metal of the bottom flanges and at the faying surfaces on the top of flanges with the underside of roof plates.

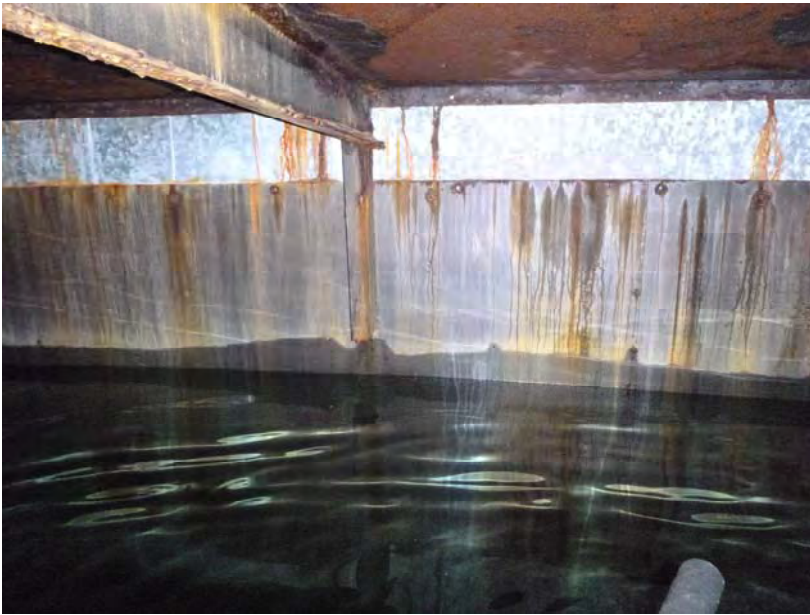
Photo #15:

*Tank 1, Interior, Shell:
Typical shell condition above
maximum water surface with
significant coating failure,
blisters, fractures, and loss
of metal.*

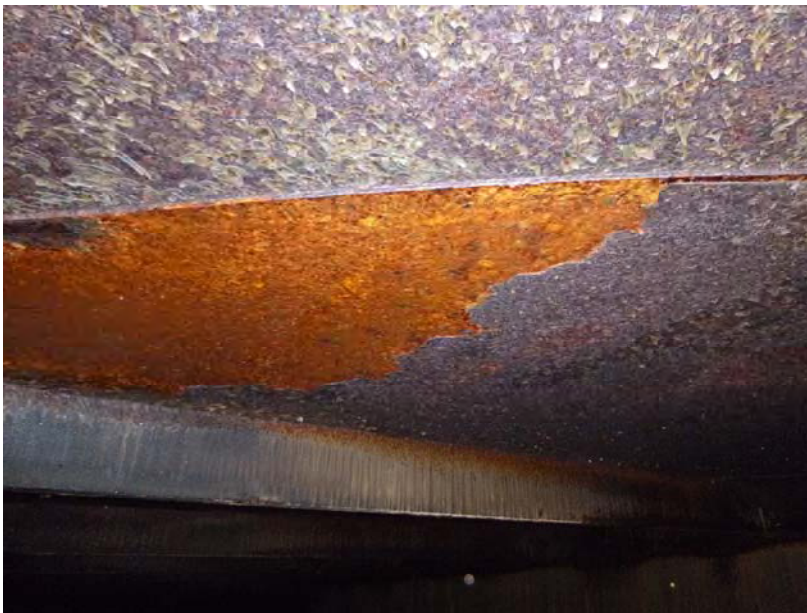
Photo #18:

Tank 1, Interior, Roof: Girder web with significant coating failure and potential loss of metal.

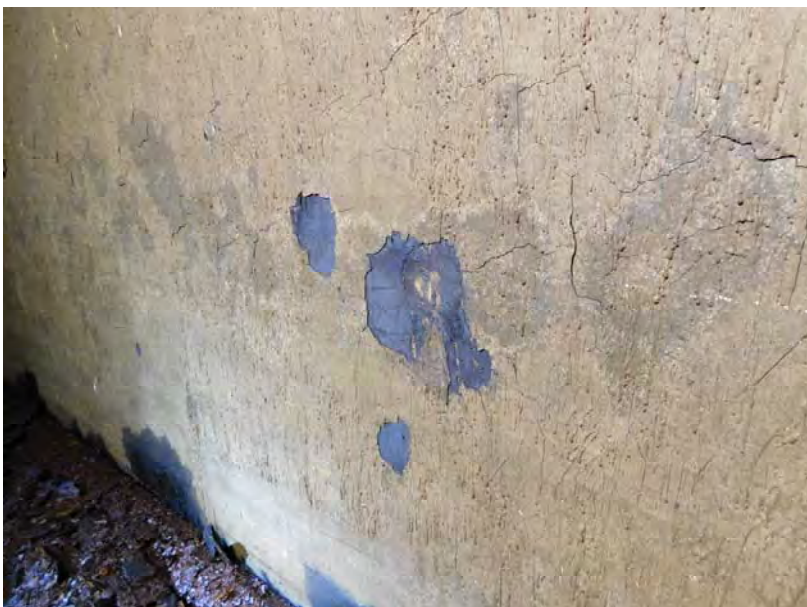
*Tank 2, Interior, Floor:
Closeup of floor with coating
removed bare steel with no
loss of metal or pitting.*

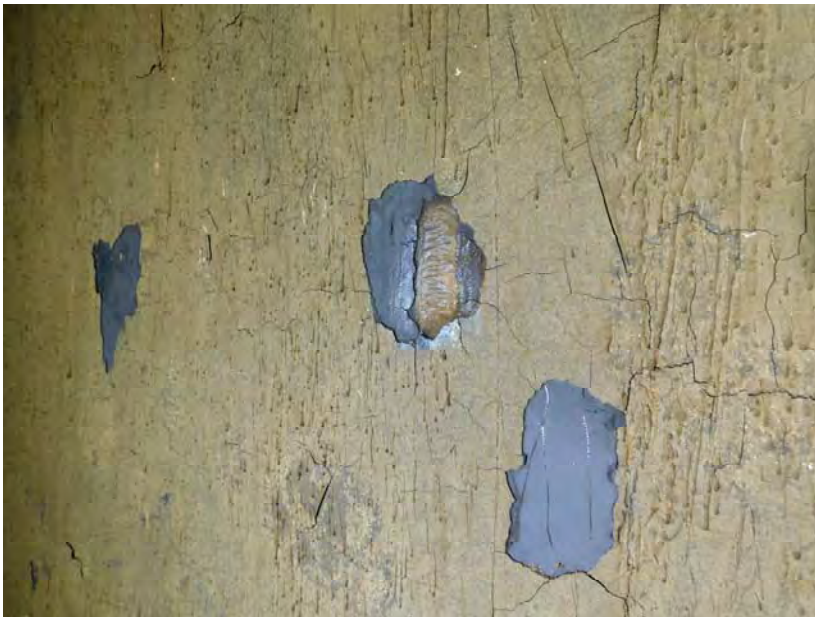
Photo #30:

*Tank 2, Interior, Shell: Failed
coal tar jet set primer and hot
coal tar enamel on interior
shell on lower half.*

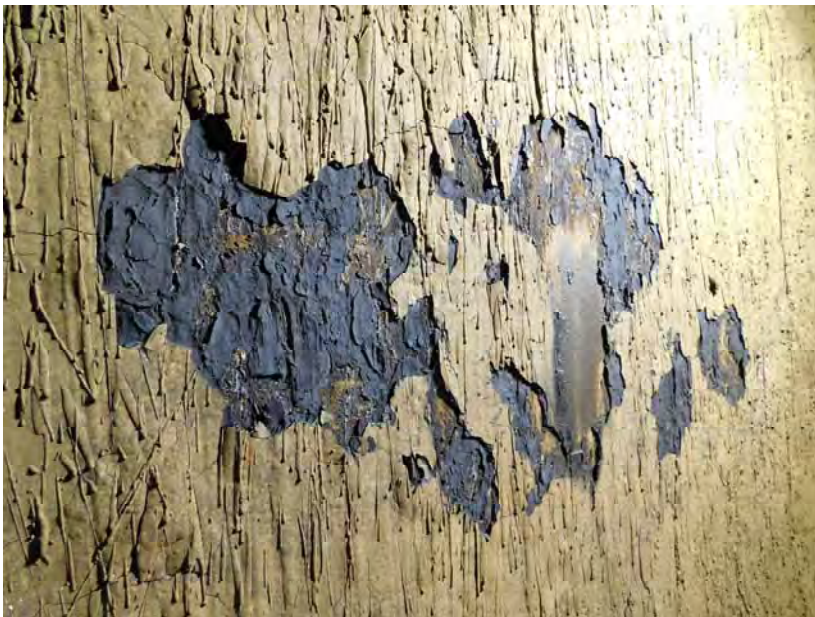
Photo #31:

Tank 2, Interior, Shell: Failed coal tar jet set primer and hot coal tar enamel on interior shell on lower half. Close up of vertical weld seam with metal intact.

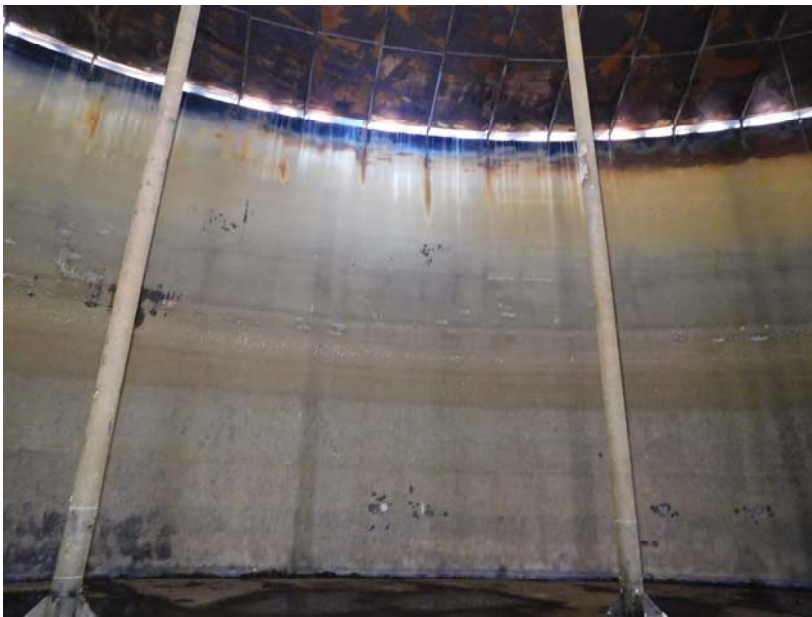
Tank 2, Interior, Shell: Blister domes on interior shell hot coal tar enamel coating.

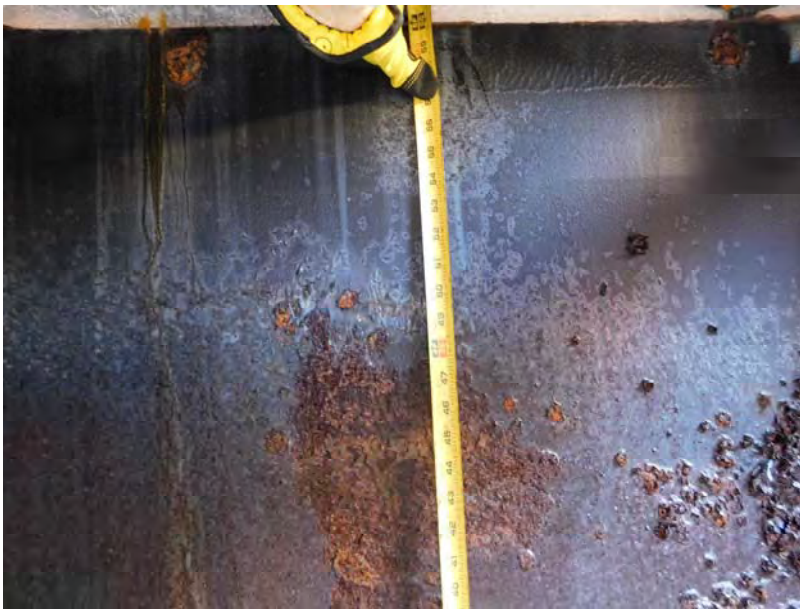
Photo #39:

Tank 2, Interior, Shell: Upper shell in the vapor space is failing with evidence of corrosion and metal loss.

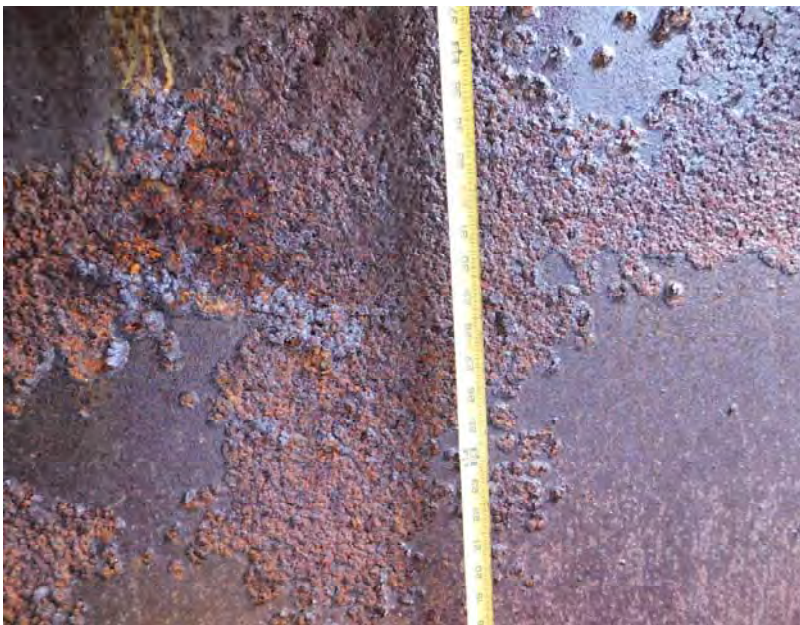
Photo #40:

Tank 2, Interior, Shell: Upper shell in the vapor space just below vent screening is failing with evidence of corrosion and metal loss.

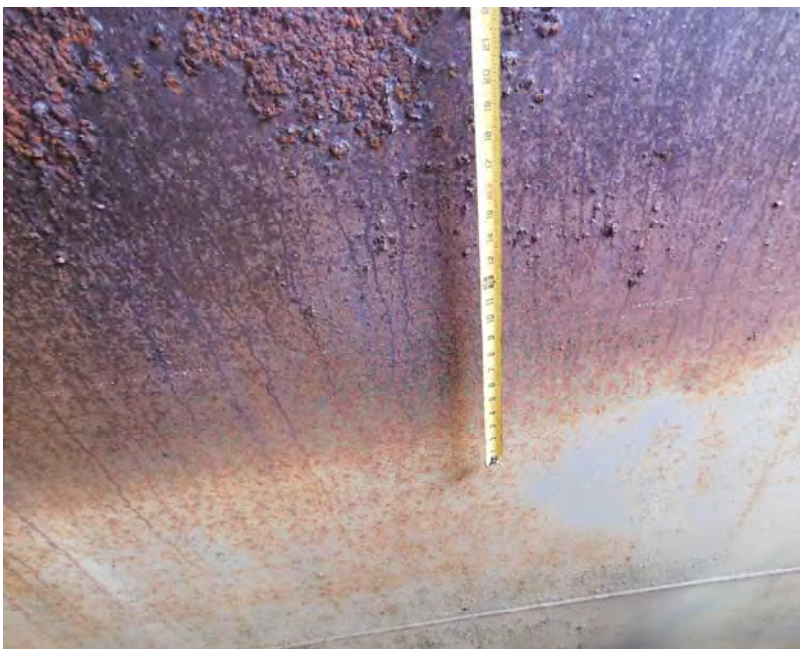
Photo #41:

Tank 2, Interior, Shell: Upper shell in the vapor space is failing with evidence of corrosion and metal loss (closeup).

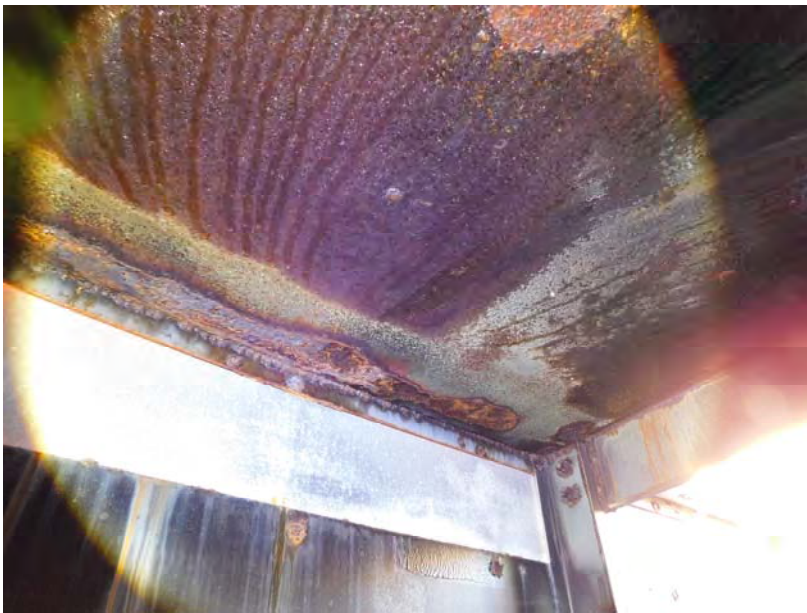
Photo #42:

Tank 2, Interior, Shell: Upper shell in the vapor space is failing with evidence of corrosion and metal loss. Just below large, corroded areas transitioning to normally submerged region.

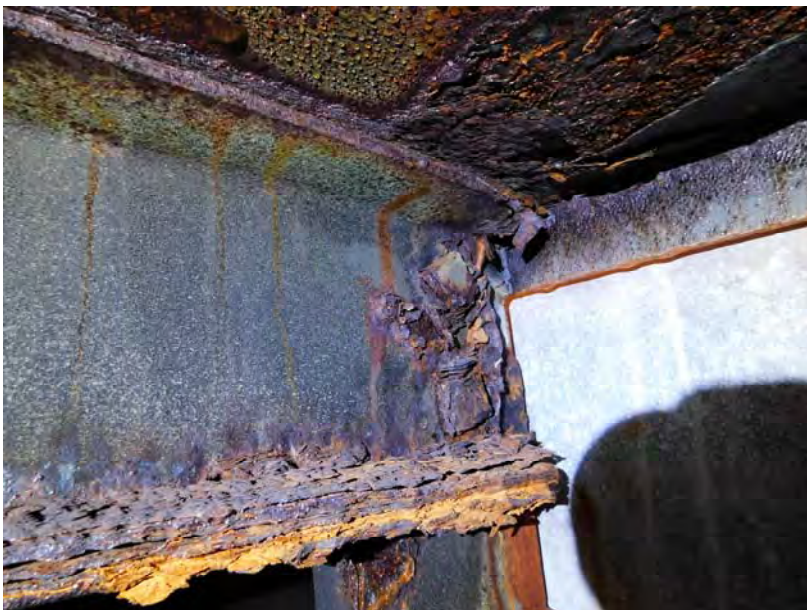
Photo #43:

Tank 2, Interior, Shell: Outer bay adjacent to the abandoned shell vents has moderate corrosion on the roof plates.

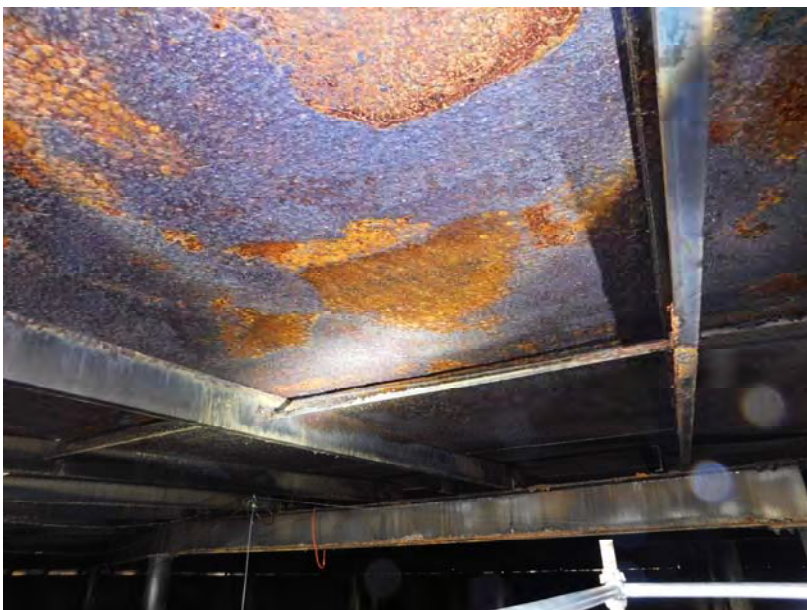
Photo #44:

Tank 2, Interior, Shell: Outer bay adjacent to the abandoned shell vents. The nuts and bolts that fasten the rafters to the shell support exhibited 50% ± metal loss

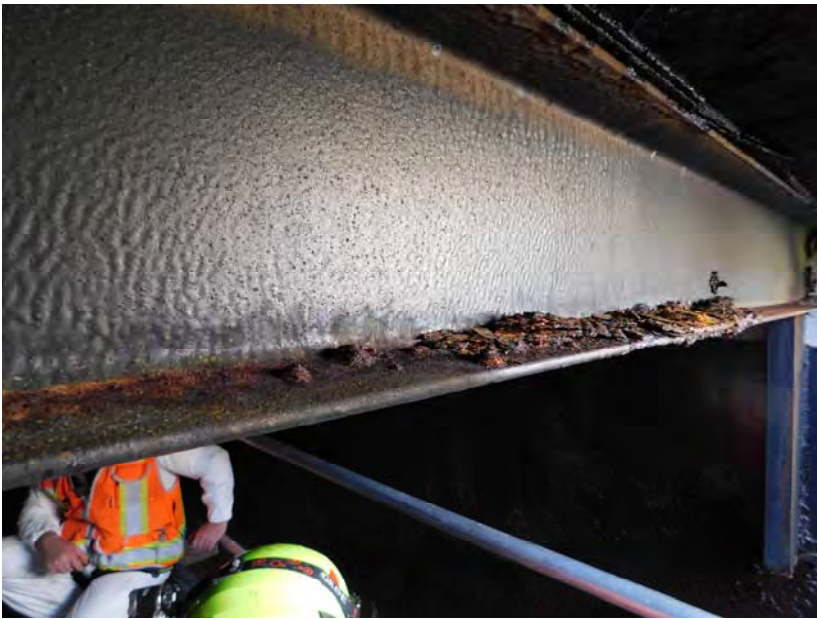
Photo #45:

Tank 2, Interior, Roof: Failure of interior protective coatings on underside of roof plates with loss of metal.

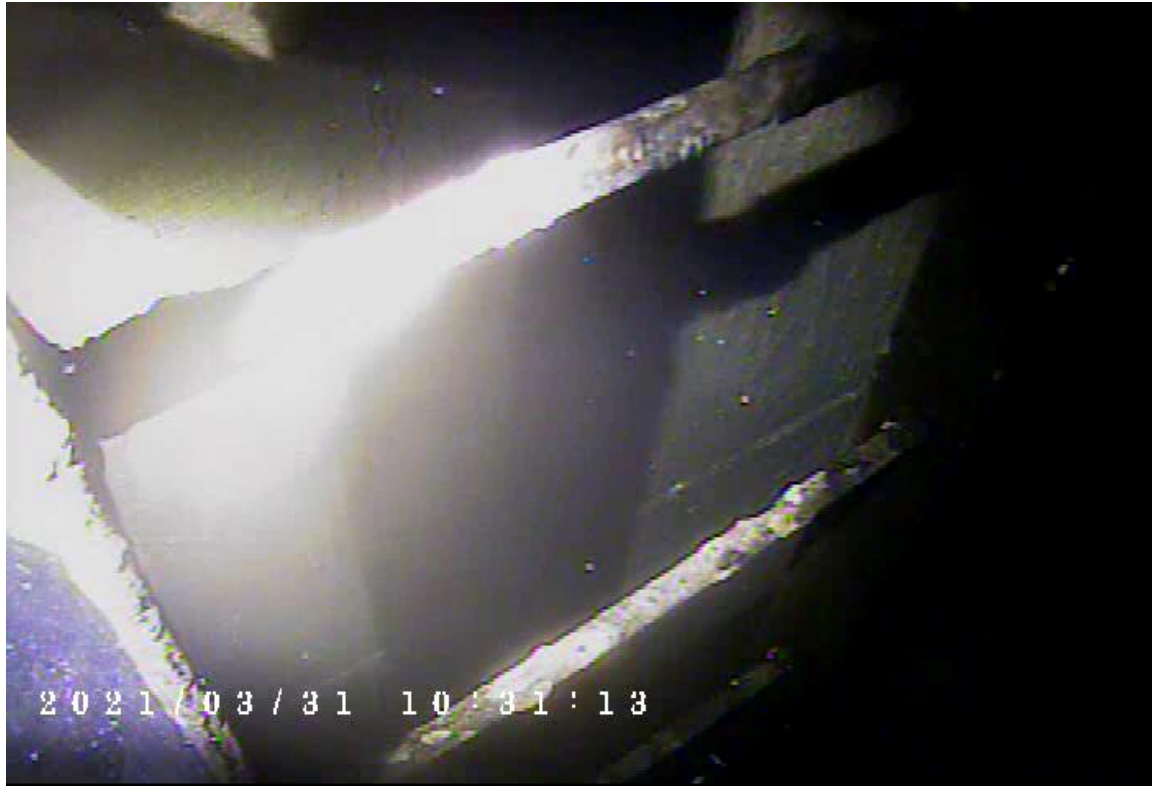
Image 1 – Minor pitting on ladder coating

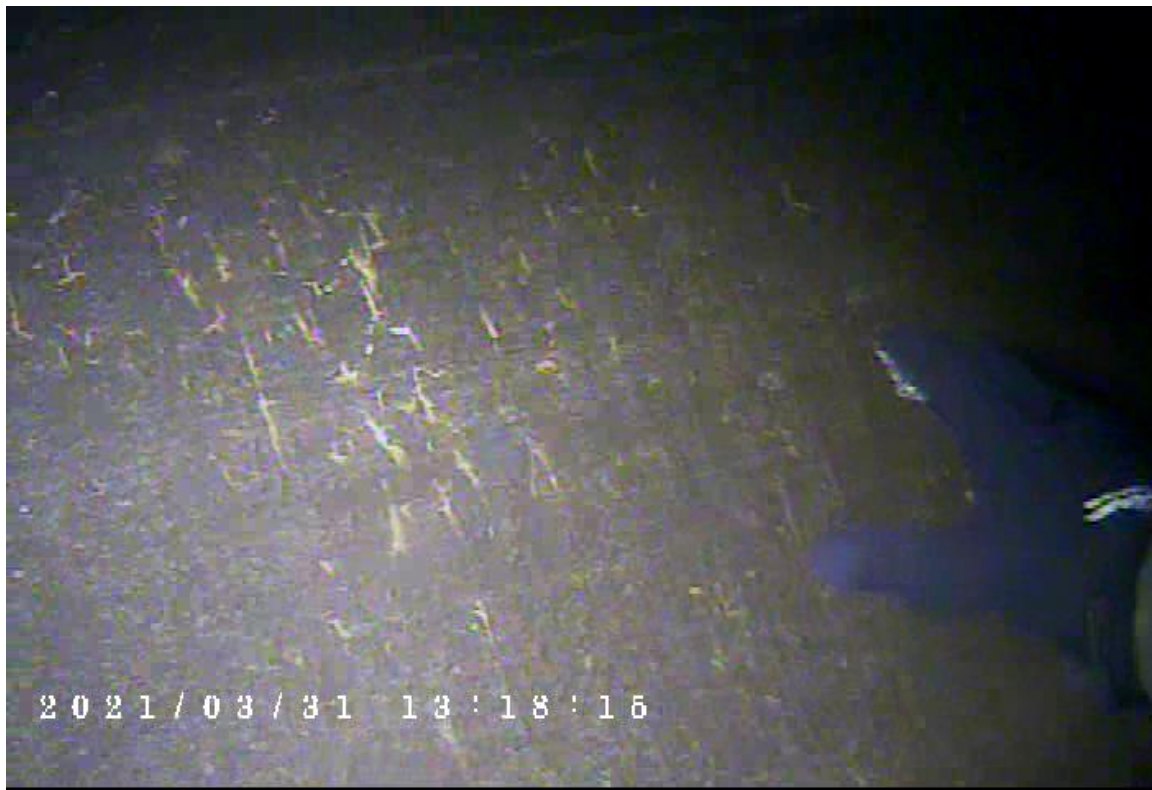
Image 6 – 2-foot-wide area of cracking paint 10-feet left of the ladder (typical)

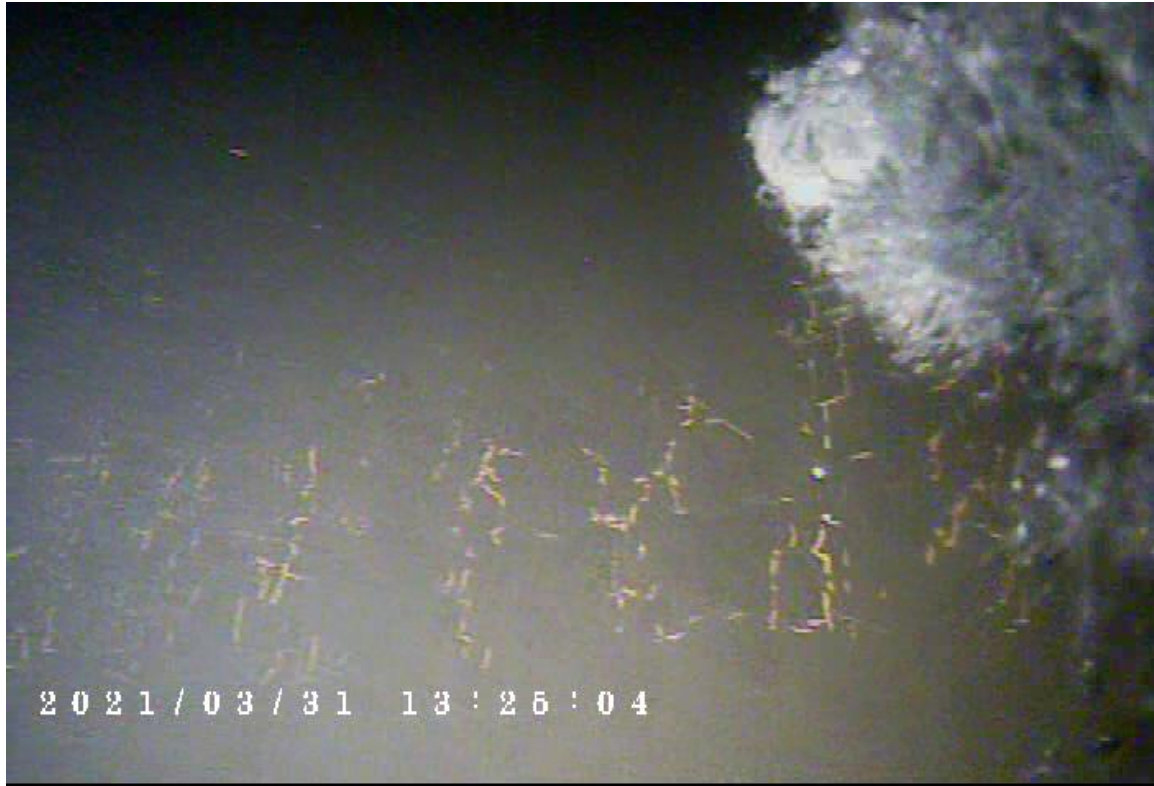
Image 7 – Coating cracking in vertical stripe pattern above first horizontal seam

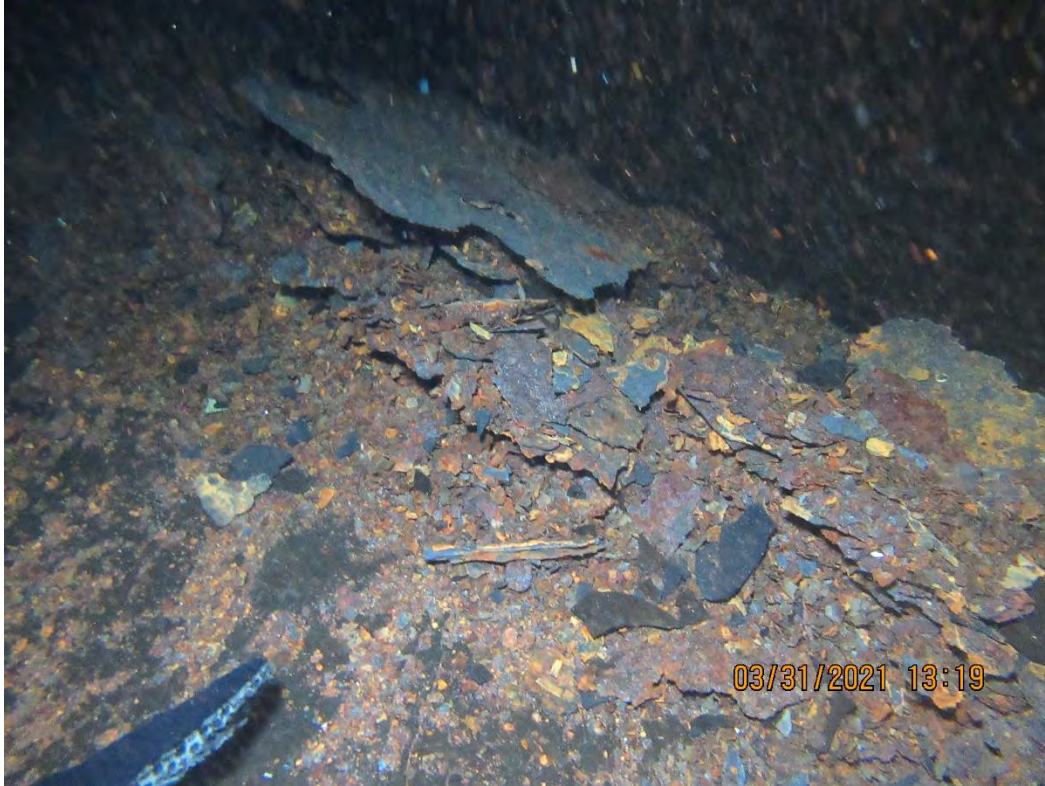
Image 9 – Rust pile on floor at wall in northeast quadrant

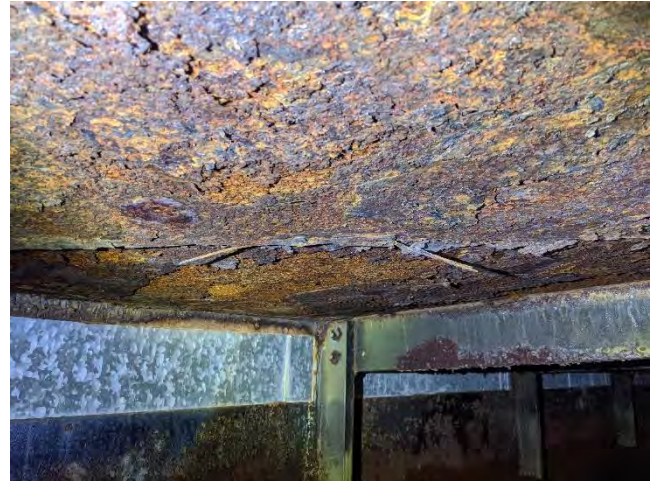
Photo 4-4. Moderate corrosion on roof plate

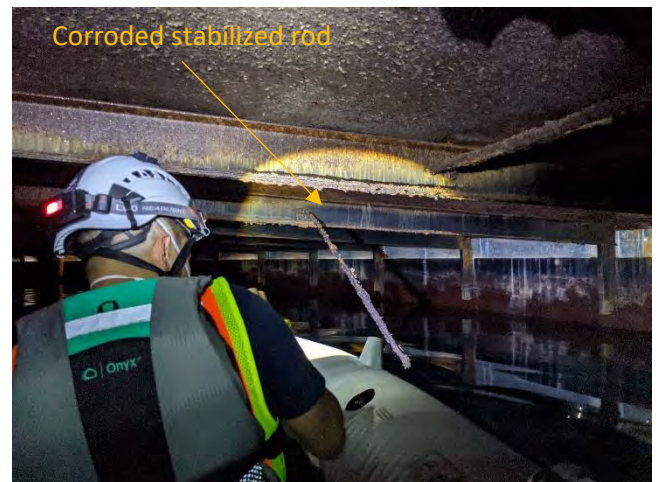
Photo 4-6 corroded stabilizer rod

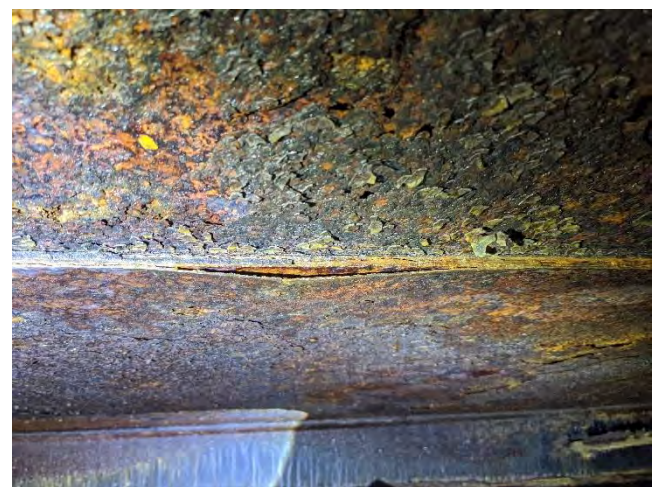
Photo 4-8 Failed coating and moderate corrosion

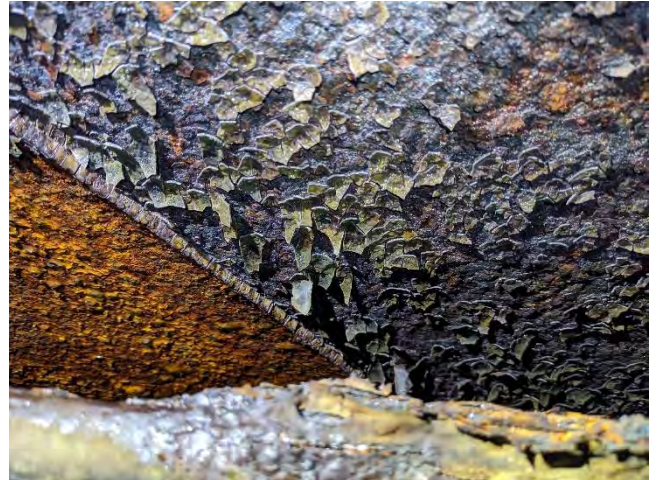
Photo 4-10 failed coating

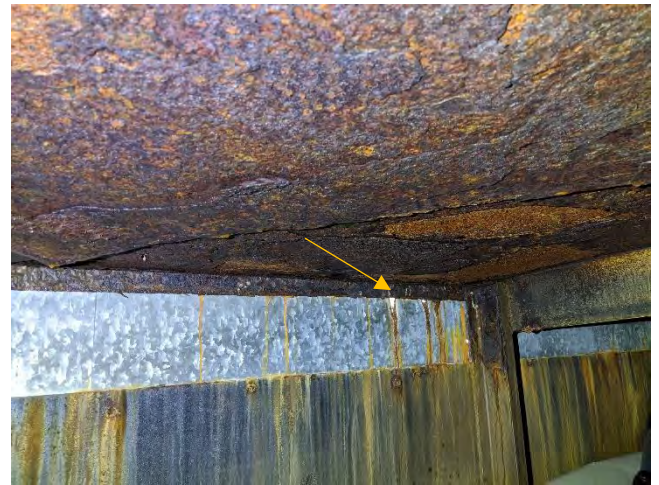
Photo 4-12 holes found in sheet metal

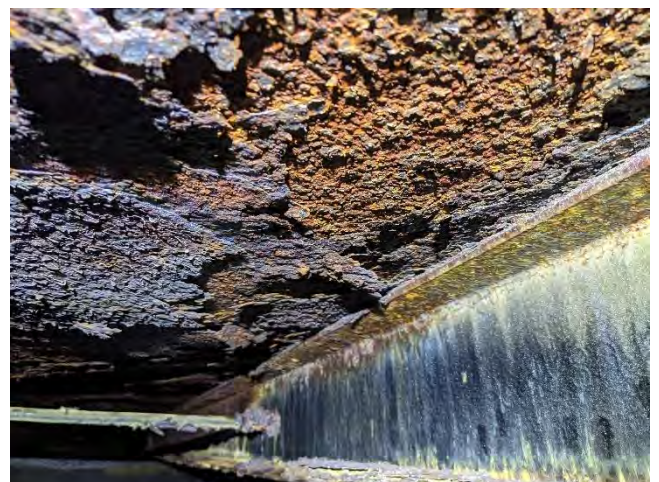
Photo 4-14 Moderate corrosion

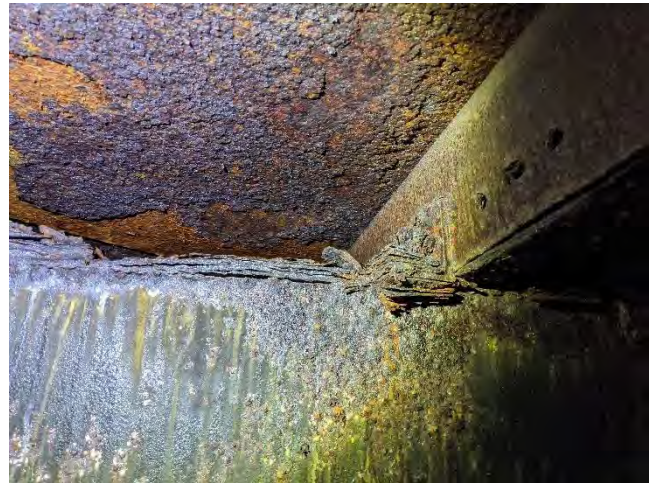
Photo 4-16 moderate corrosion

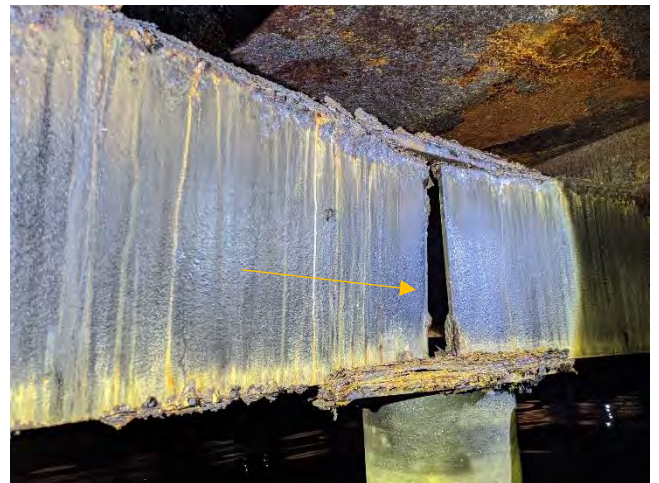
Photo 4-18 girder not lining up

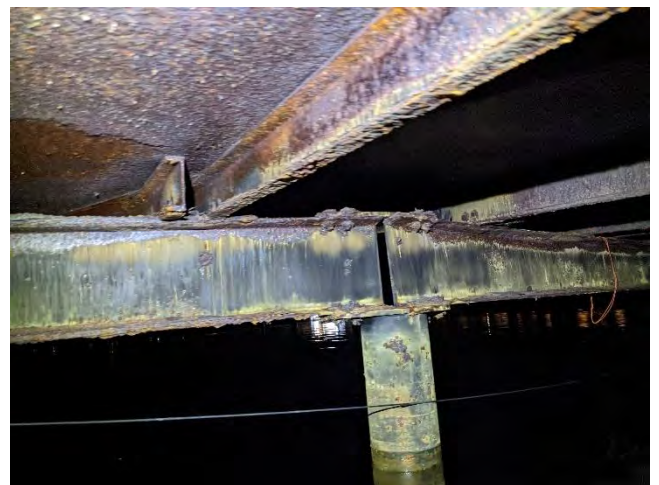
Photo 4-20 Failed coating intermediate bay

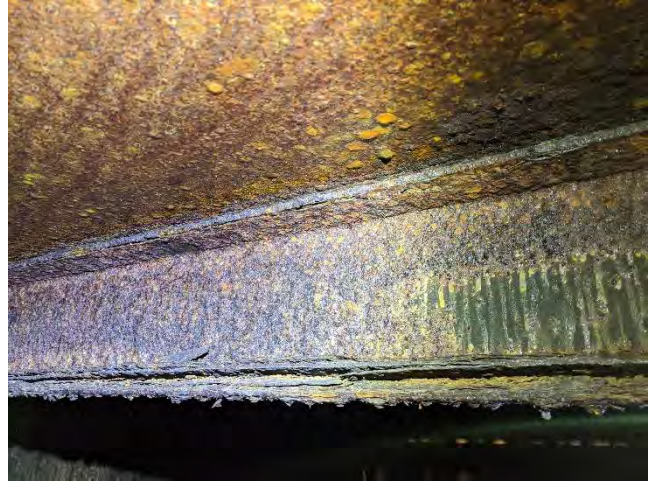
Photo 4-22 Moderate corrosion on flange
