Seeger Dam Spillway Repair Update

Operations Committee

September 17, 2021

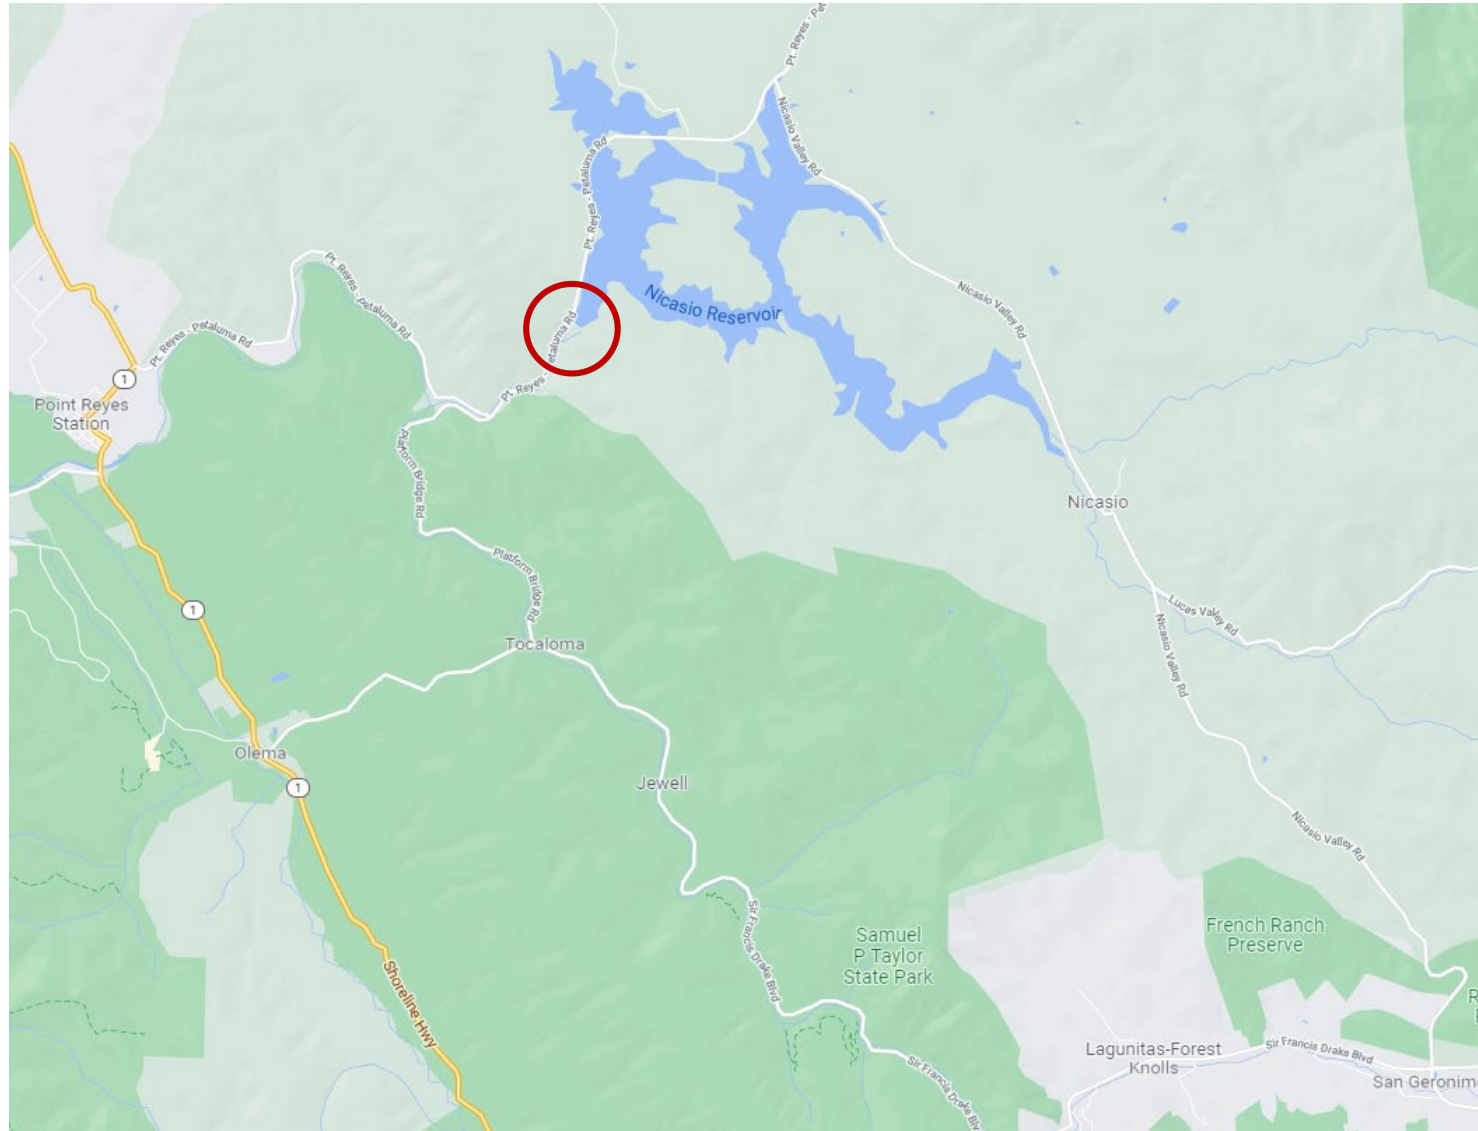
Seeger Spillway Voids

Voids exposed, compromised material removed

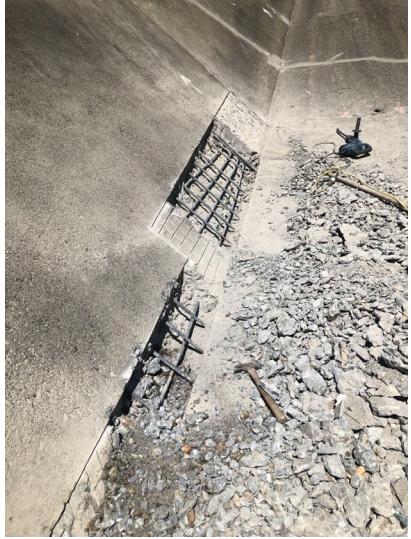
1. Voids completely exposed
