Lead and Copper Rule Revision Customer Service Line Inventory Compliance Plan and Results FINAL

**Marin Water
220 Nellen Avenue
Corte Madera, CA 94925**

June 28, 2024

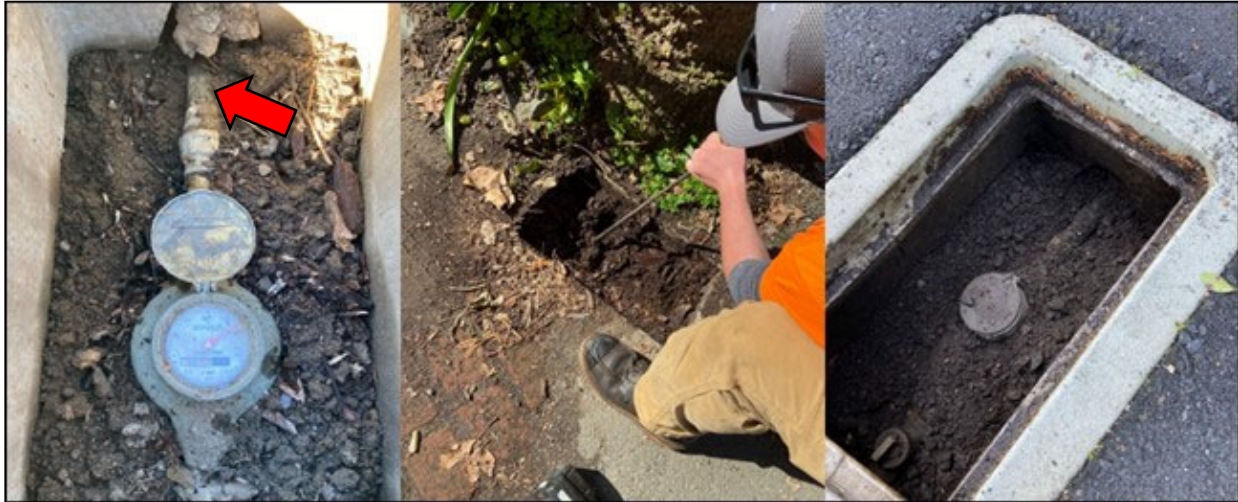
The material type of the service was visually examined within the meter box downstream (i.e. customer side) of the meter, as shown in Figure 4 below, and recorded with a handheld computer connected to the District's SAP database.

Figure 4. Field verification of customer service lines by Marin Water staff. Note: location of service pipe material verification indicated by red arrow.

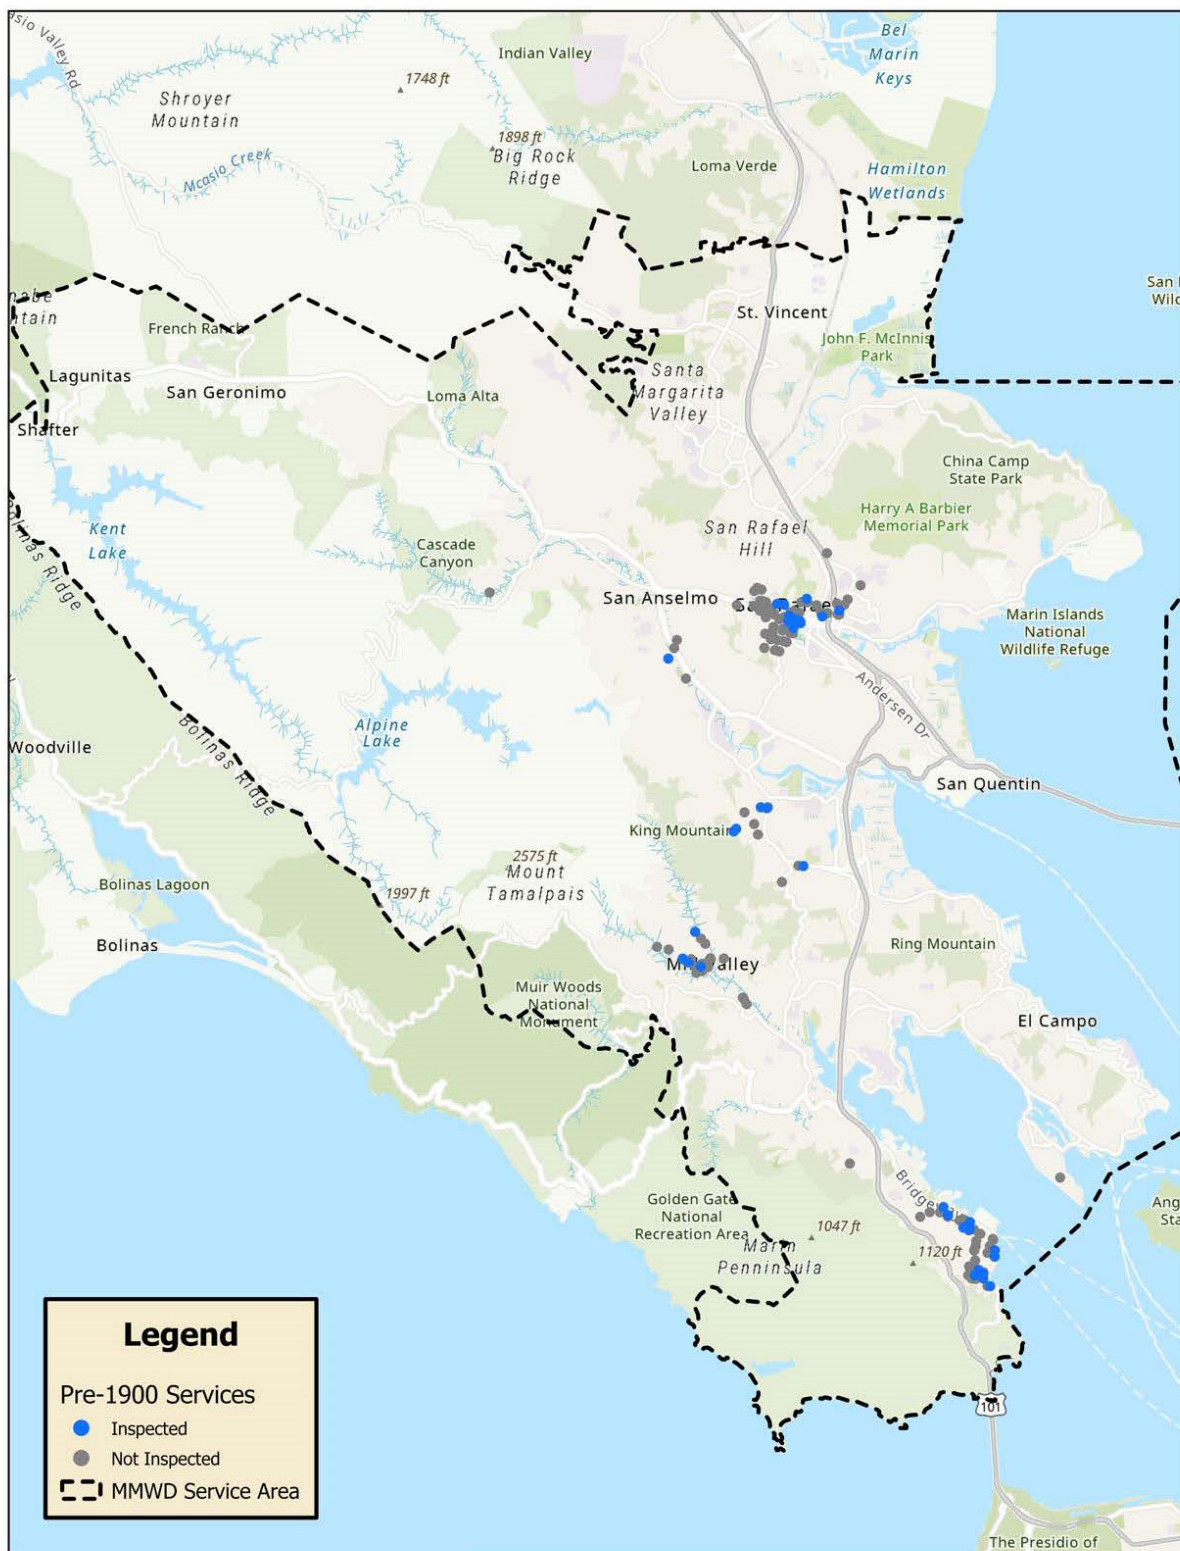
Appendix A. Figure A2. Field investigation results of customer service lines for pre-1900 era

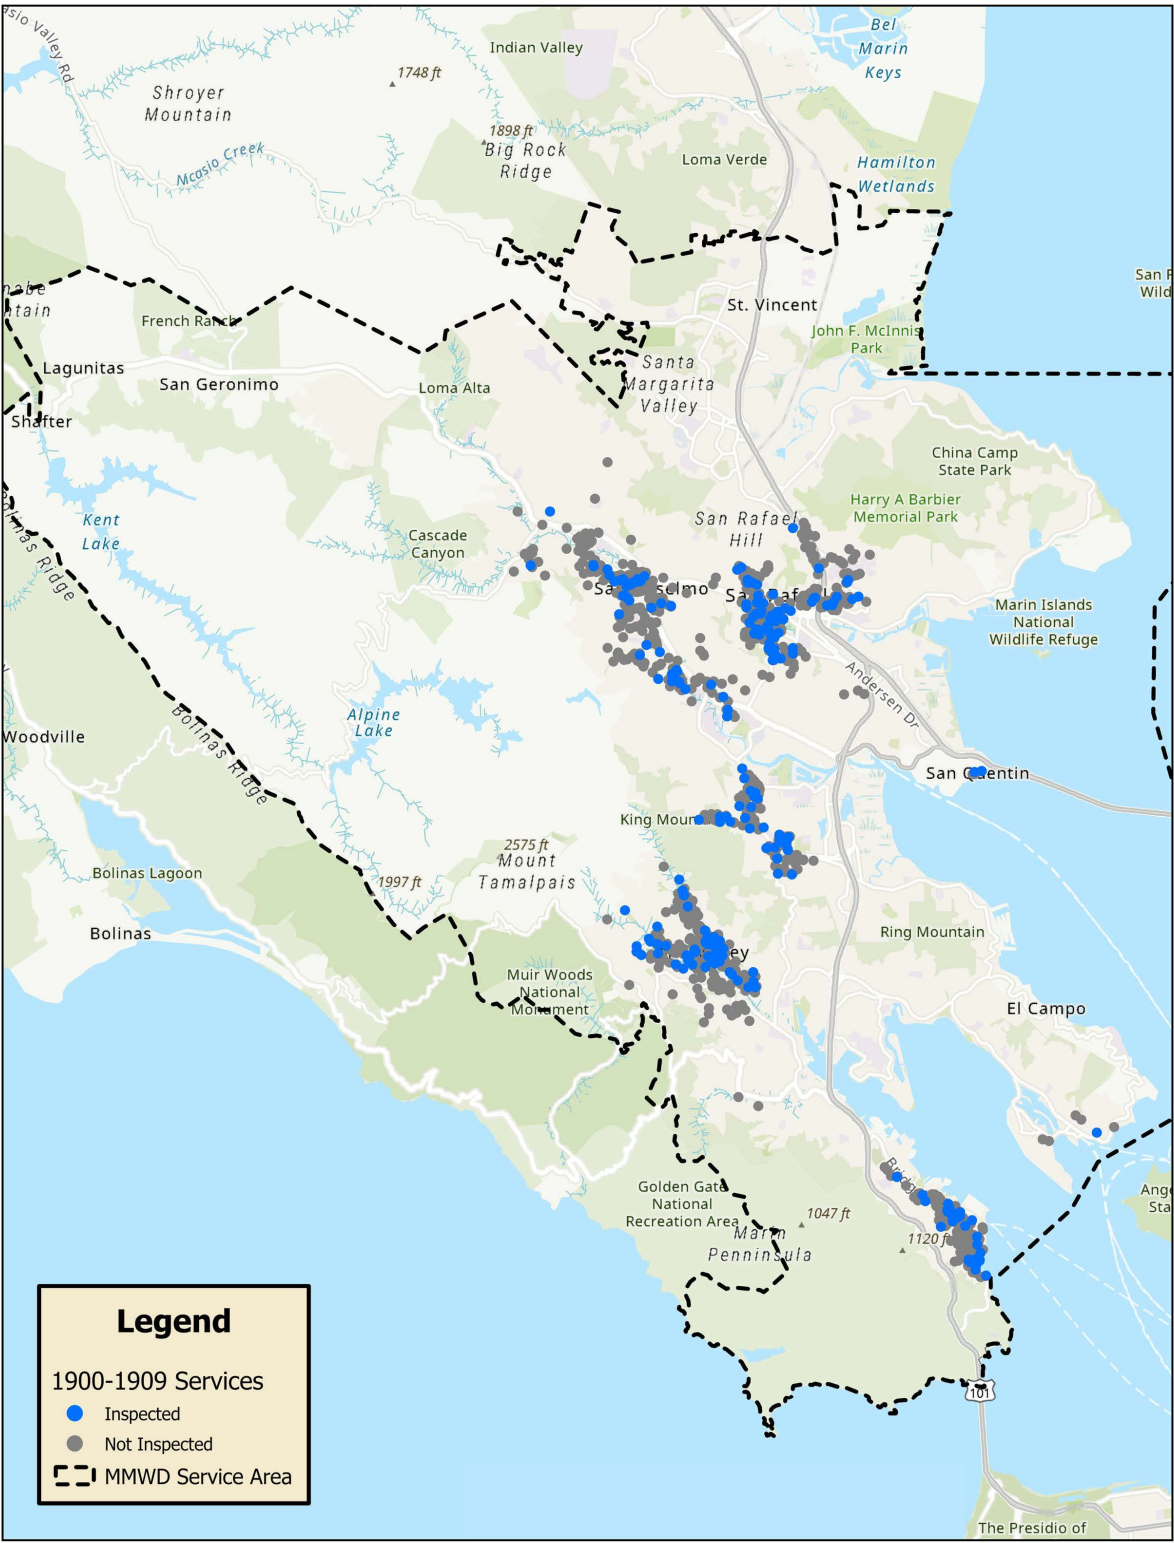
Appendix A. Figure A3. Field investigation results of customer service lines for 1900-1909 era

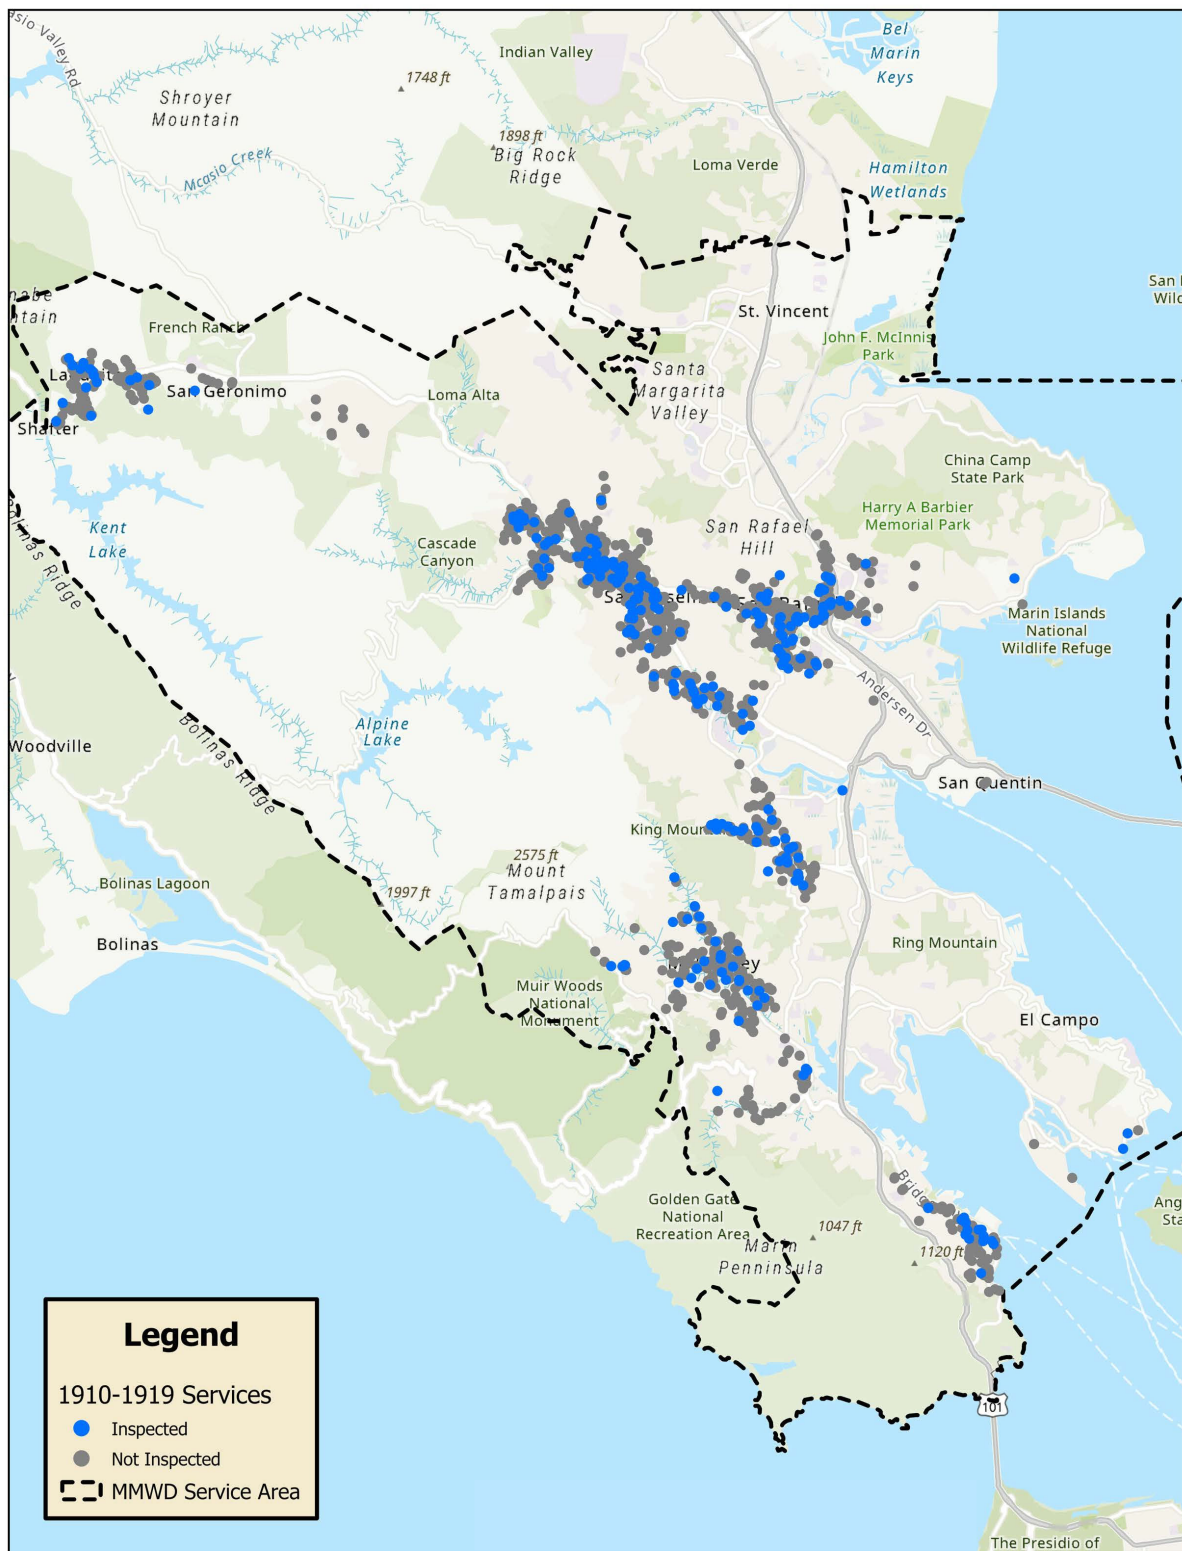
Appendix A. Figure A4. Field investigation results of customer service lines for 1910-1919 era

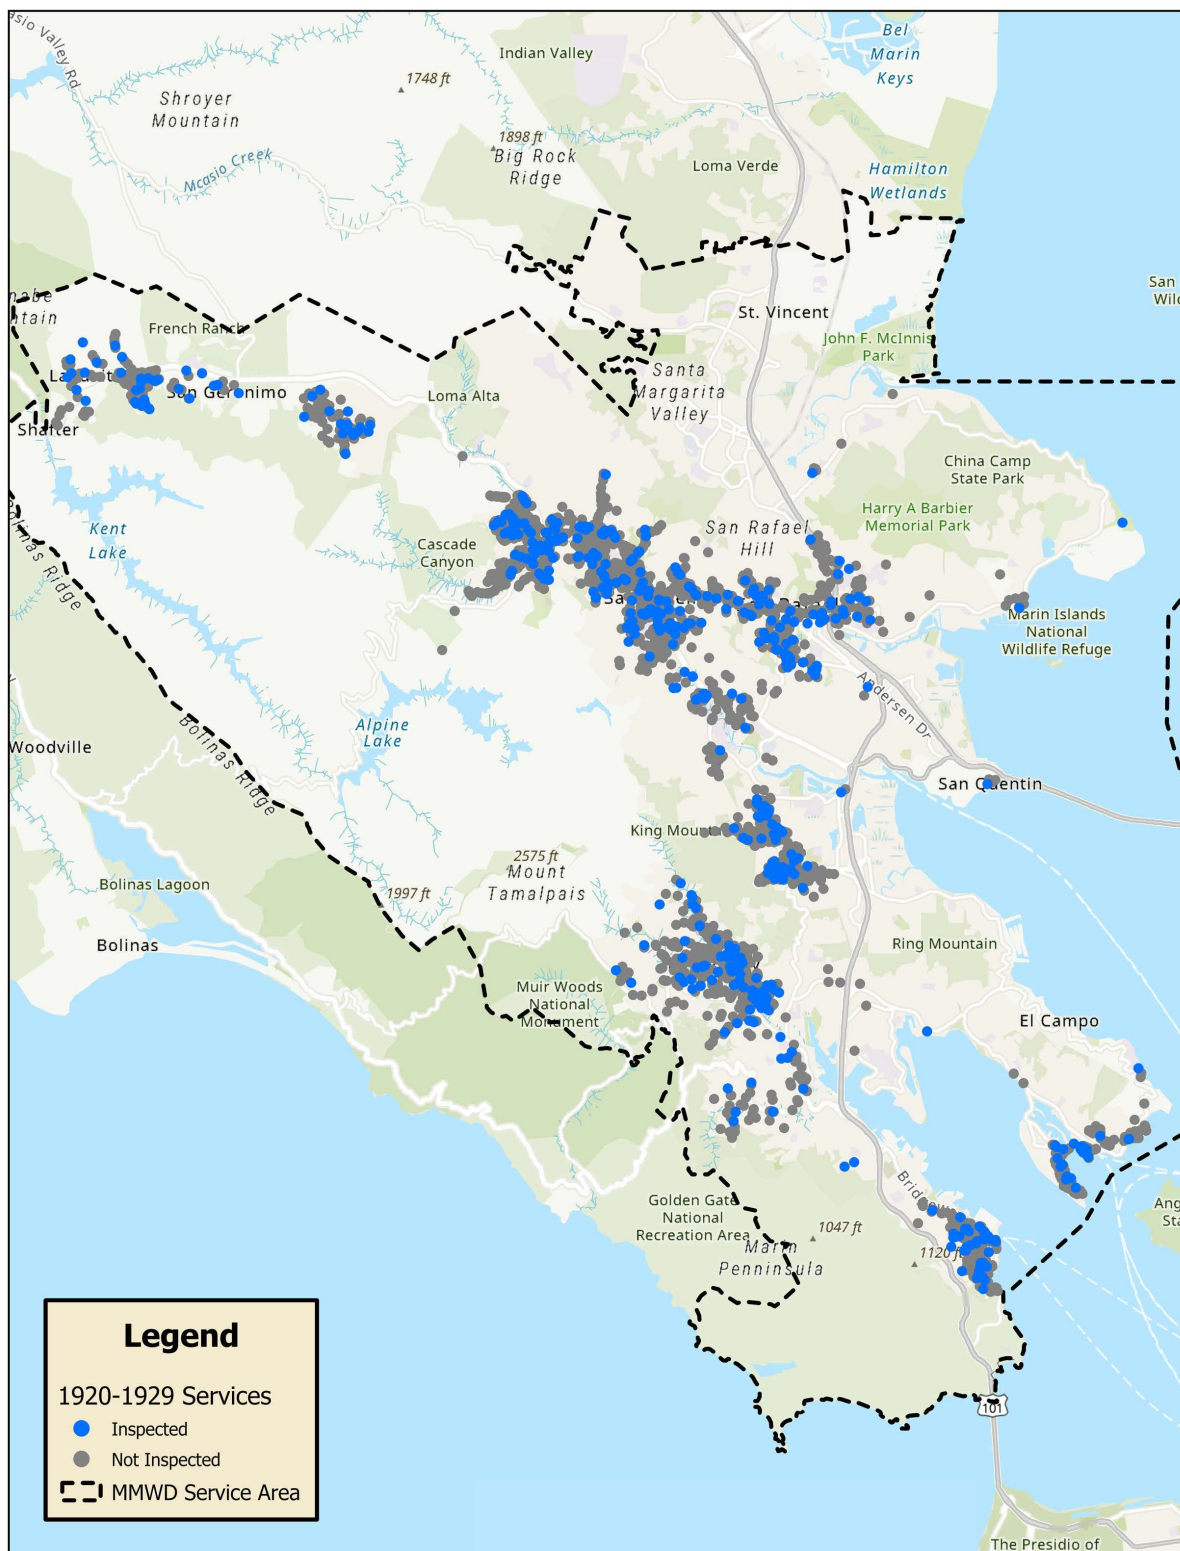
Appendix A. Figure A5. Field investigation results of customer service lines for 1920-1929 era

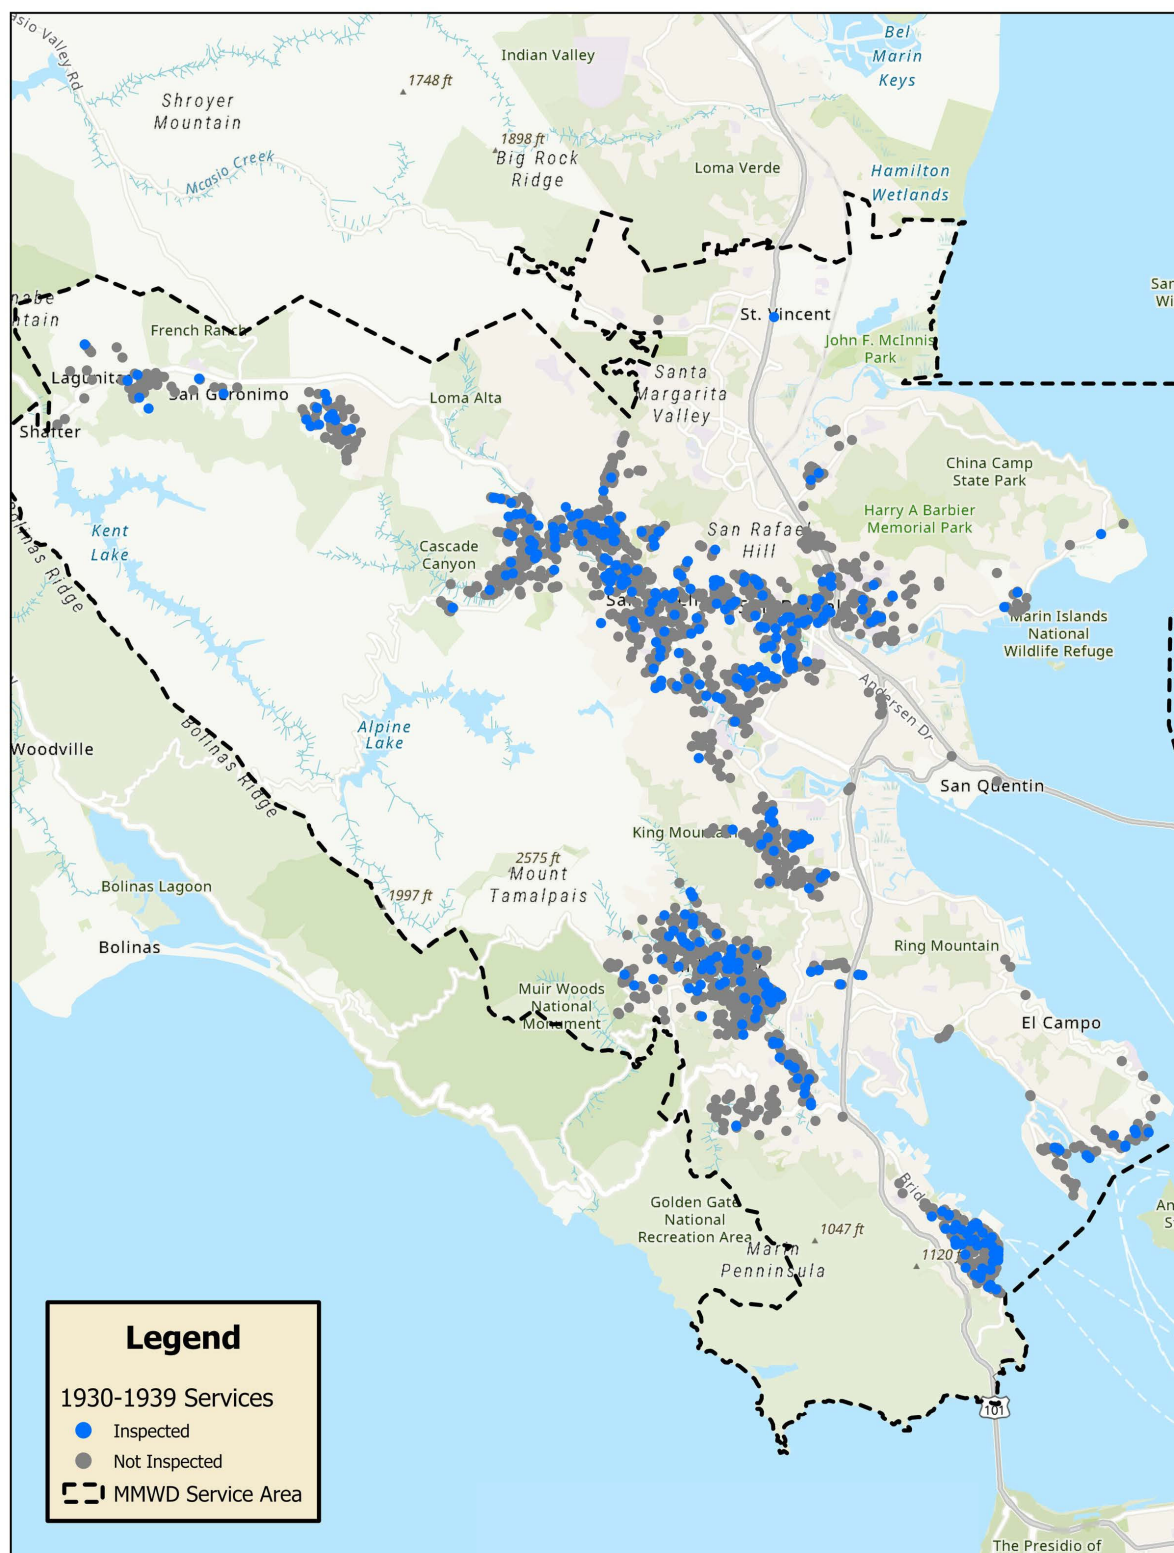
Appendix A. Figure A6. Field investigation results of customer service lines for 1930-1939 era

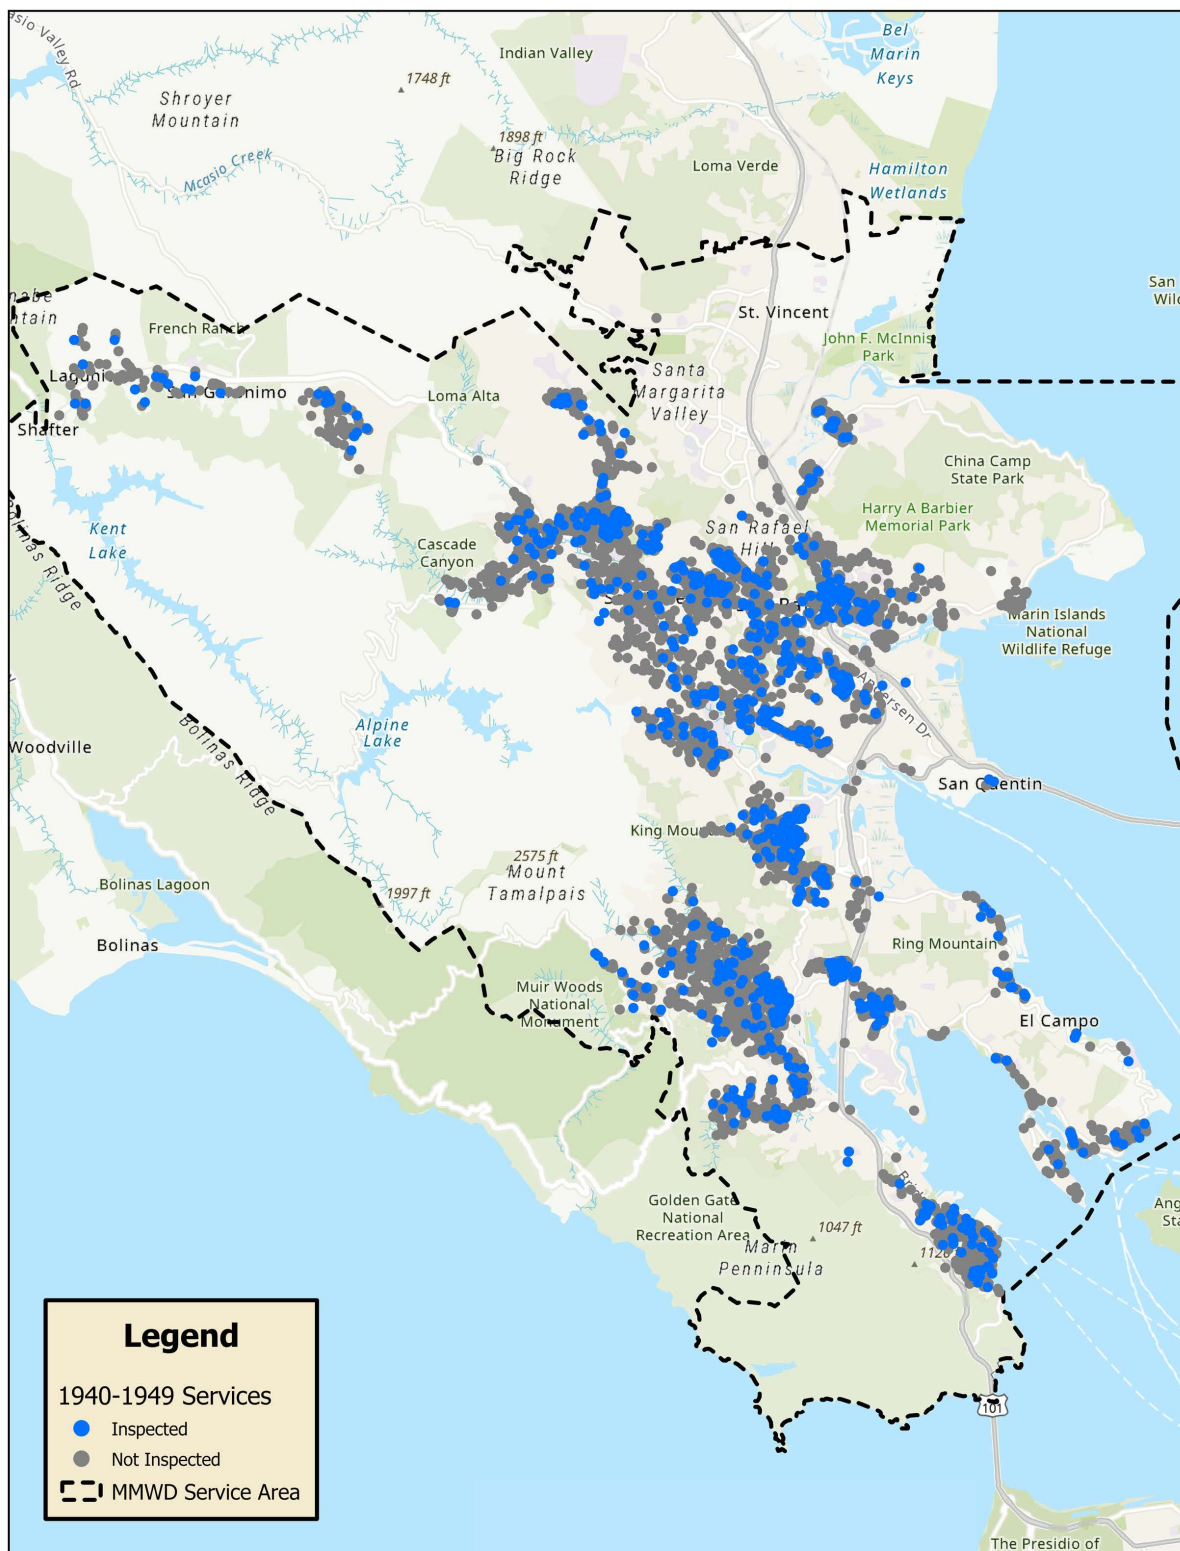
Appendix A. Figure A7. Field investigation results of customer service lines for 1940-1949 era

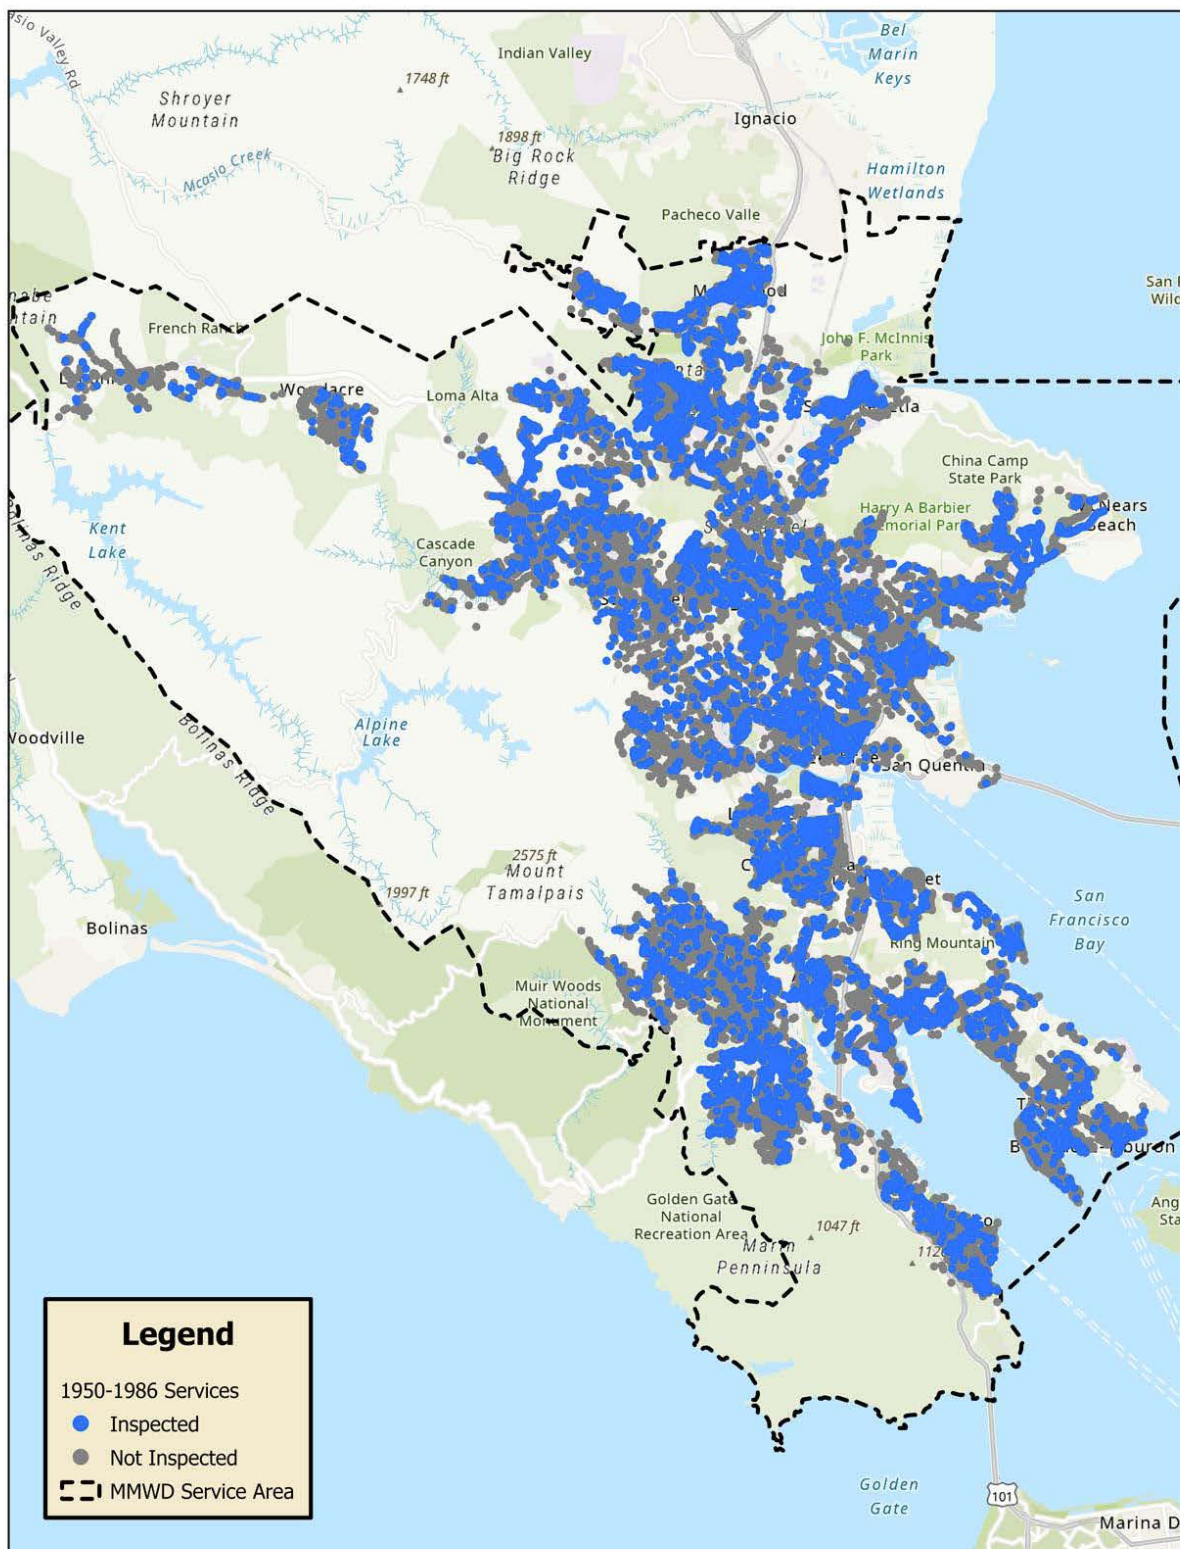
Appendix A. Figure A8. Field investigation results of customer service lines for 1950-1985 era

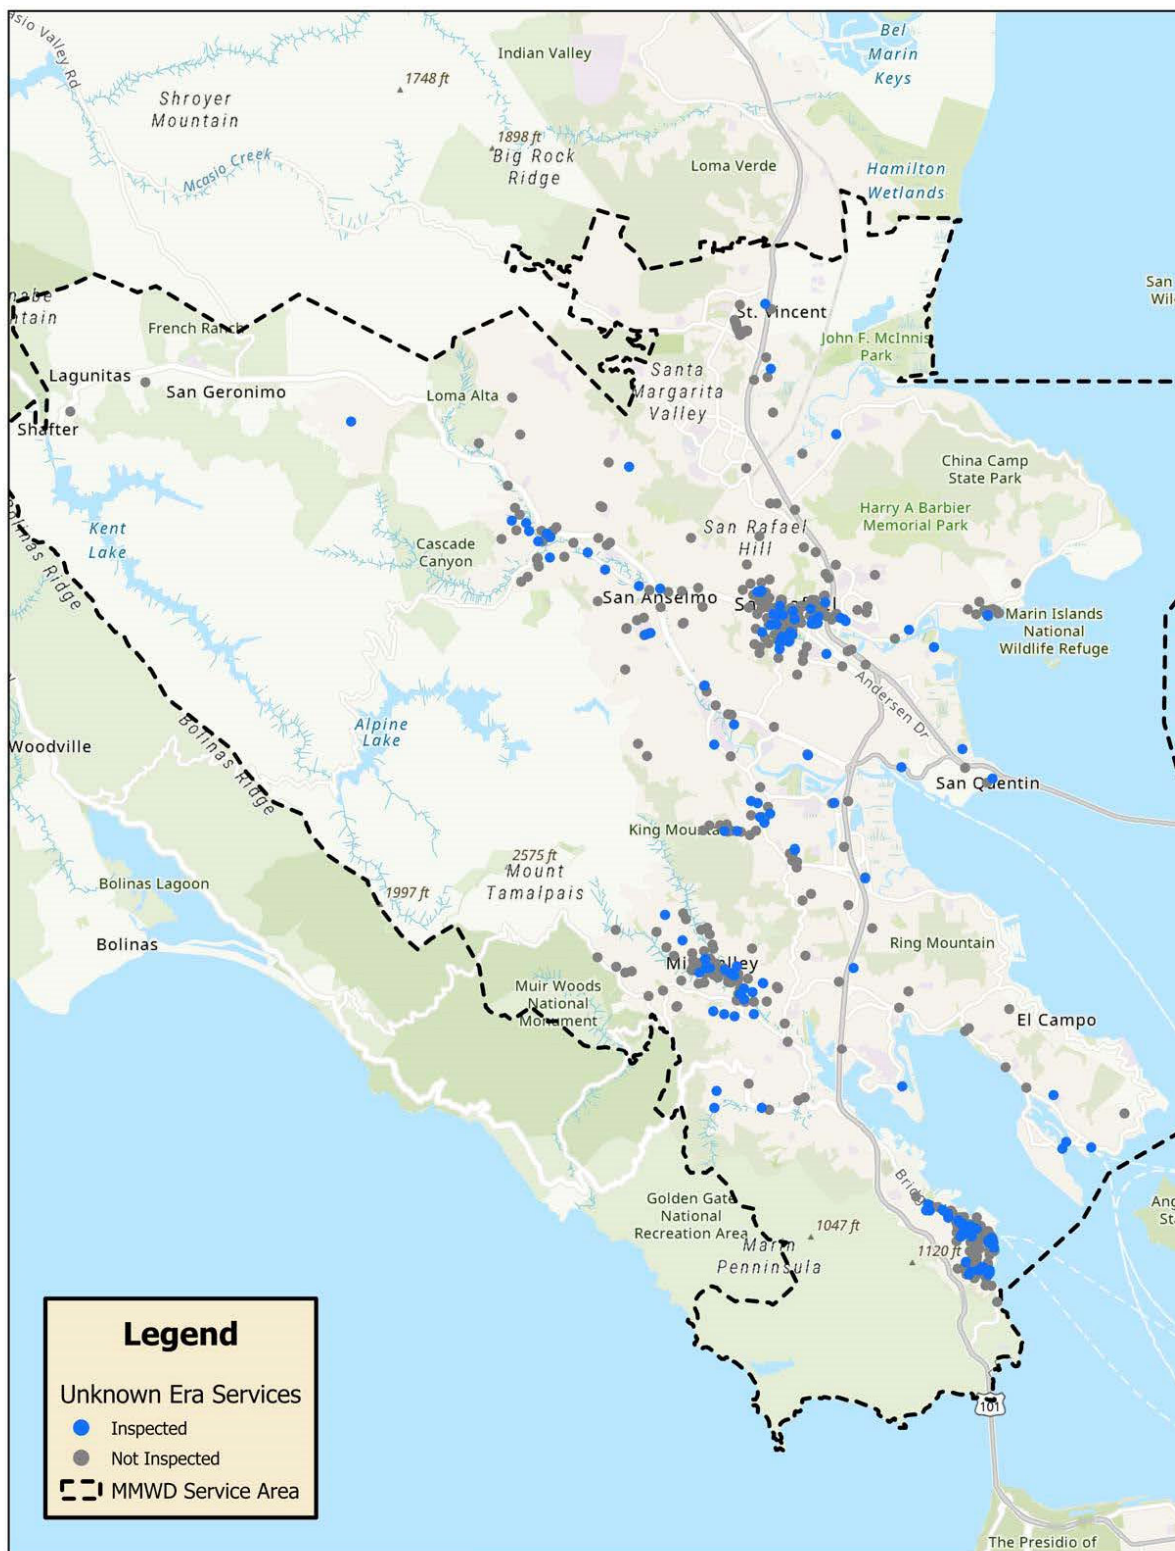
Appendix A. Figure A9. Field investigation results of customer service lines for unknown era
