**San Geronimo Creek Watershed
Sediment Source Sites Assessment and Evaluation**

**For the San Geronimo Creek
Watershed Planning Program**

**Prepared by
Stetson Engineers Inc.**

**Prepared for
Marin Municipal Water District**

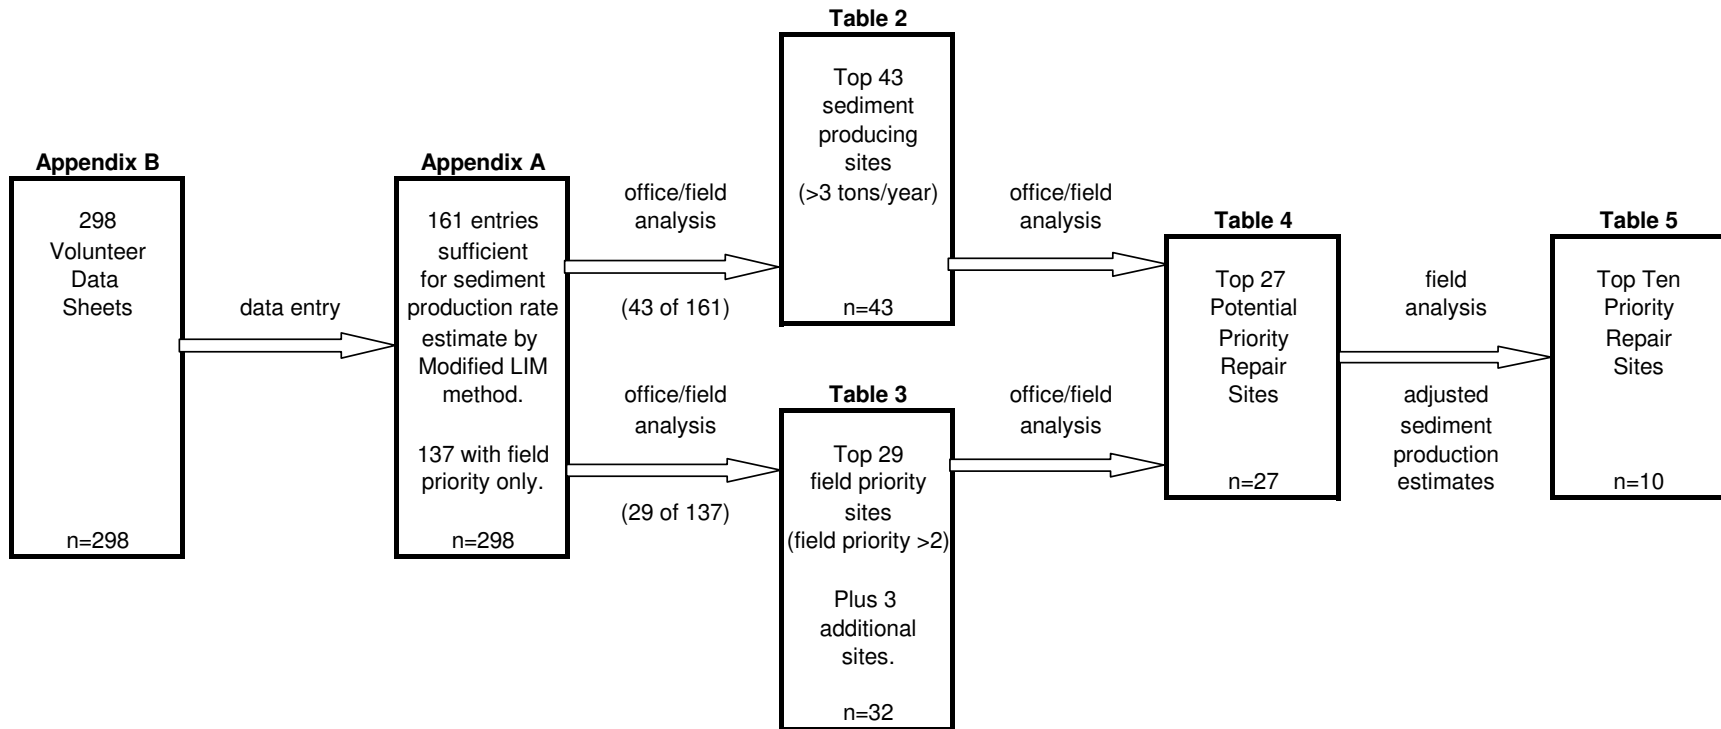
Figure 1. Priority Repair Site Selection Procedure Flow Chart

Figure 1 shows the procedure Stetson Engineers used to select potential priority sites and ultimately select the top ten priority sites from the volunteer field crew data sheets. First, Stetson Engineers selected the top 43 sediment producing sites according to the Modified LIM calculation (more than 3 tons/year) and entered these sites into Table 2 for further office and possible field analysis. Also, recognizing that many of the sites producing relatively little sediment according to the LIM calculation (less than 3 tons/year), or with insufficient field data to perform a LIM calculation, may in fact be priority sites, Stetson Engineers selected the top 29 sites with the highest volunteer field priority designations (field priority of 3 or 4) and entered these sites into Table 3. Figure 3 shows the locations of the 75 sites selected for further office and field analysis. The Top 75 sites includes 43 sites from Table 2, 29 sites from Table 3, and 3 additional sites added by Stetson Engineers during an initial field reconnaissance (Table 3).
