NOTICE OF REGULAR BI-MONTHLY MEETING BOARD OF DIRECTORS

The Smith Saddle Tanks have been in service for 60 years and their interior and exterior coatings have reached the end of their useful lives - extensive corrosion has formed throughout the roof structures of the tanks. Previous inspection reports and video inspections have documented the interior conditions of the tanks, summarizing interior coating failures and severe corrosion on the roof structures of the tanks, the rafters and entry points, and specifically above the waterline.

The Consultant conducted a comprehensive evaluation of the tanks including structural, seismic, interior and exterior coating, safety, security and site area improvements. One of the tanks was completely drained and a detailed interior inspection of the floor, shell and roof steel framing and plates along with protective coatings was conducted. The structural and seismic evaluation identified significant areas of the existing tanks construction that are not in conformance with national standards which result in deficiencies in structural performance. Examples of structural deficiencies include lack of tank anchorage and strengthening to decrease o

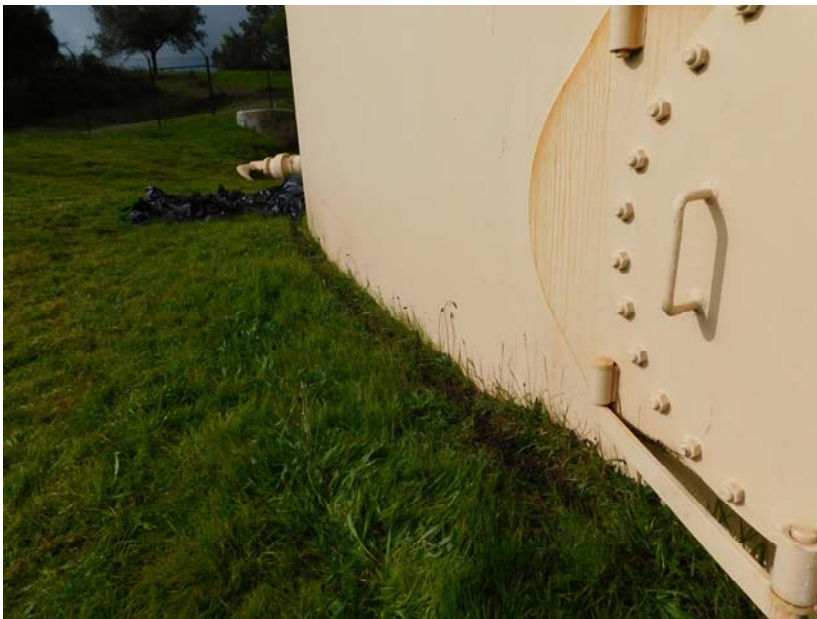
Photo #1:

*Tank 1, Exterior, Floor:
Buried shell and floor plate
with vegetation and debris
and water ponding against
floor plate and shell bottom.*

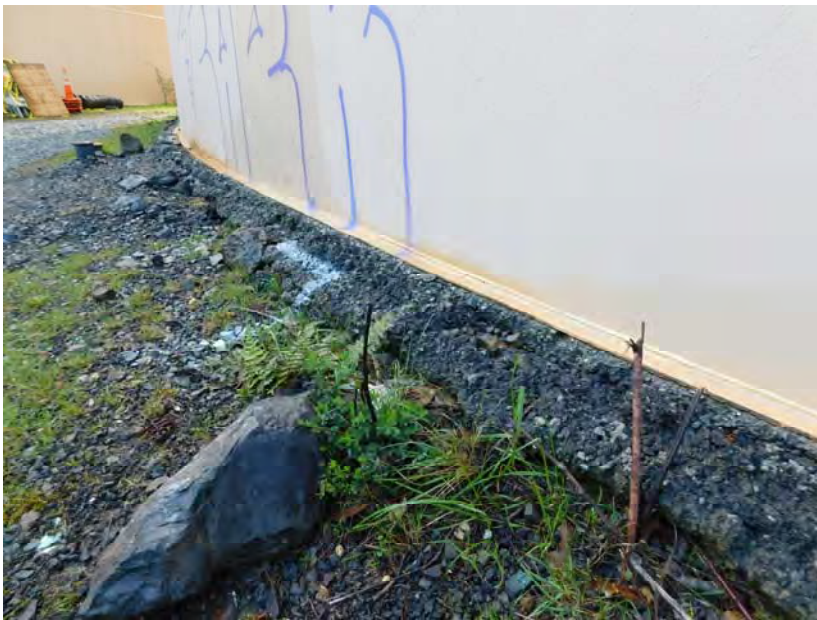
Photo #2:

*Tank 1, Exterior, Floor: Oiled
subgrade and asphalt
material eroded significantly
exposing underside of floor
plate.*

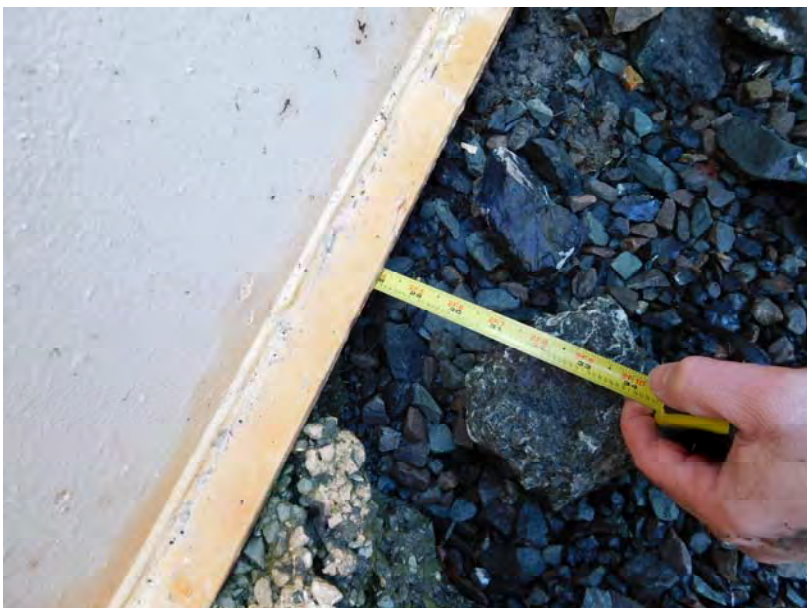
Photo #3:

*Tank 1, Exterior, Floor:
Exposed underside of floor
plate with subgrade
materials eroded away.*

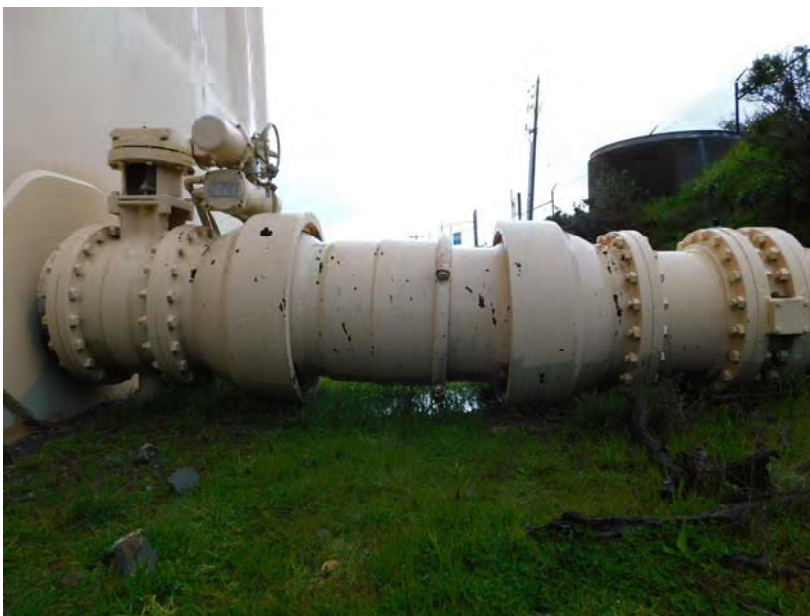
Photo #8:

*Tank 1, Exterior,
Appurtenances: 24-Inch
Inlet, orientation, supports,
obstruct travel, and lack
isolation.*

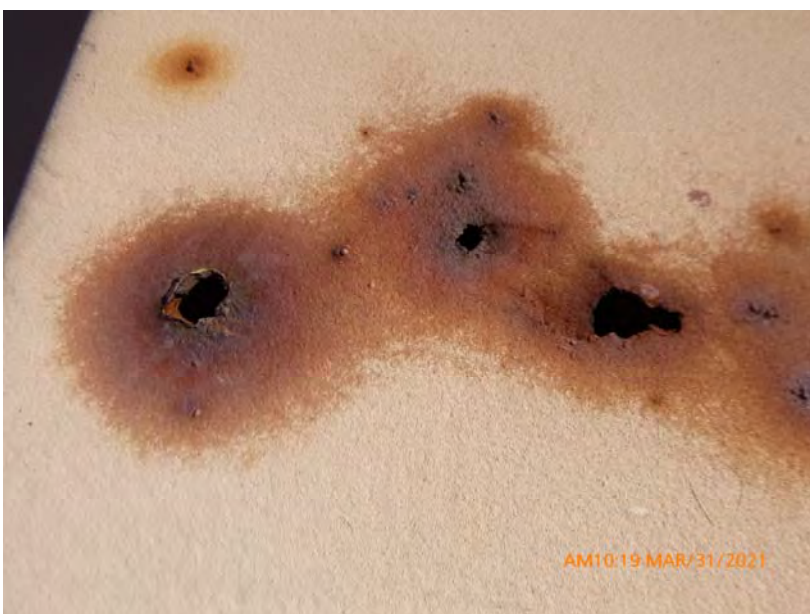
Photo #9:

*Tank 1, Exterior,
Appurtenances: Roof access
hatch cover with holes in
steel plate.*

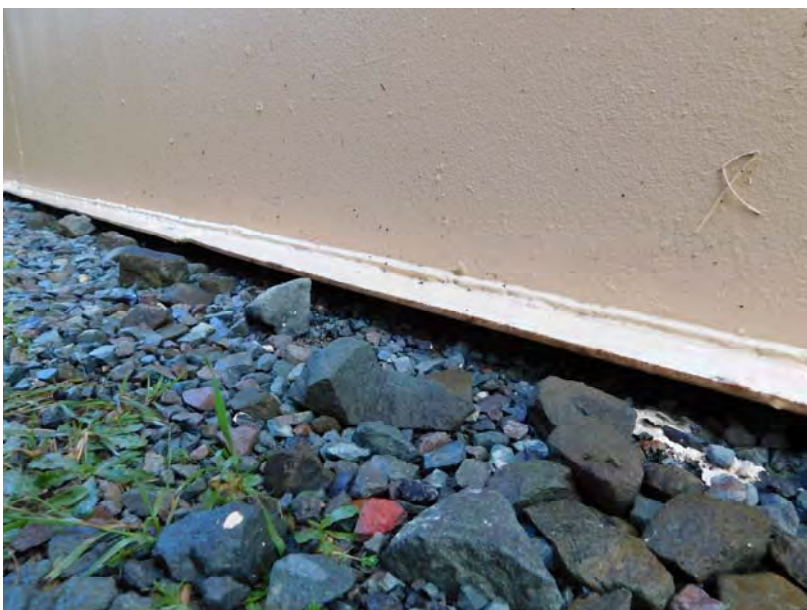
Photo #21:

*Tank 2, Exterior, Floor:
Asphalt subgrade materials
eroded away from annular
ring resulting in loss of
bearing and support.*

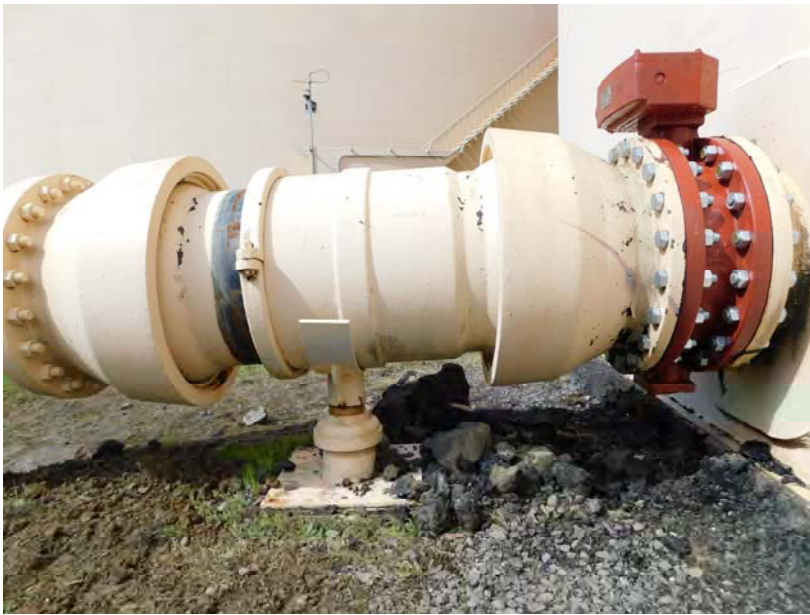
Photo #25:

Tank 2, Exterior,
Appurtenances: Unanchored
gravity supports for above
ground 30-inch outlet piping.

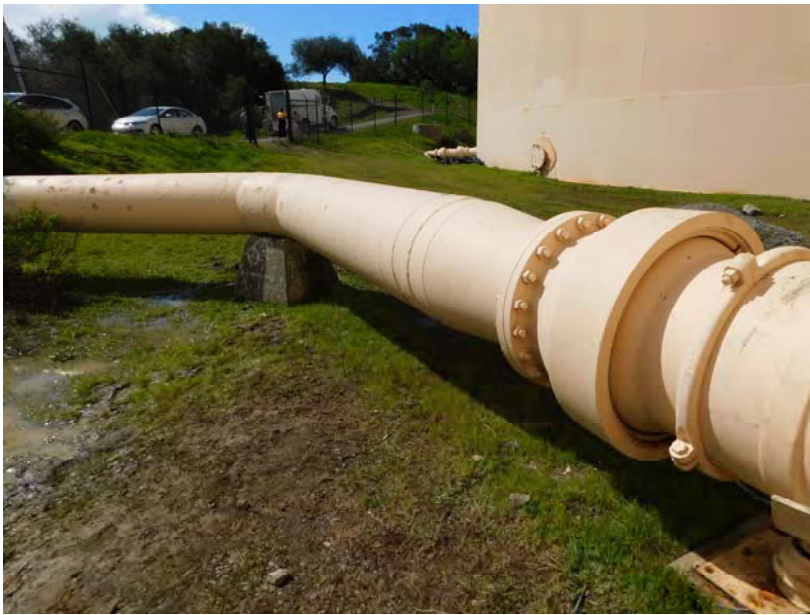
Photo #26:

Tank 2, Exterior,
Appurtenances: 24-Inch inlet
piping above ground
obstructing vehicle and
pedestrian travel around
tanks.

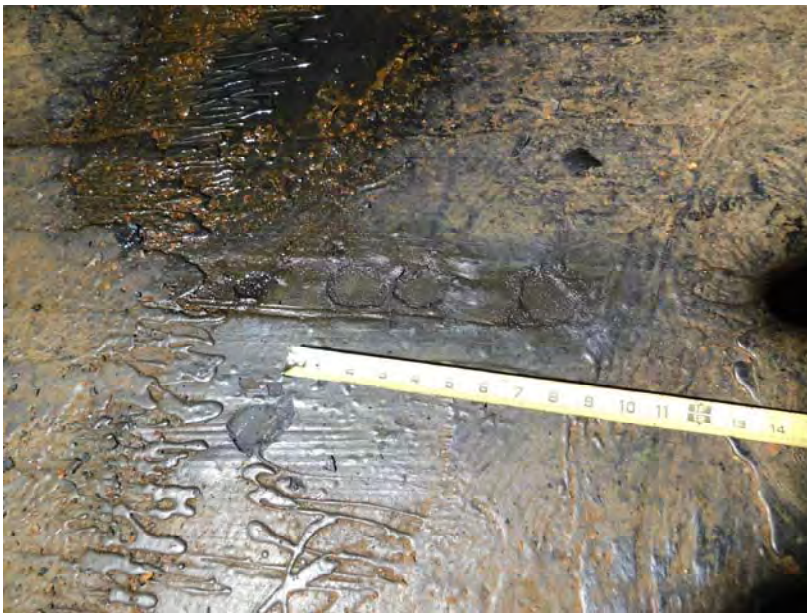
Photo #28:

*Tank 2, Interior, Floor:
Closeup of floor with coating
removed bare steel with no
loss of metal or pitting.*

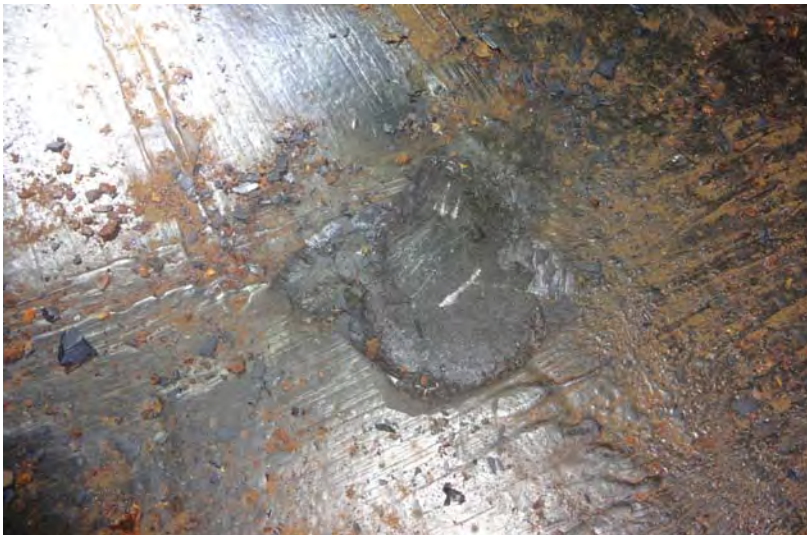
Photo #29:

*Tank 2, Interior, Floor:
Closeup of floor with coating
removed bare steel with no
loss of metal or pitting.*

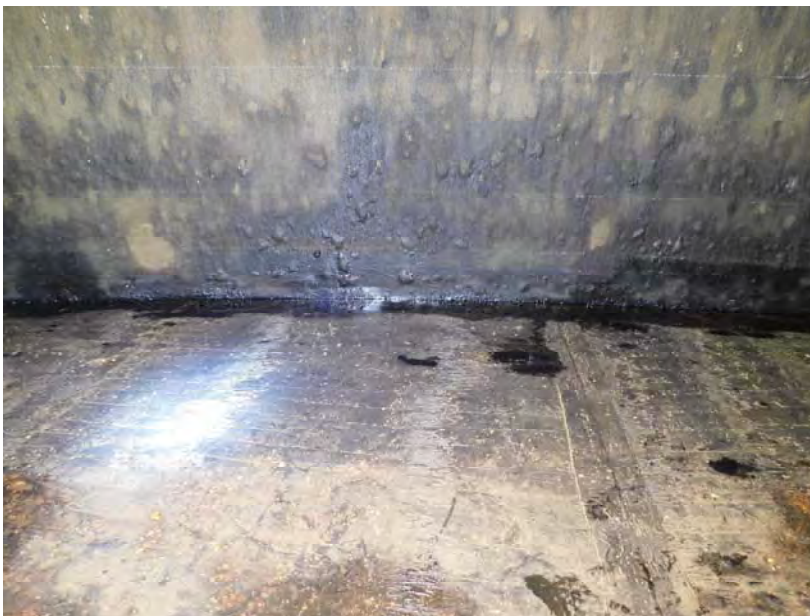
Photo #36:

Tank 2, Interior, Shell: Blister domes on interior shell hot coal tar enamel coating.

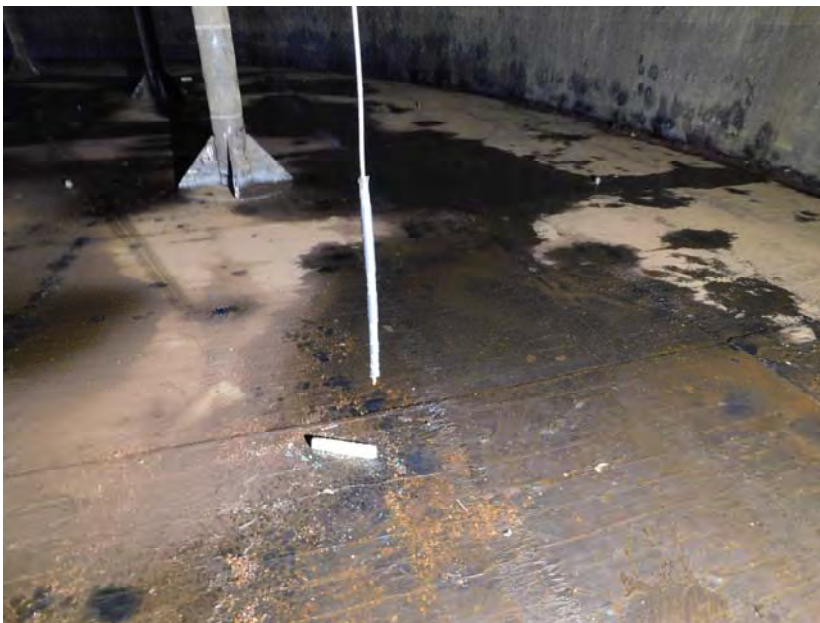
Photo #51:

*Tank 2, Interior,
Appurtenances; Cathodic
protection anode string with
failed weight.*

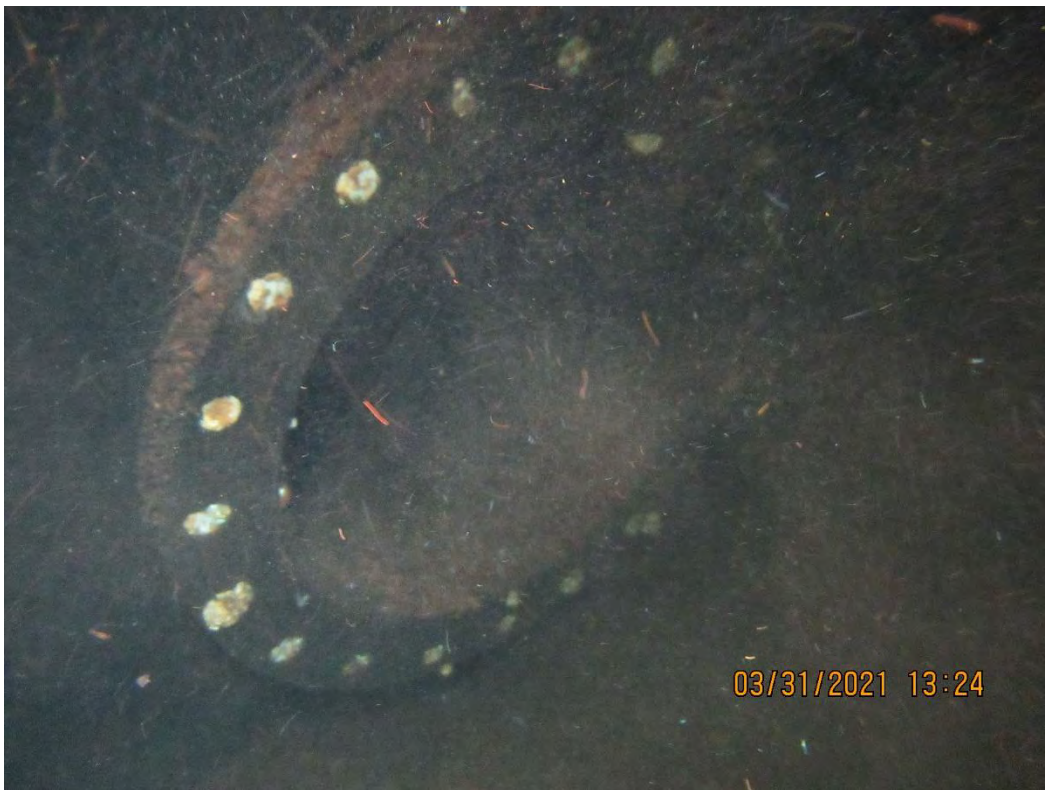
Image 10 – Inlet on wall (assumed to be southernmost inlet)

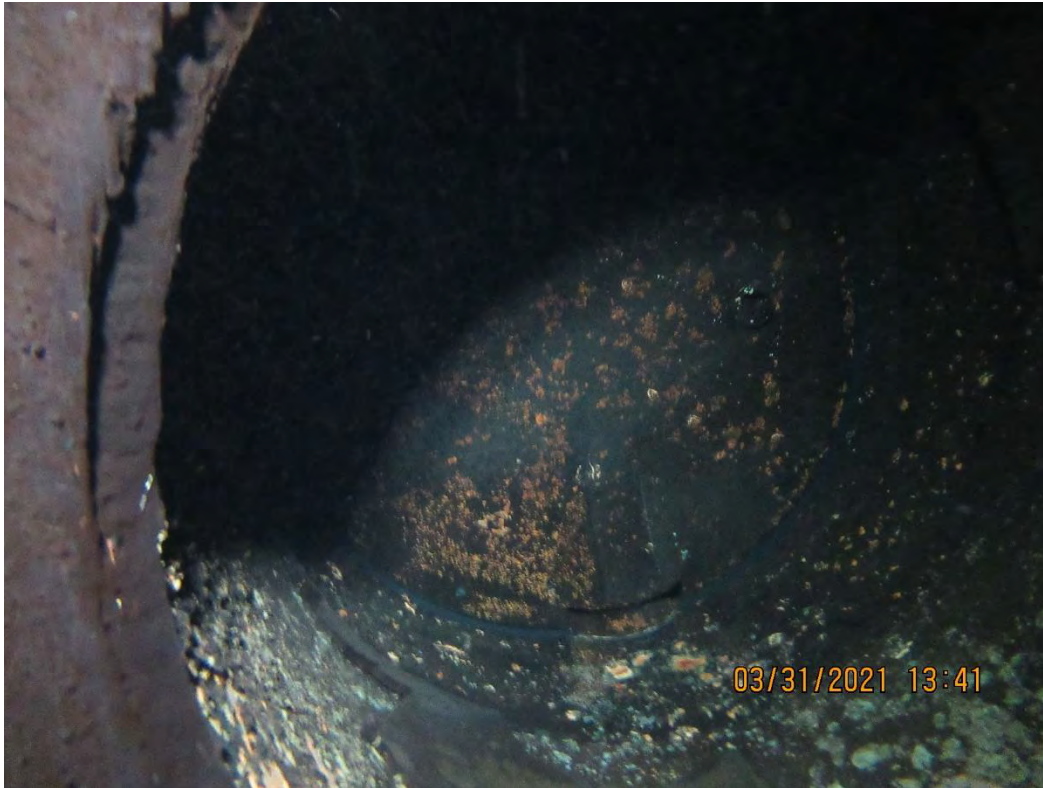
Image 20 – Typical blistering at the base of a column

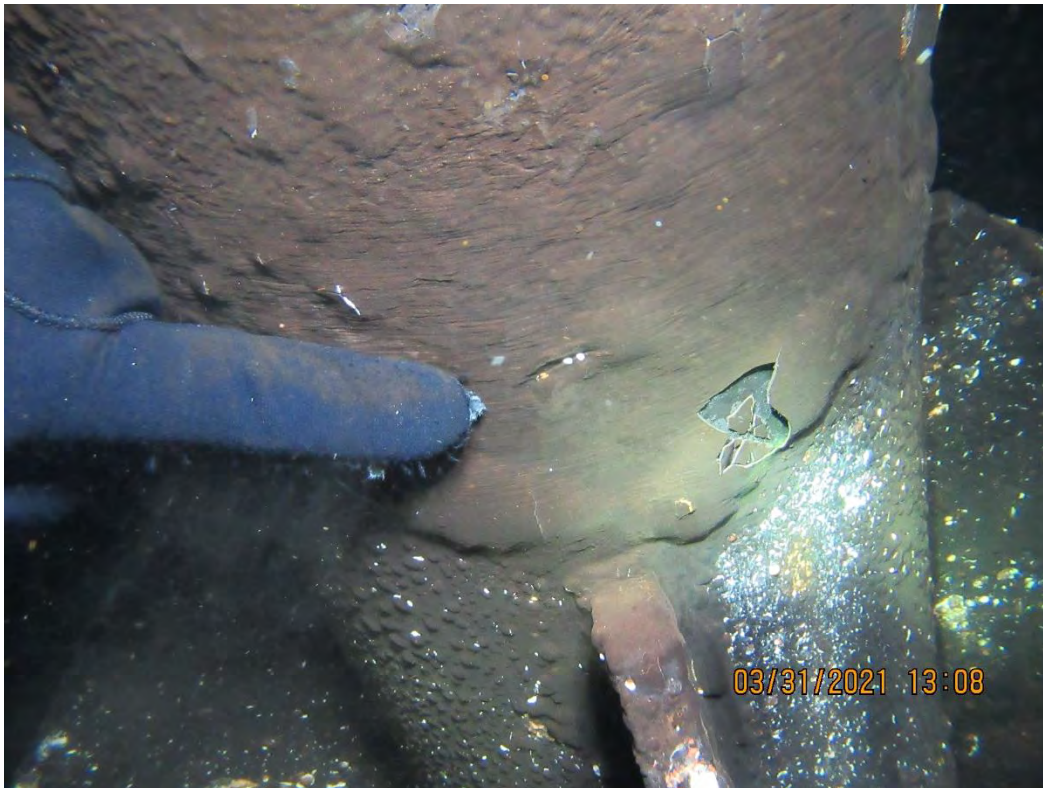
Image 21 – Multiple popped blisters at the base of a column

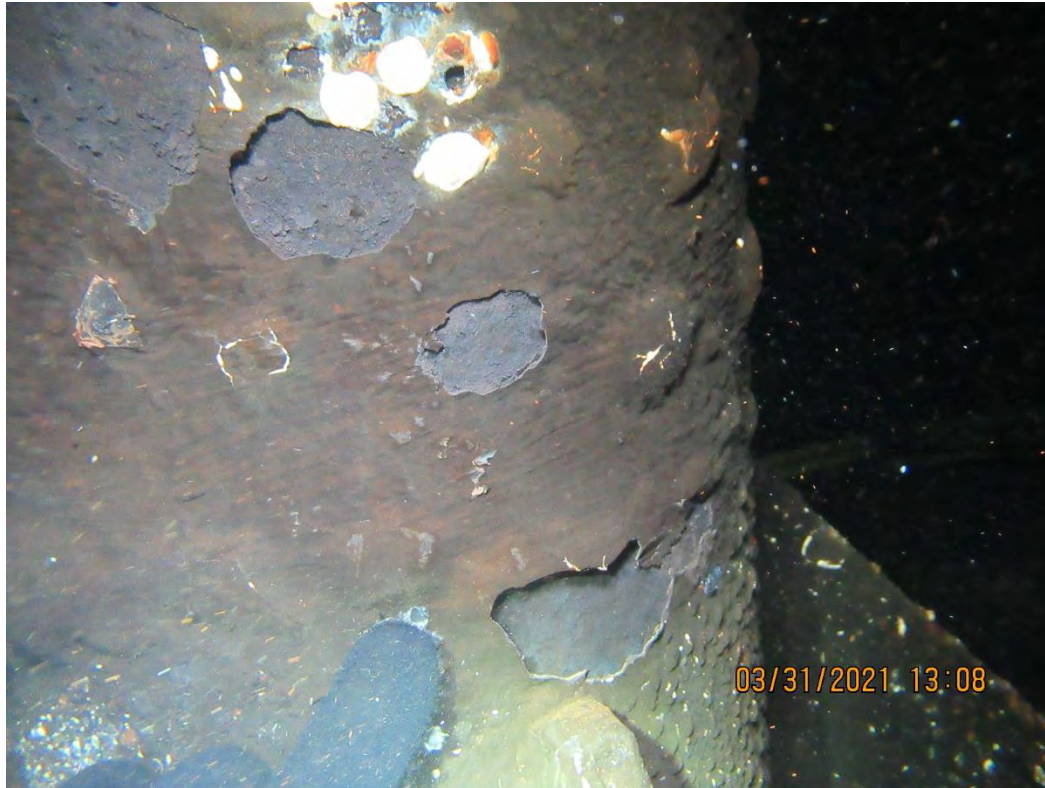
Image 22 – Exposed steel beneath a popped column coating blister

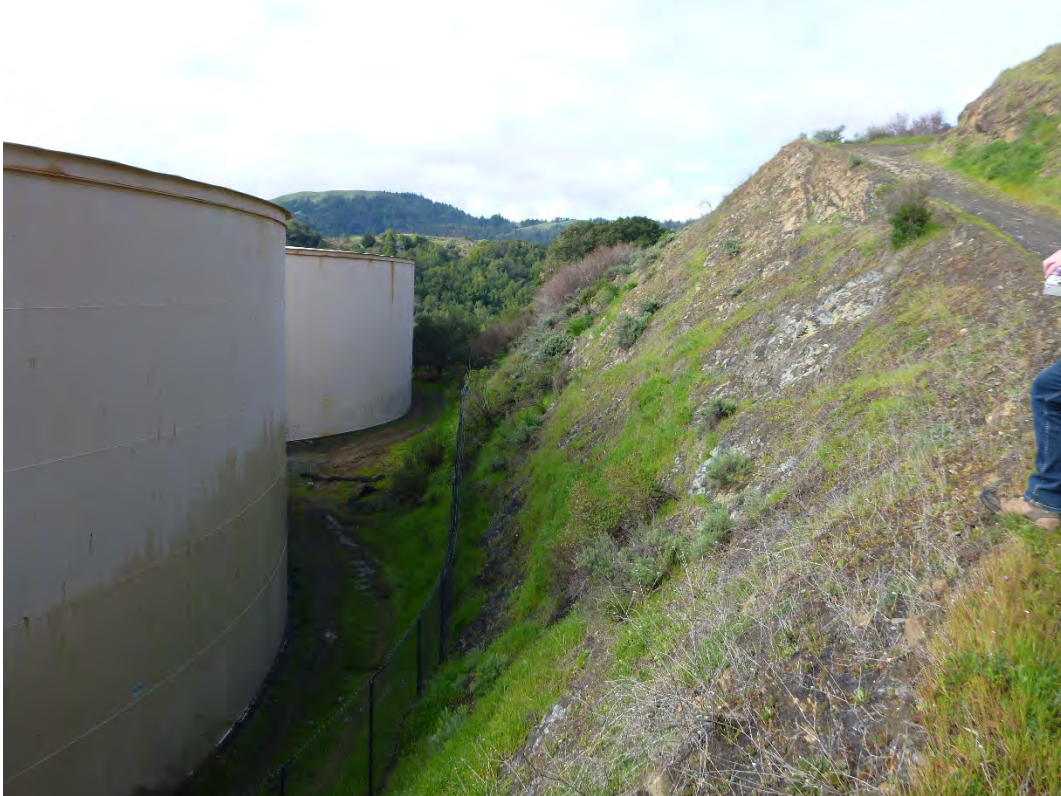
Cut slope exposing sandstone bedrock on northwest side of tanks. Photo by GEI.

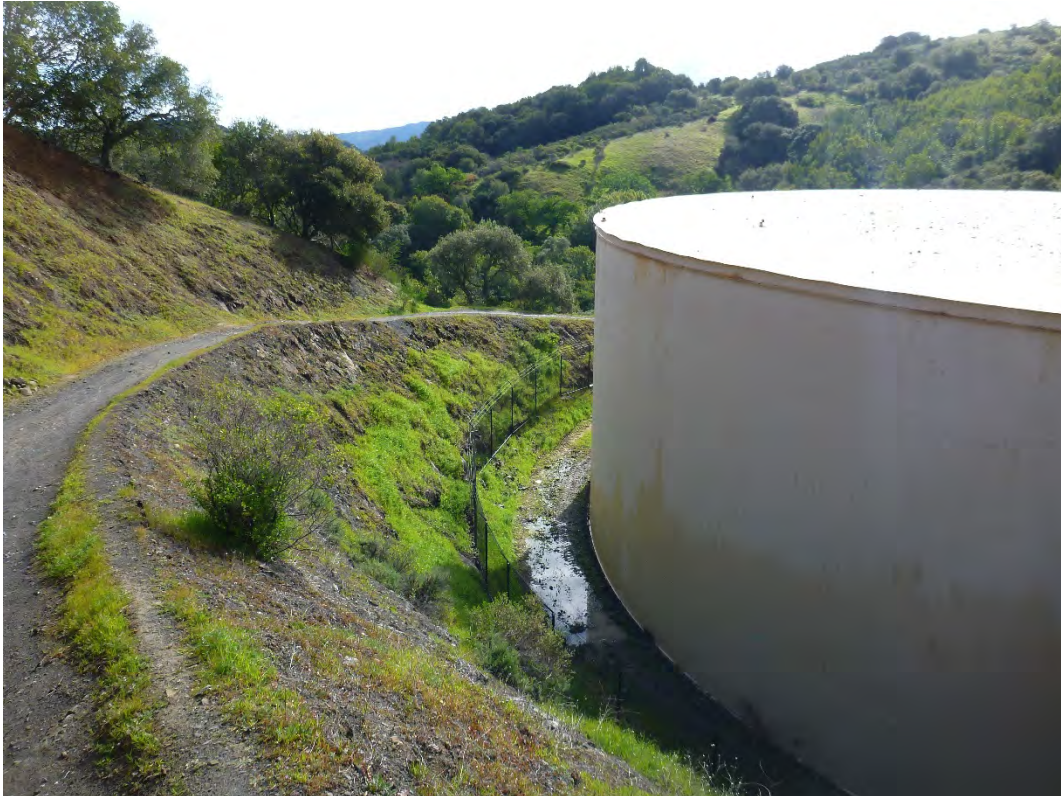
Cut slope exposing sandstone bedrock on east side of tanks. Photo by GEI.

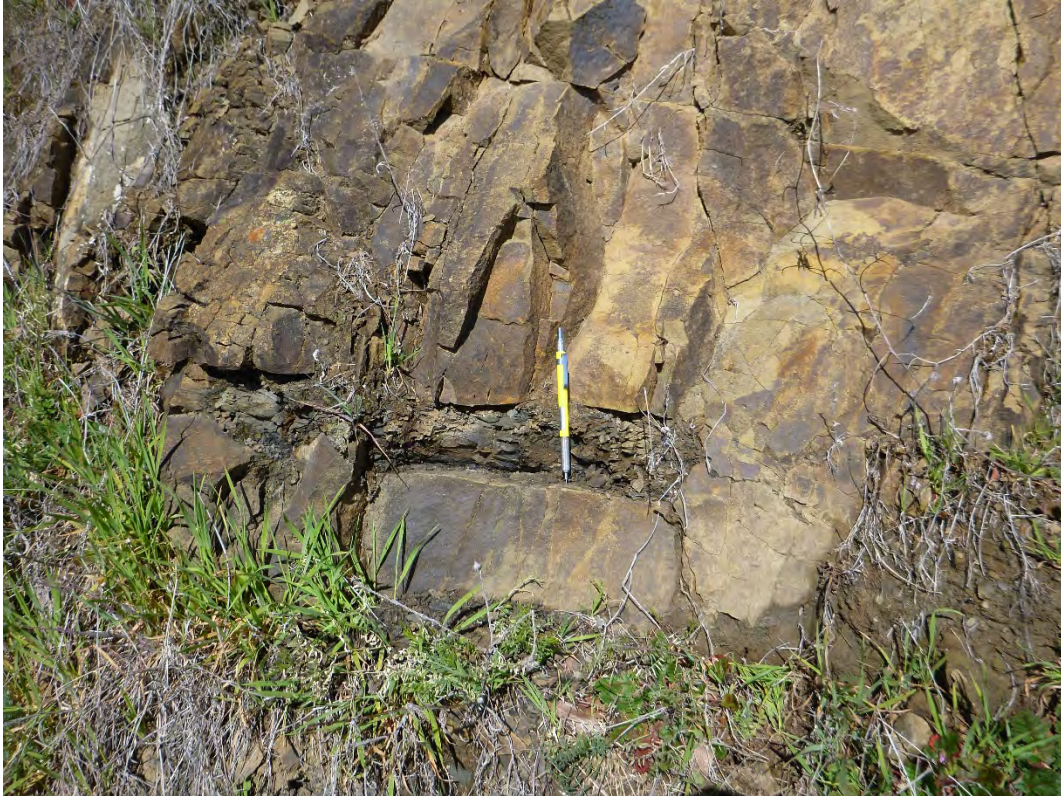
Close up of sandstone bedrock exposed in cut slope. Note minor shale bed. Photo by GEI.

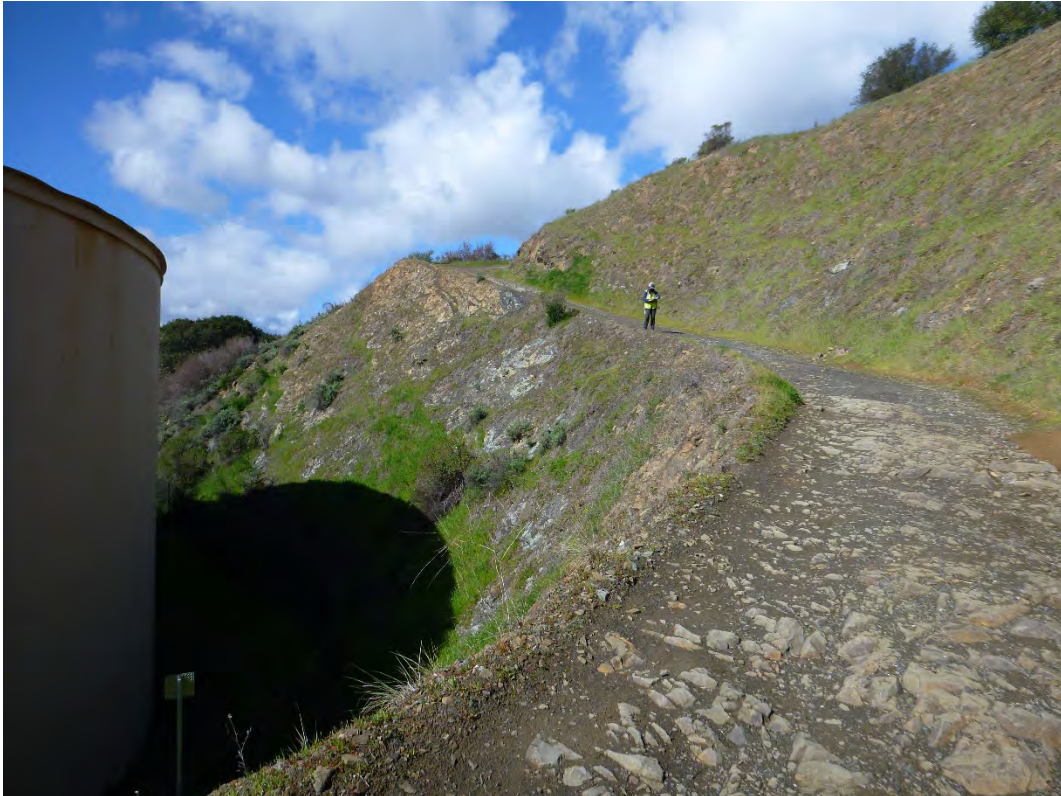
Cut slope and access road exposing sandstone bedrock. Photo by GEI.

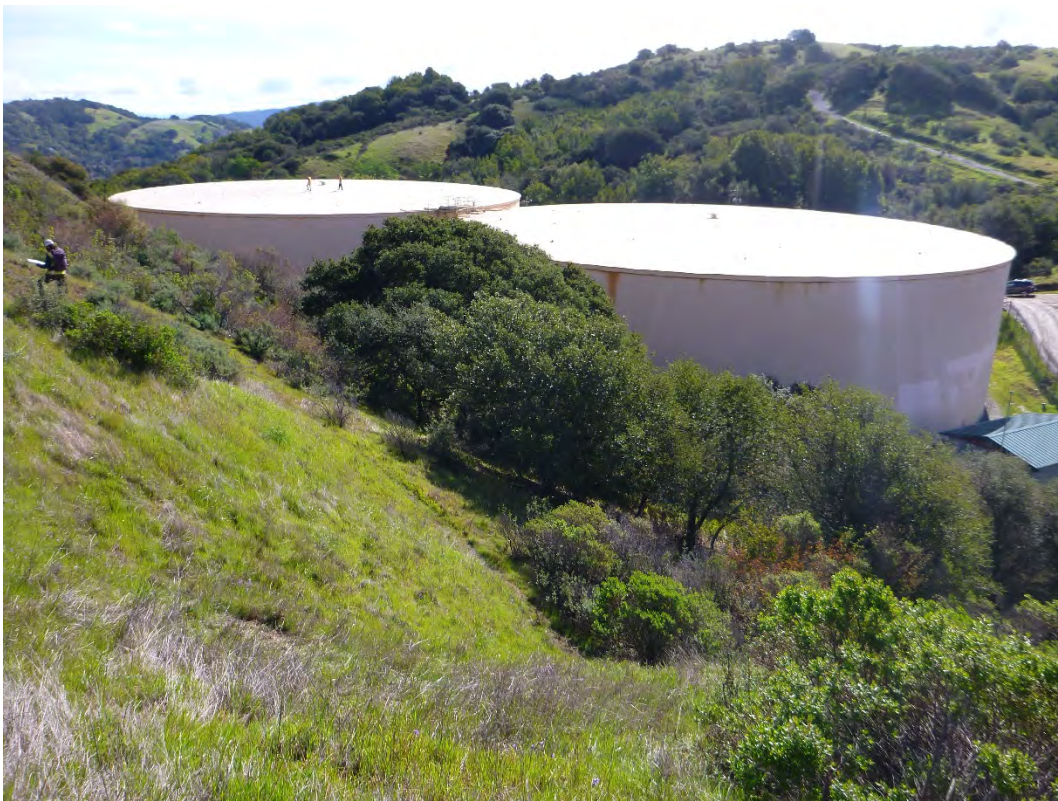
Overview of tank site from access road above. View to southeast. Photo by GEI.

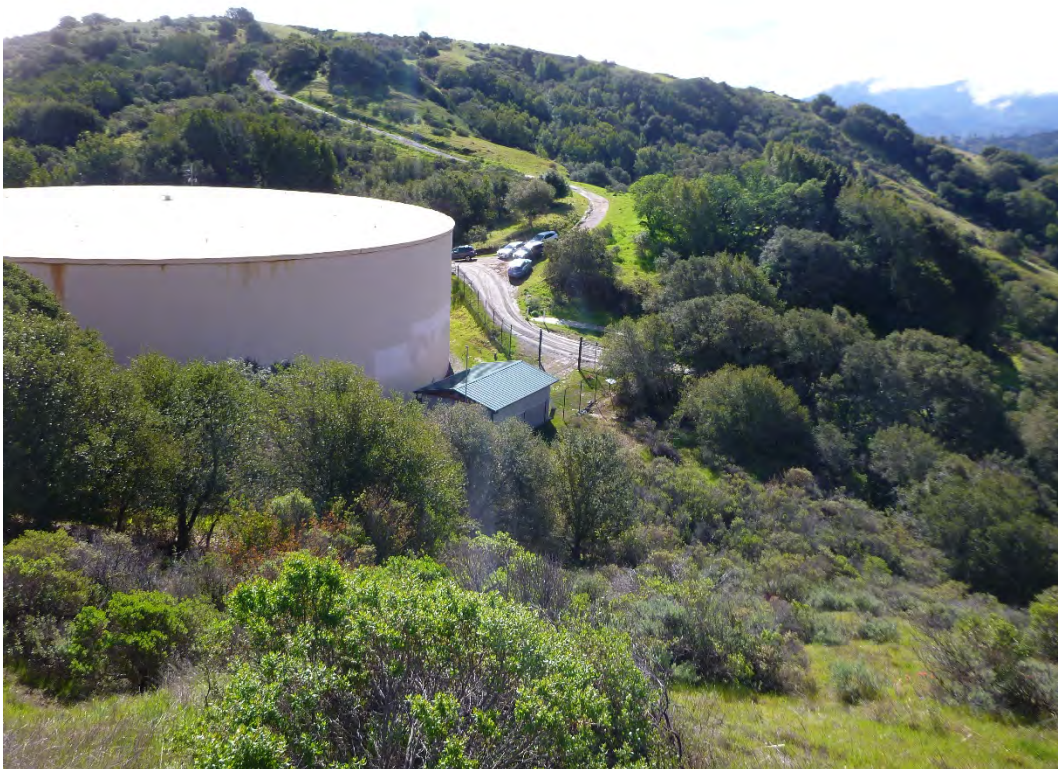
West end of tank site from access road above. Note small building on fill pad. Photo by GEI.

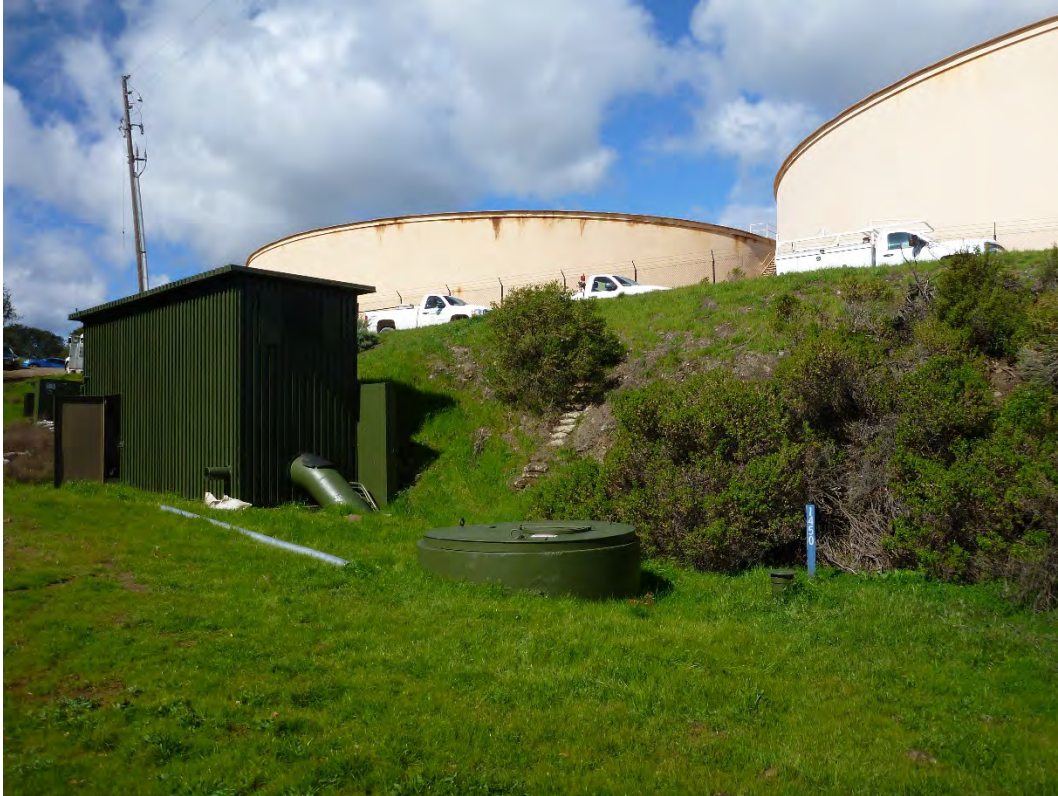
Fill slope on southeast side of tanks. Photo by GEI.

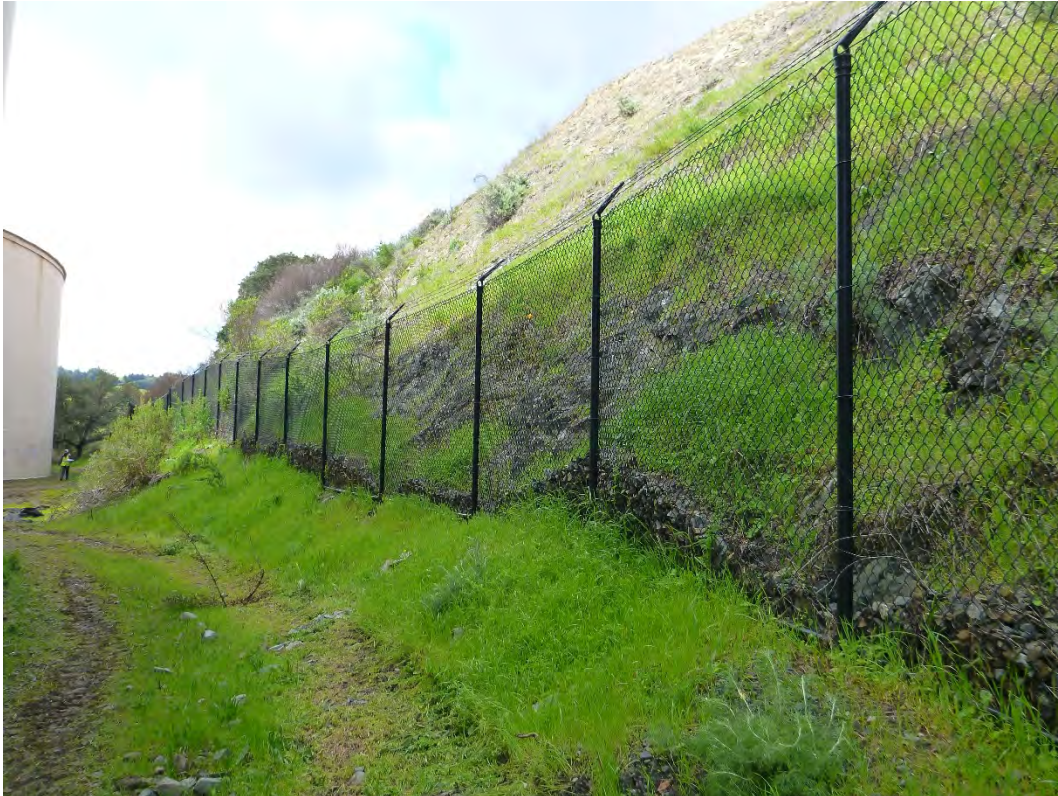
Perimeter fencing along northwest side of tanks. Note rock debris piled against base of fence. Photo by GEI.

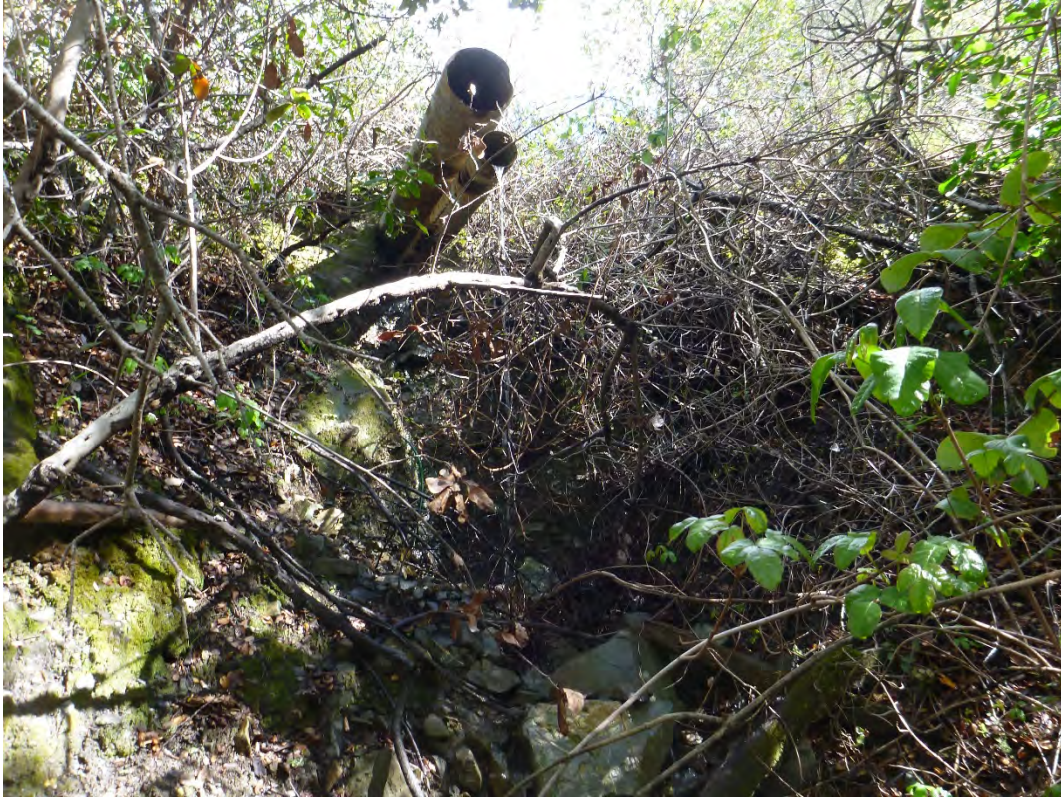
Drain pipes emanating from fill slope at west end of site. Note water draining from lower pipe. Photo by GEI.

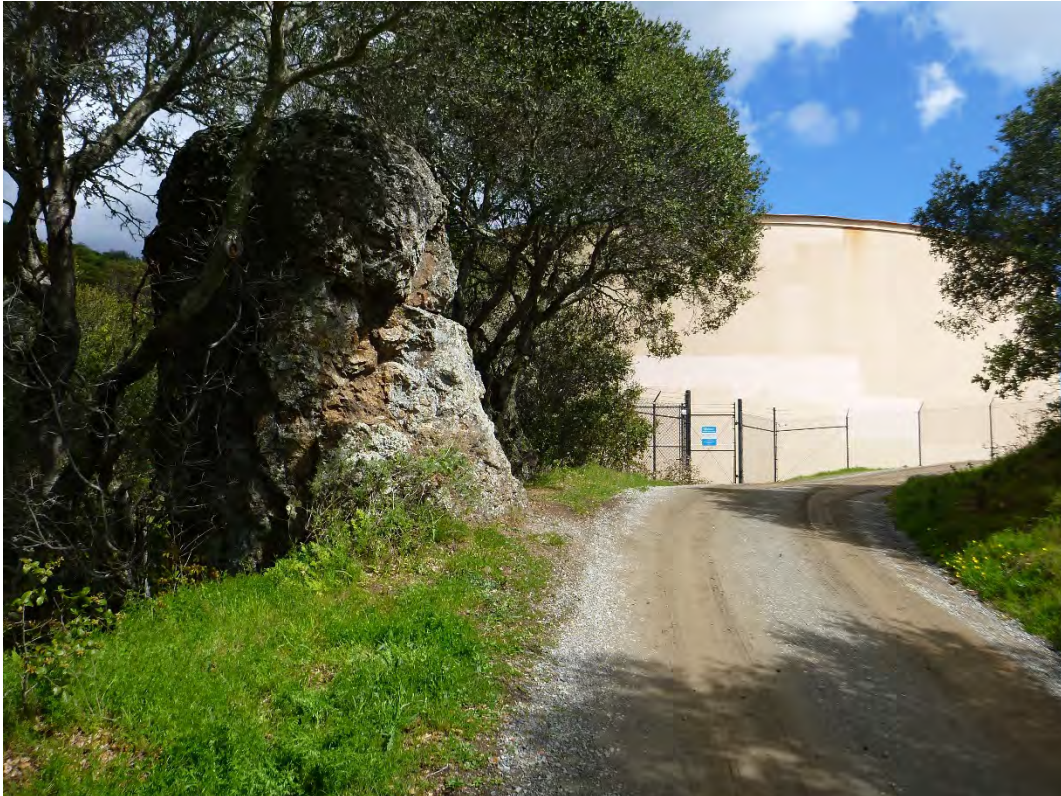
Outcrop of greenstone near west end of site. View to northeast. Photo by GEI.

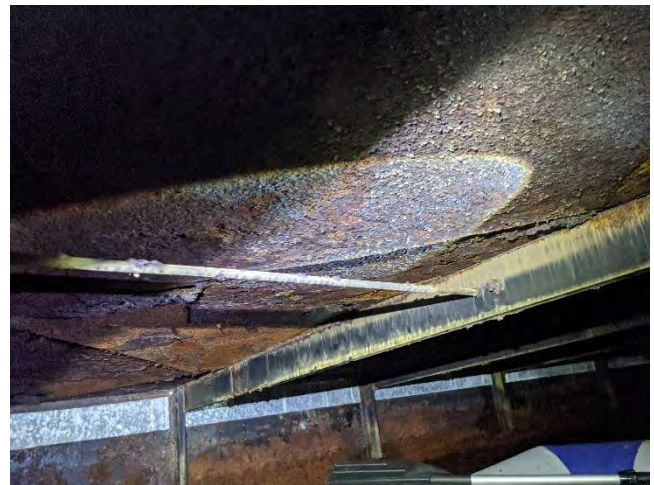
Photo 4-2. Metal loss on rafter/outer bay

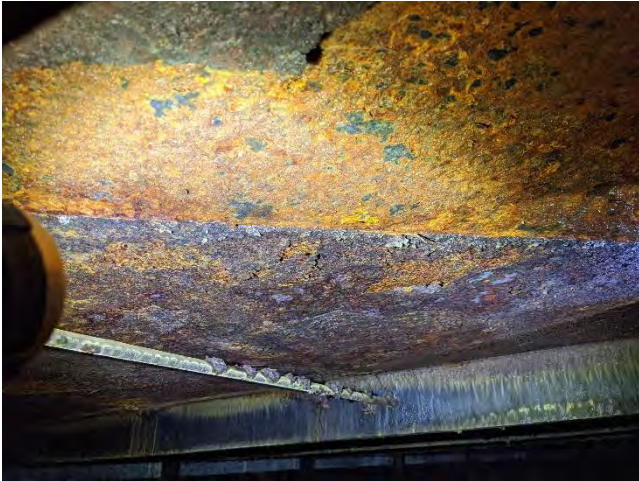
Photo 4-3. Failed coating on roof plate

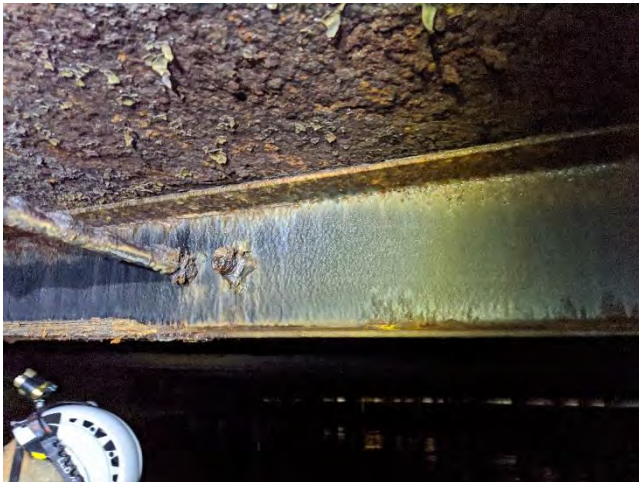
Photo 4-5 intact coating on web

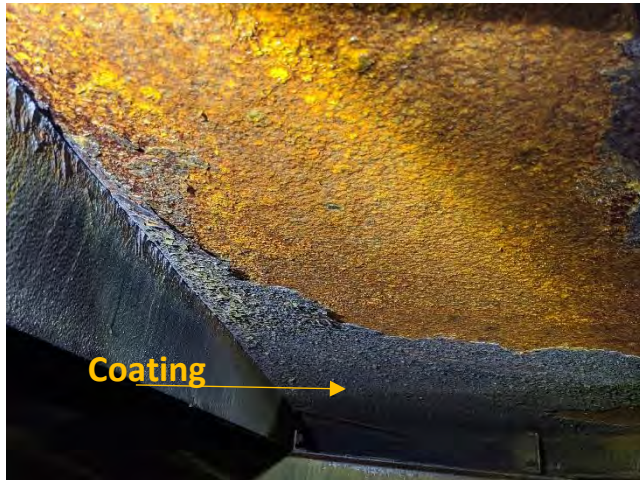
Photo 4-9 bare steel and failed coating

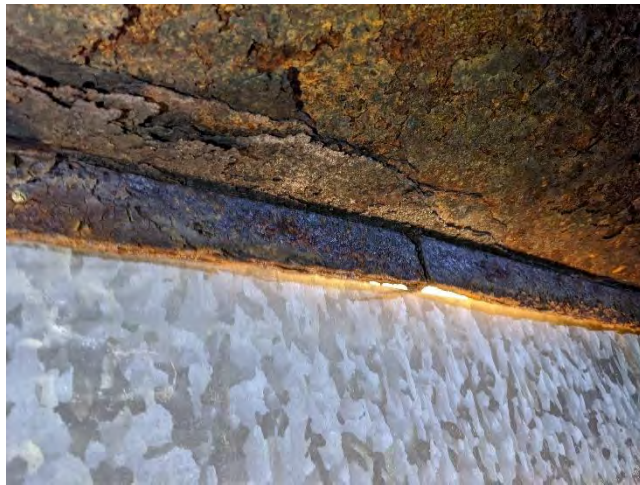
Photo 4-11 Gaps between sheet metal

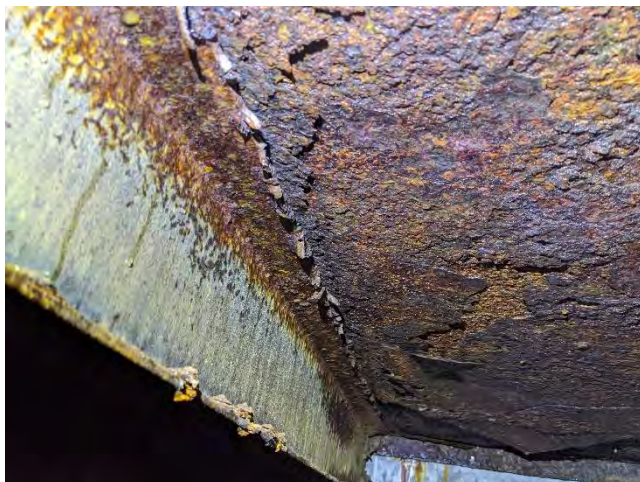
Photo 4-13 Moderate corrosion on flange

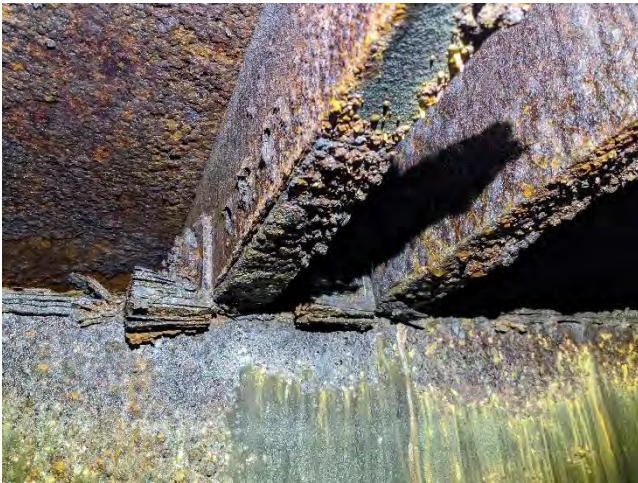
Photo 4-15 Moderate corrosion on connections

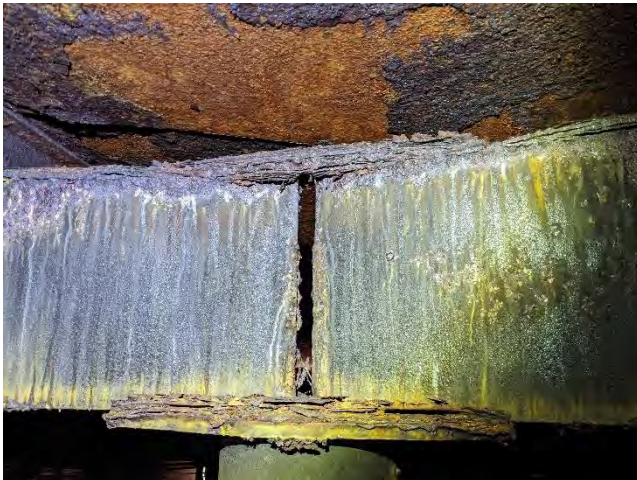
Photo 4-17 Failed coating moderate corrosion

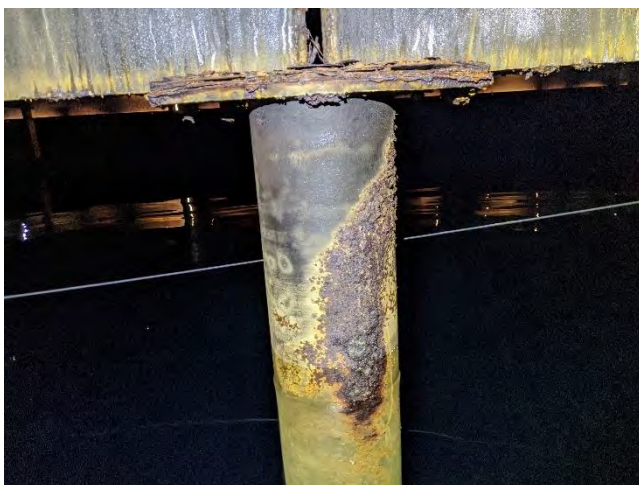
Photo 4-19 Failed coating on support column

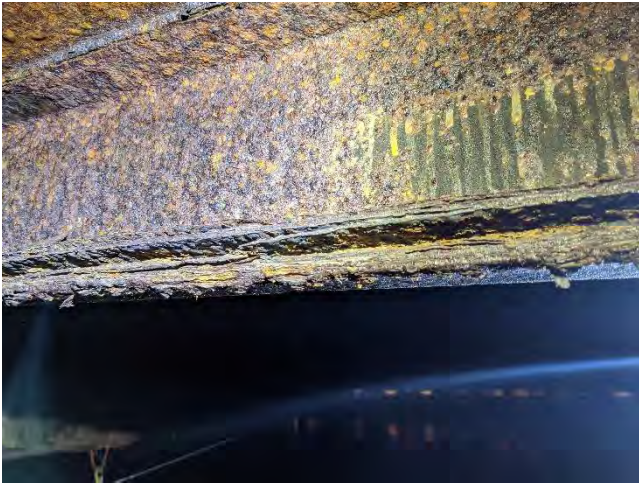
Photo 4-21 Moderate corrosion on flange

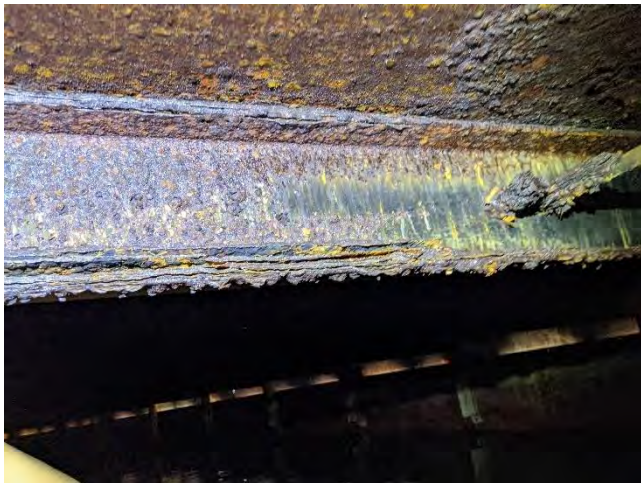
Photo 4-23 Moderate corrosion on flange

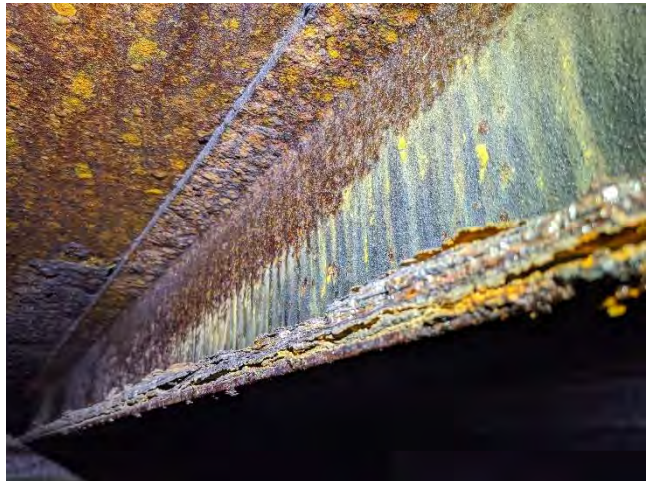
Photo 4-24 Moderate corrosion on flange

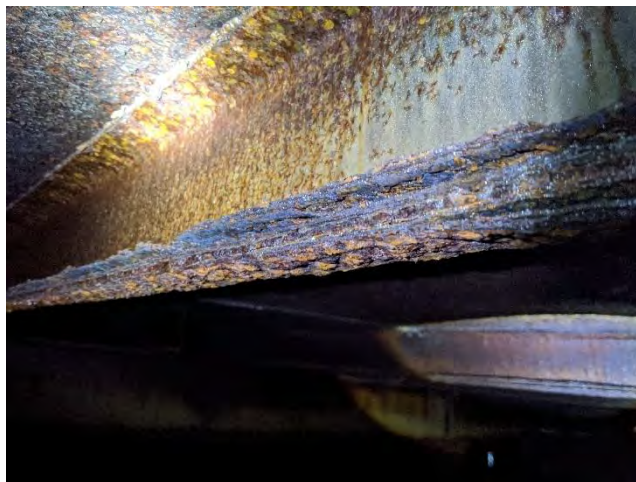
Photo 4-25 Moderate corrosion on flange

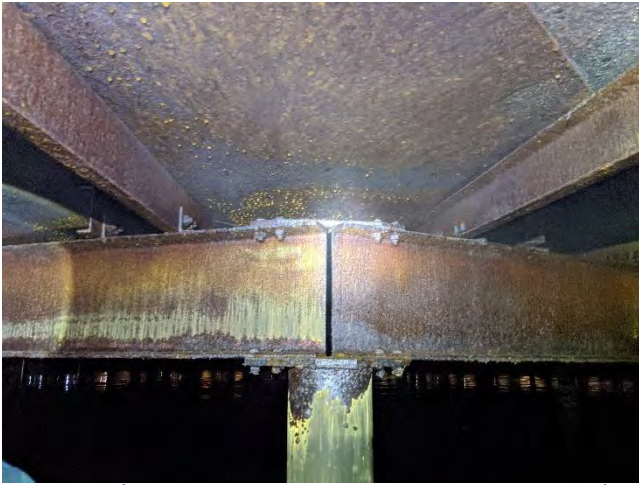
Photo 4-26 minor corrosion on center girder
