NOTICE OF REGULAR BI-MONTHLY MEETING BOARD OF DIRECTORS

The Smith Saddle Tanks have been in service for 60 years and their interior and exterior coatings have reached the end of their useful lives - extensive corrosion has formed throughout the roof structures of the tanks. Previous inspection reports and video inspections have documented the interior conditions of the tanks, summarizing interior coating failures and severe corrosion on the roof structures of the tanks, the rafters and entry points, and specifically above the waterline.

The Consultant conducted a comprehensive evaluation of the tanks including structural, seismic, interior and exterior coating, safety, security and site area improvements. One of the tanks was completely drained and a detailed interior inspection of the floor, shell and roof steel framing and plates along with protective coatings was conducted. The structural and seismic evaluation identified significant areas of the existing tanks construction that are not in conformance with national standards which result in deficiencies in structural performance. Examples of structural deficiencies include lack of tank anchorage and strengthening to decrease o

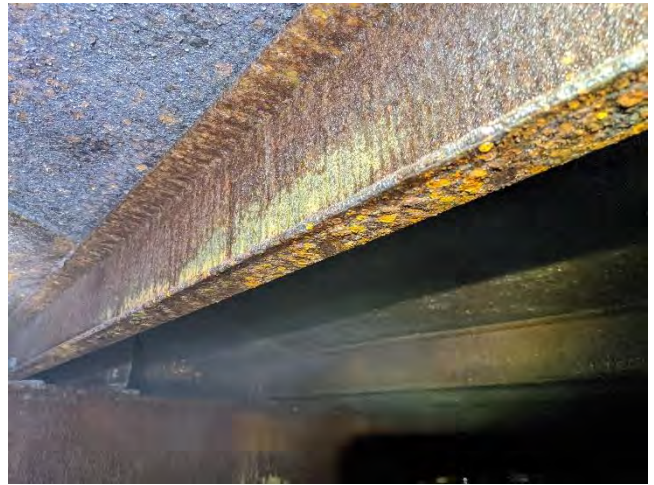
Photo 4-27 minor corrosion

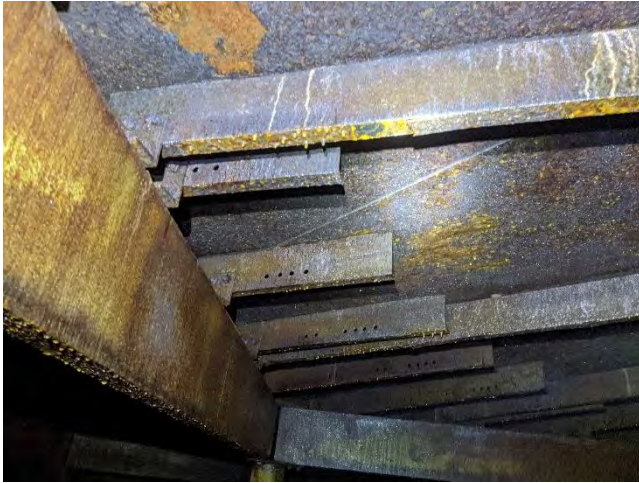
Photo 4-28 minor corrosion

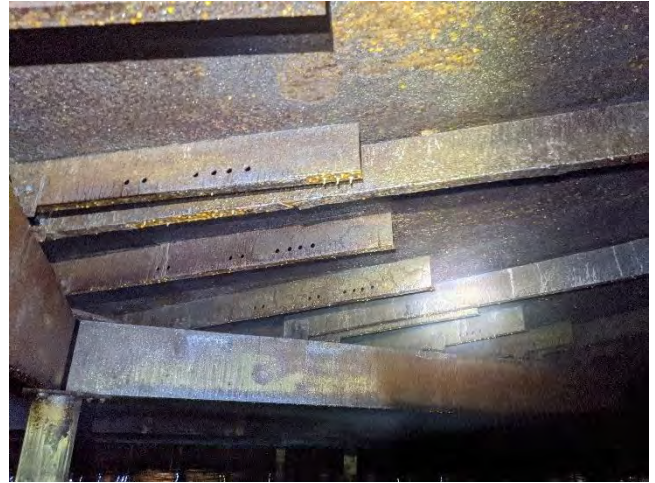
Photo 4-29 minor corrosion

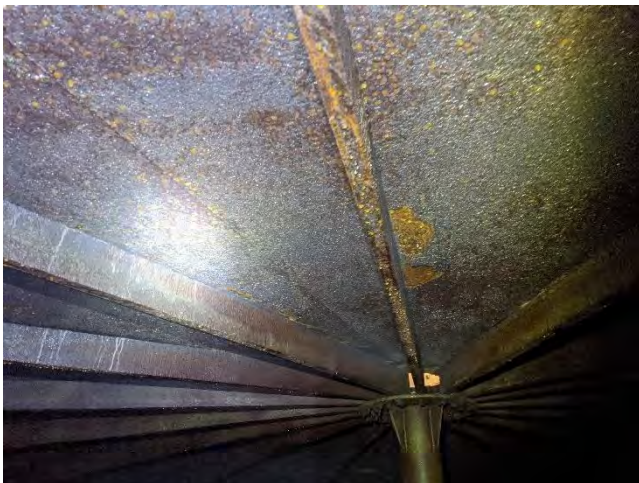
Photo 4-30 failed coating & minor corrosion

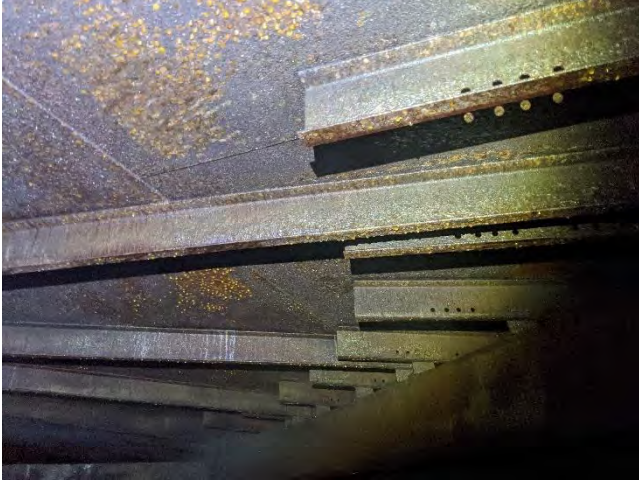
Photo 4-32 failed coating & minor corrosion

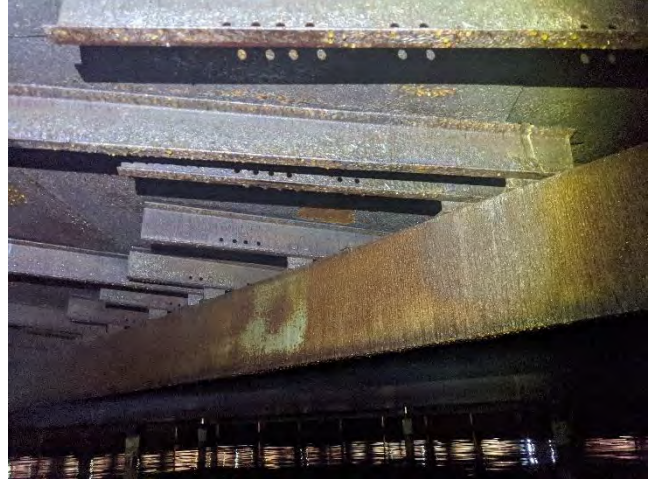
Photo 4-33 failed coating & minor corrosion

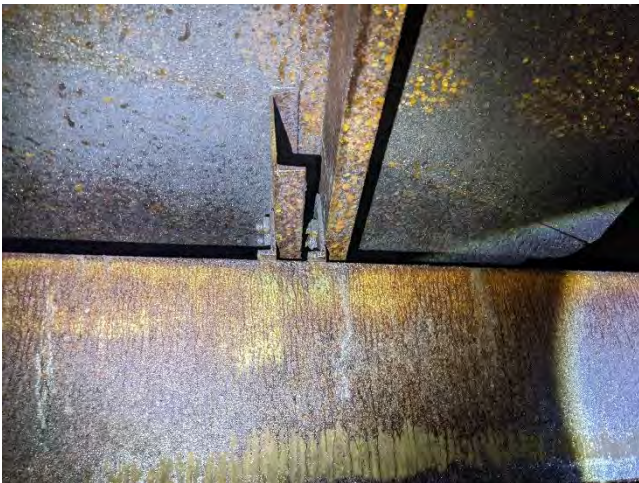
Photo 4-34 failed coating & minor corrosion

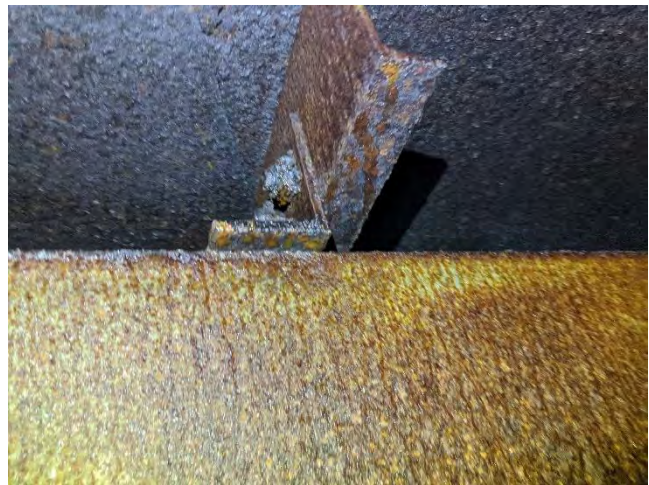
Photo 4-35 failed coating & minor corrosion

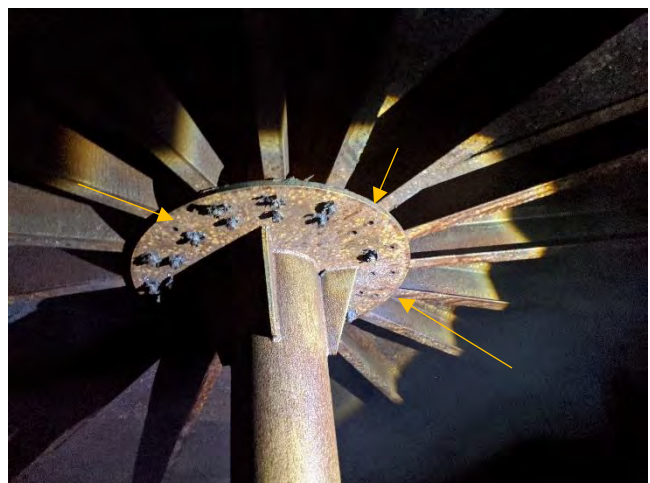
Photo 4-37 missing bolts

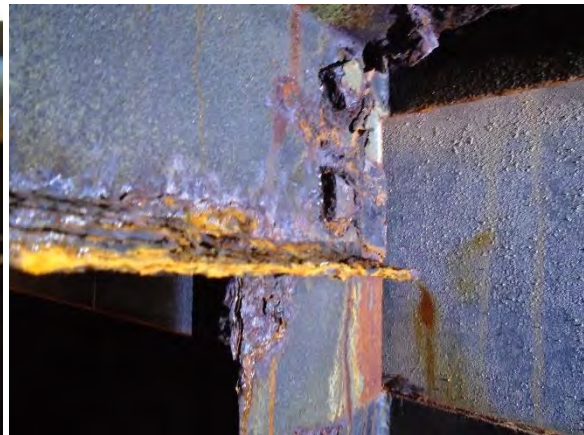
Photo 4-2. Metal loss on rafter/outer bay

The lining system on the roof plates and rafters of the tank is completely failed and should be replaced. Moderate to minor corrosion observed.

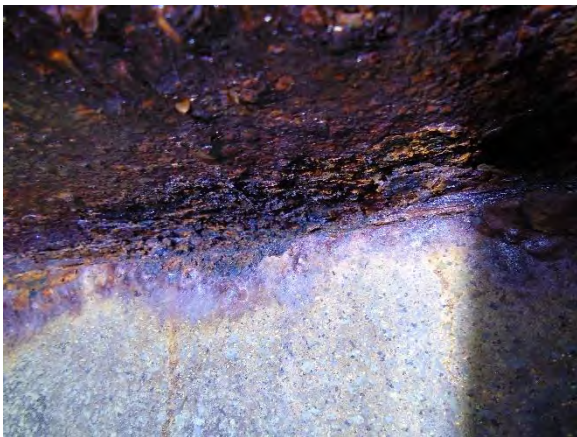
Photo 4-5 Rafter fused to roof plate

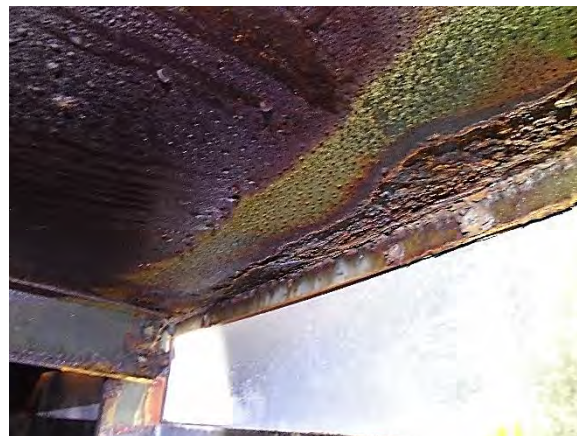
Photo 4-7 Coating and corrosion above shell vents and roof plates

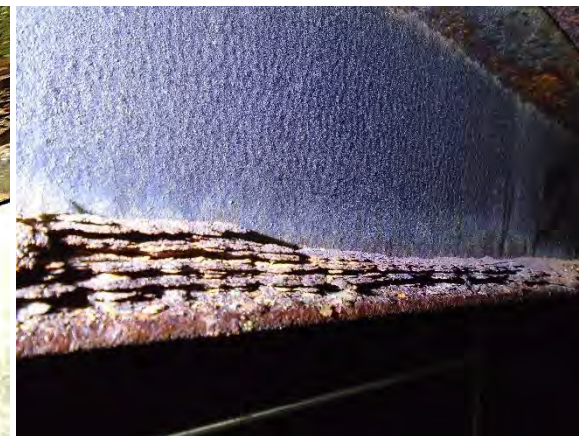
Photo 4-8 Failed coating and corrosion on rafter

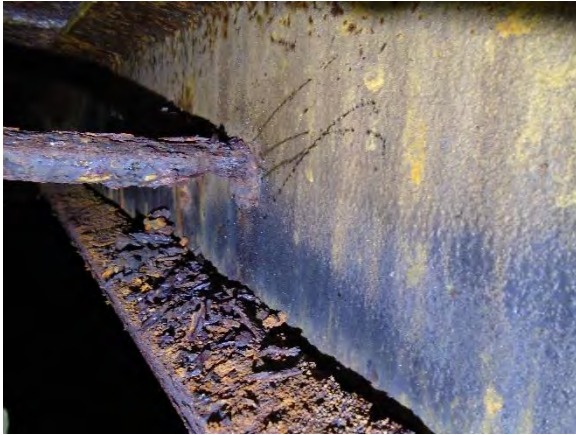
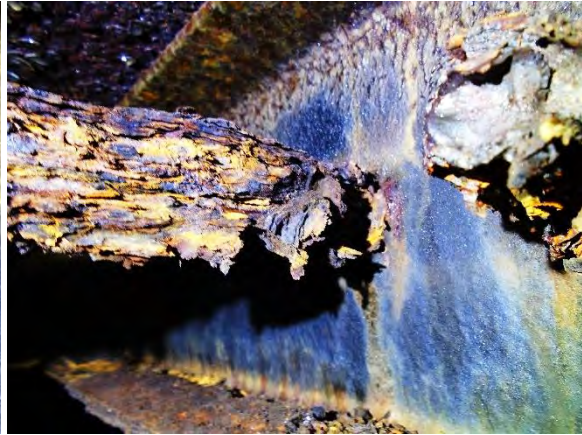
Corrosion and failed coating along rafter lips and rafter stabilizer rods.

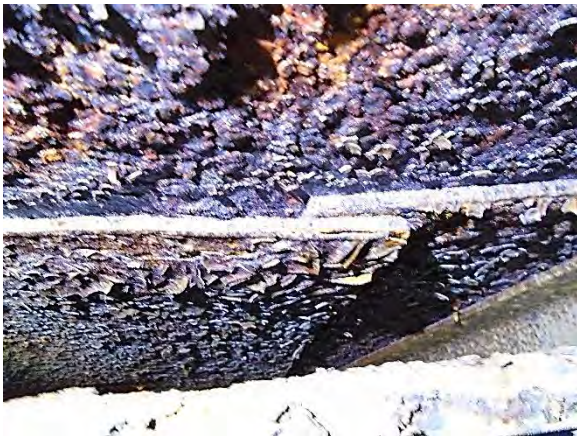
Photo 4-11 Failed coating and corrosion on plate overlaps

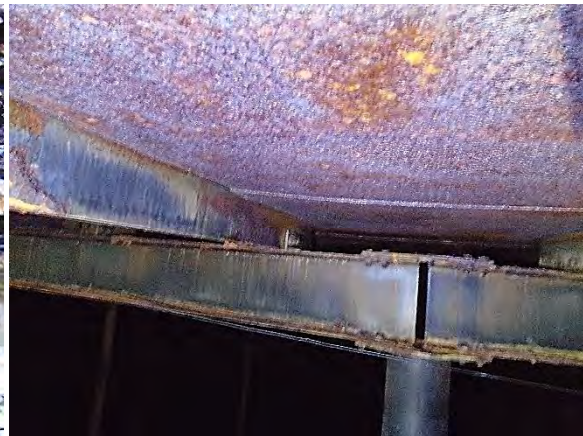
Photo 4-12 Failed coating on supports and roof plates

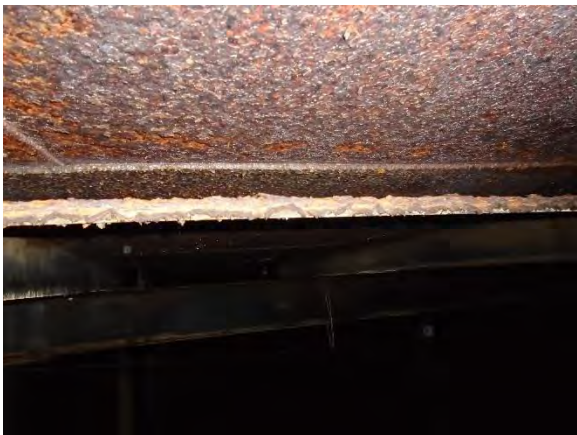
Photo 4-13 Failed coating roof plates / INT bay

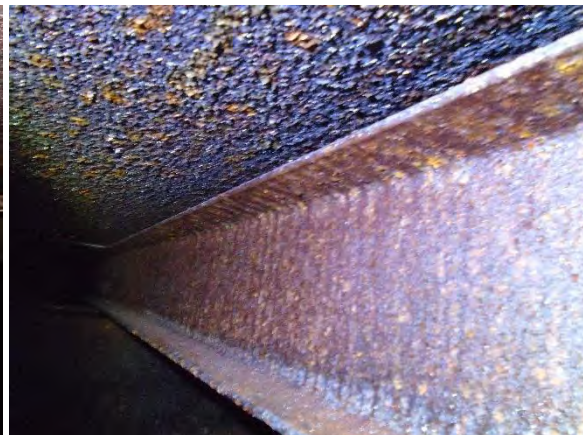
Photo 4-14 Failed coating / INT Bay

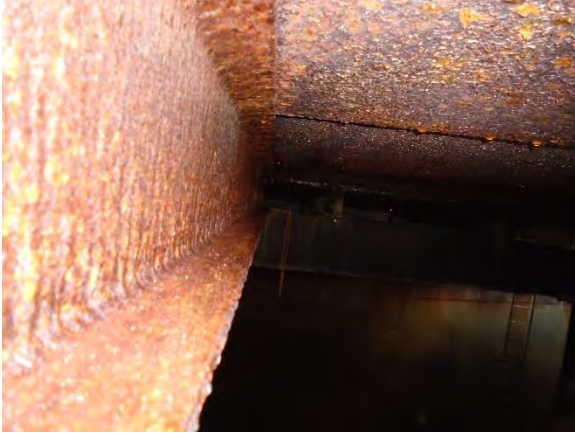
Photo 4-15 Failed coating/ INT bay

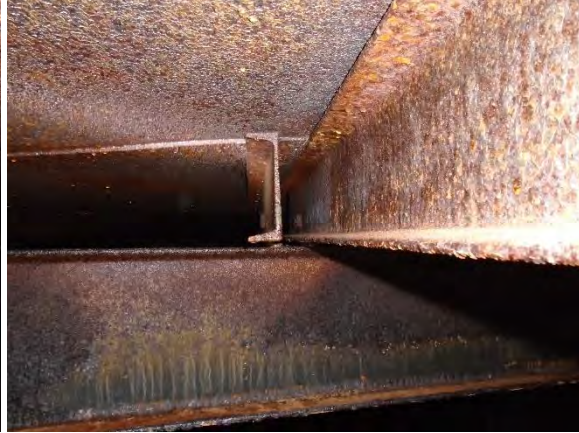
Photo 4-16 Failed coating/INT bay

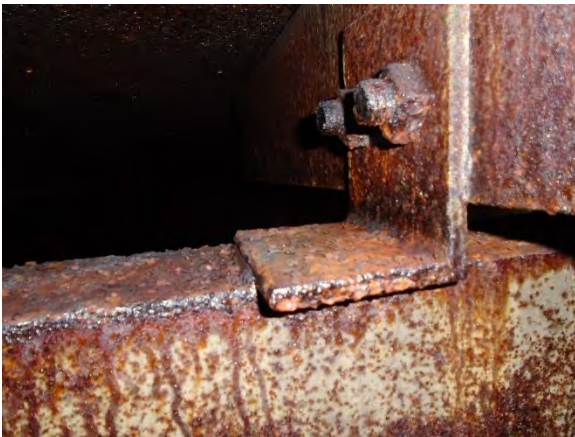
Photo 4-17 Failed coating center bay

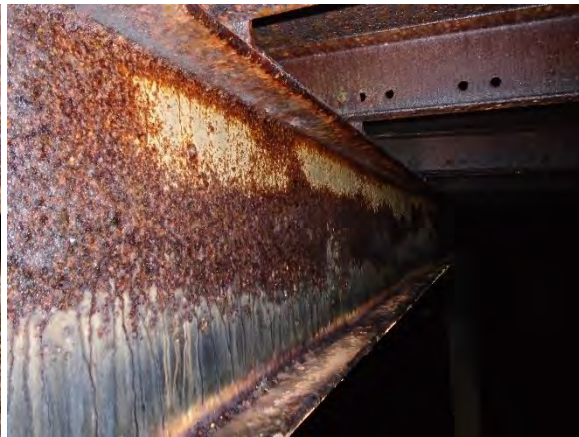
Photo 4-18 Failed coating center bay

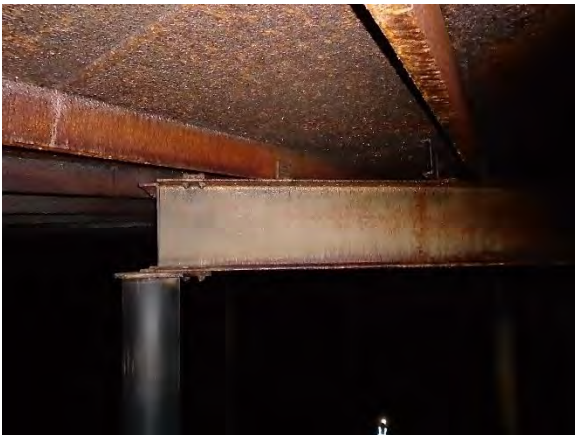
Photo 4-19 Center bay failed coating

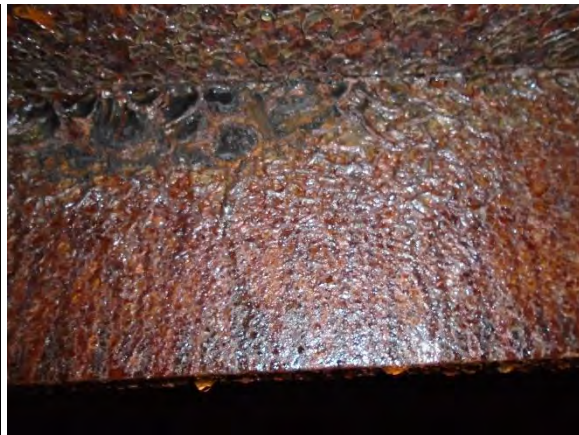
Photo 4-20 Center bay rafters fused to roof plate

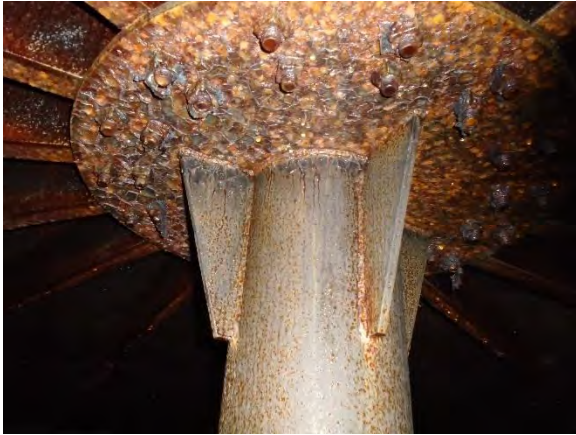
Photo 4-21 Failed coating on dollar plate

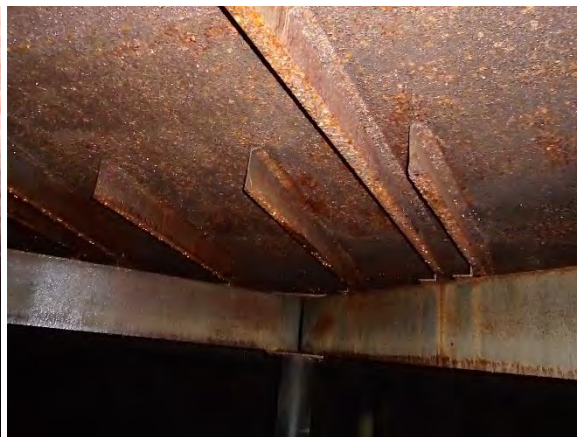
Photo 4-24 Failed coating on rafters and roof plates

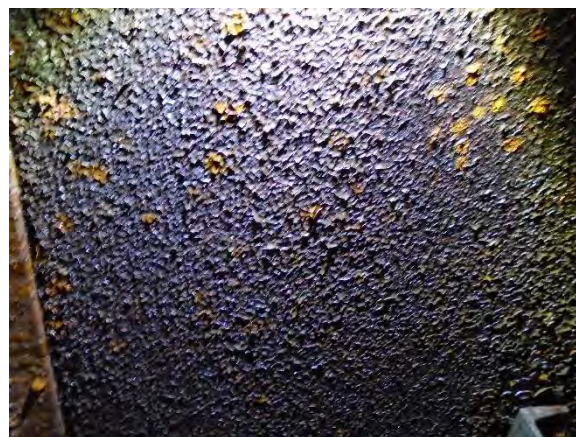
Photo 4-25 Failed coating on roof plates

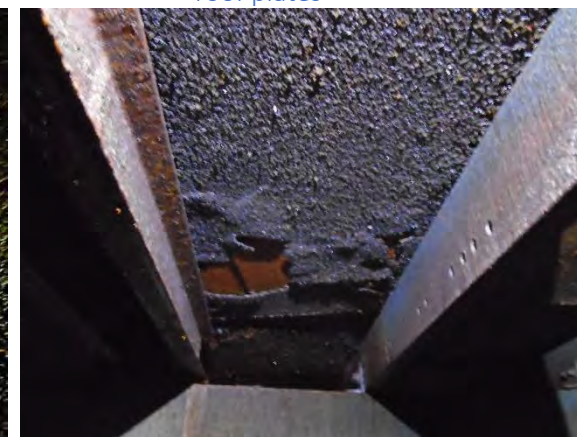
Photo 4-26 Failed coating on roof plates

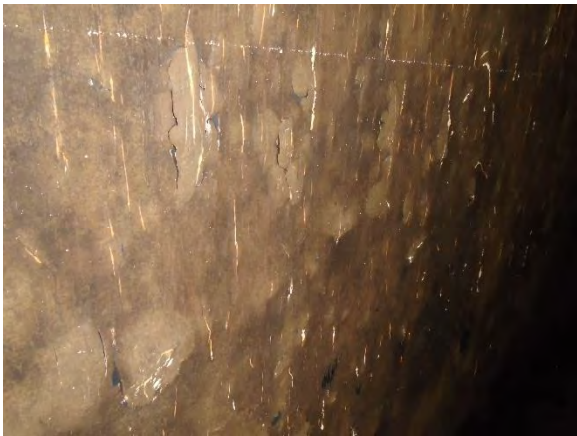
Photo 4-27 Fractures and blisters coal tar enamel

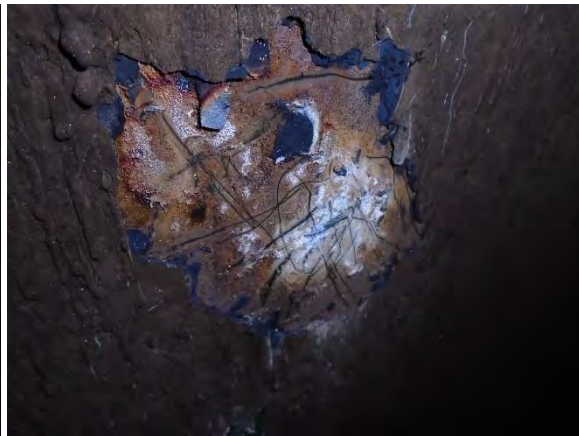
Photo 4-28 Blisters and fractures

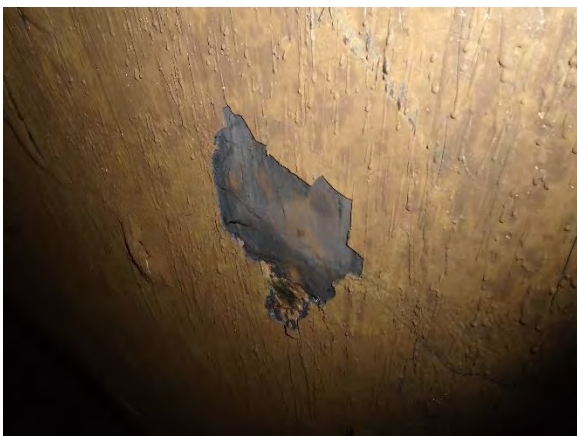
Photo 4-29 Steel being protected by C/P

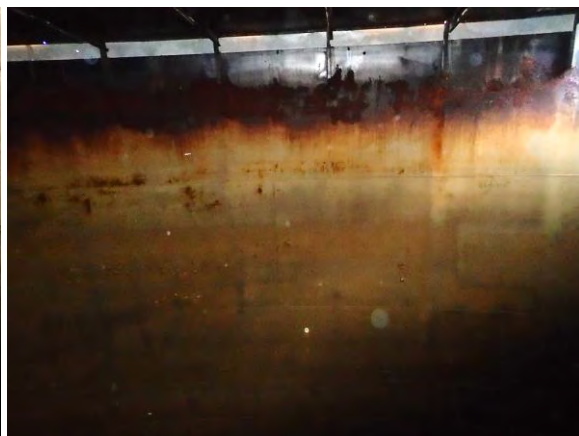
Photo 4-30 Under blister steel being protected

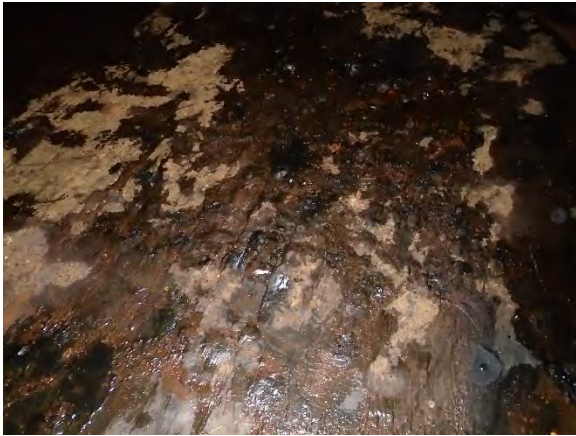
Photo 4-31 Corrosion on shell above waterline

The upper shell in the vapor area of the tank could have excessive pitting and along the shell to roof plate interface. The lower area of the shell that are in immersion is being protected by the cathodic protection system. The lining system on the shell plates of the tank is completely failed and should be replaced.

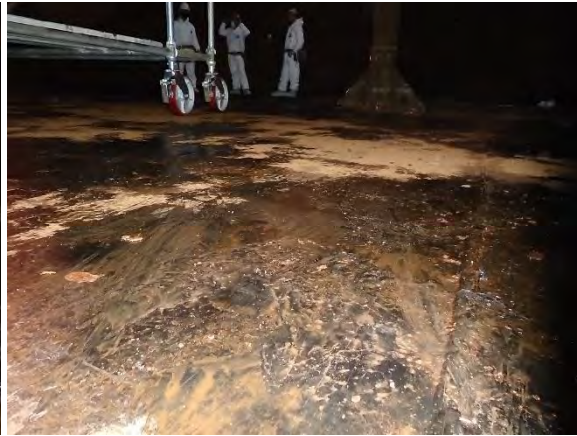
Photo 4-32 Blisters and fractures on floor

The floor plates are protected by the cathodic protection system. The lining system on the floor plates of the tank are completely failed and should be replaced.

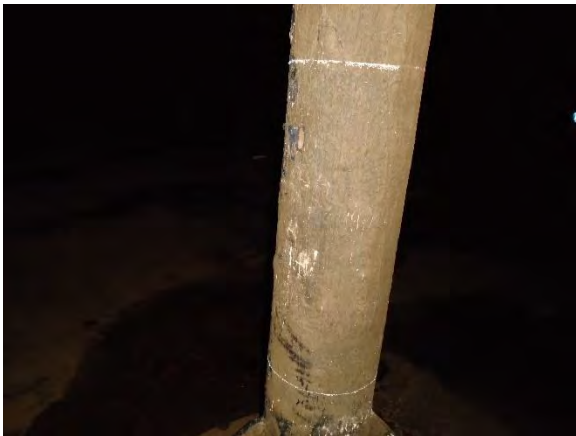
Photo 4-33 Blisters and fractures on floor

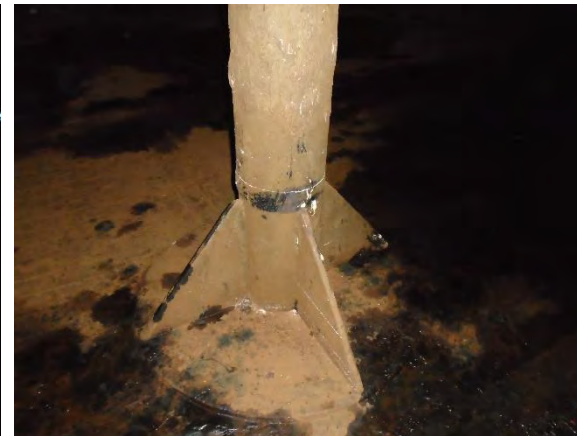
Photo 4-34 Blisters and fractures on column

The lower area of the columns that are in immersion is being protected by the cathodic protection system. The lining system on the columns of the tank is completely failed and should be replaced.

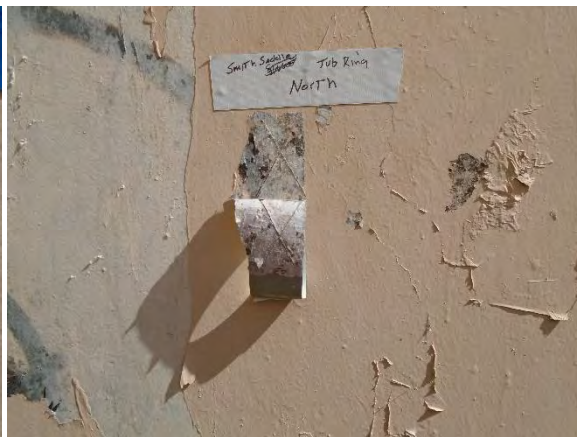
Photo 4-36 Poorly adhered coating/Mold growth

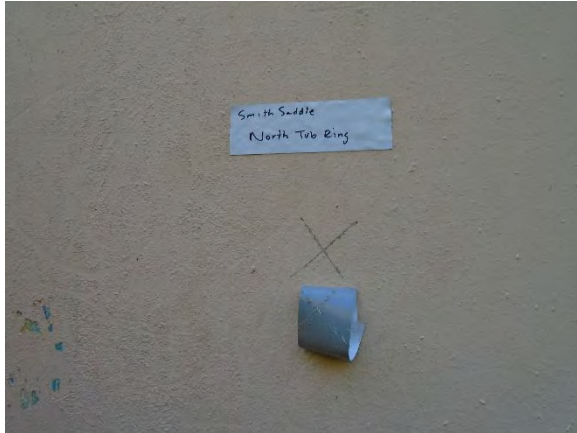
Photo 4-37 Tub ring ASTM D 3359 / result failed

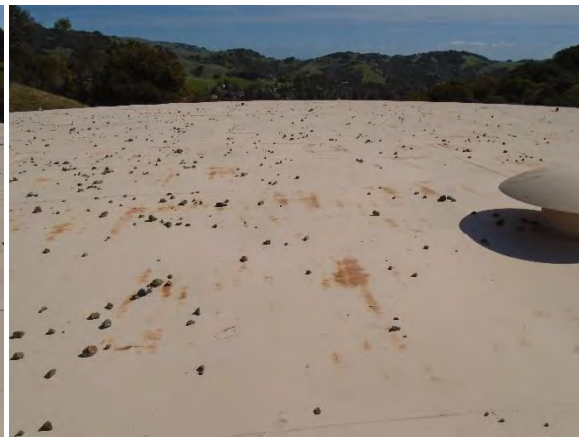
Photo 4-39 Corrosion developing through coating

The upper shell of the tank is in fair condition except along the walking trail which has excessive rock damage. The coating on the roof due to its age is thinning out and allowing the corrosion to come through the existing coating. The tub ring has been over coated numerous times and is poorly bonded. There is a light coat on the support shell that looks to be a water-based acrylic which is also poorly attached., for this reason over coating is not an option. The exterior coatings will require full removal and replacement.

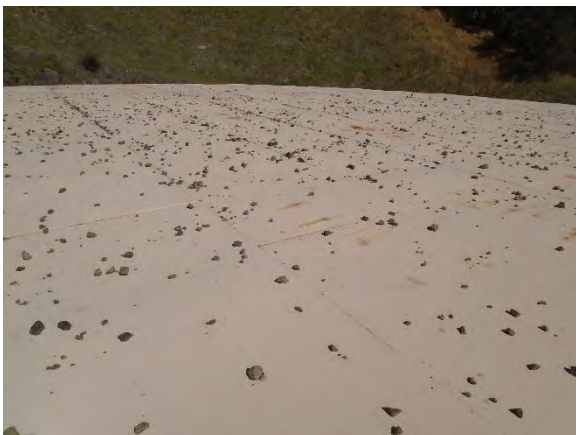
Photo 4-40 Corrosion developing through coating

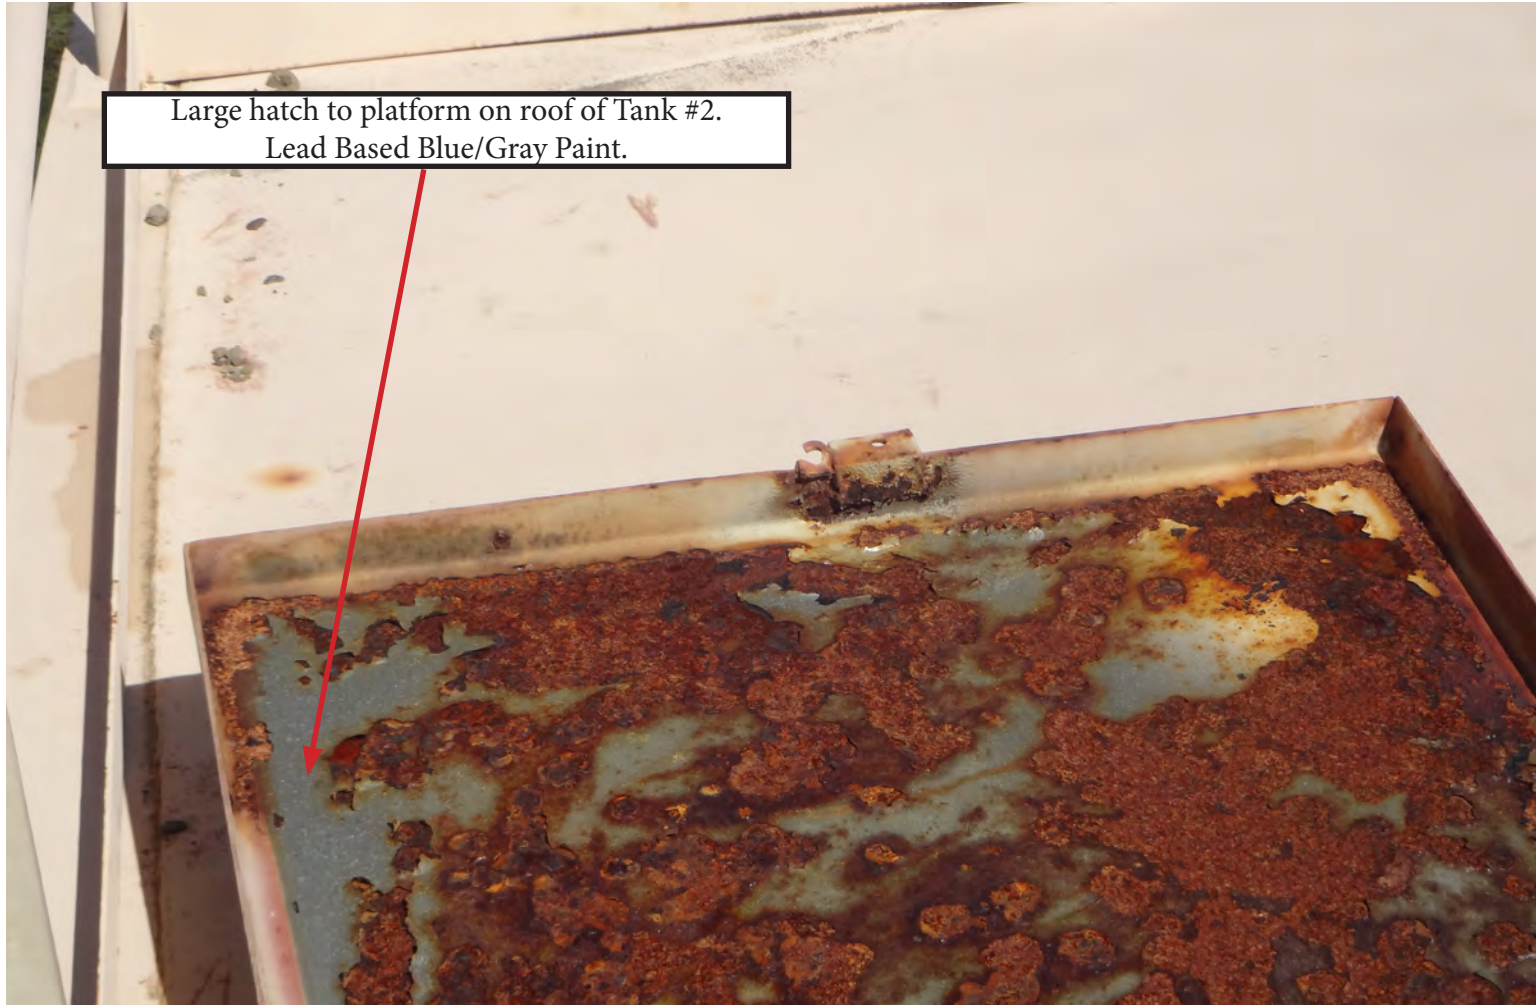
Large hatch to platform on roof of Tank #2.
Lead Based Blue/Gray Paint.
